Texas Reliability Entity Event Analysis

**Event:
June 23, 2010 DCS Event
Category 3 Event**

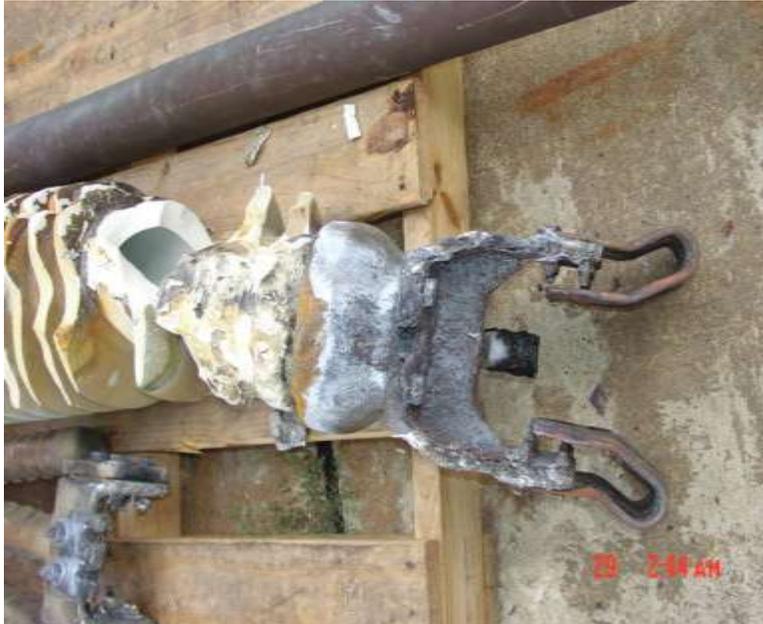
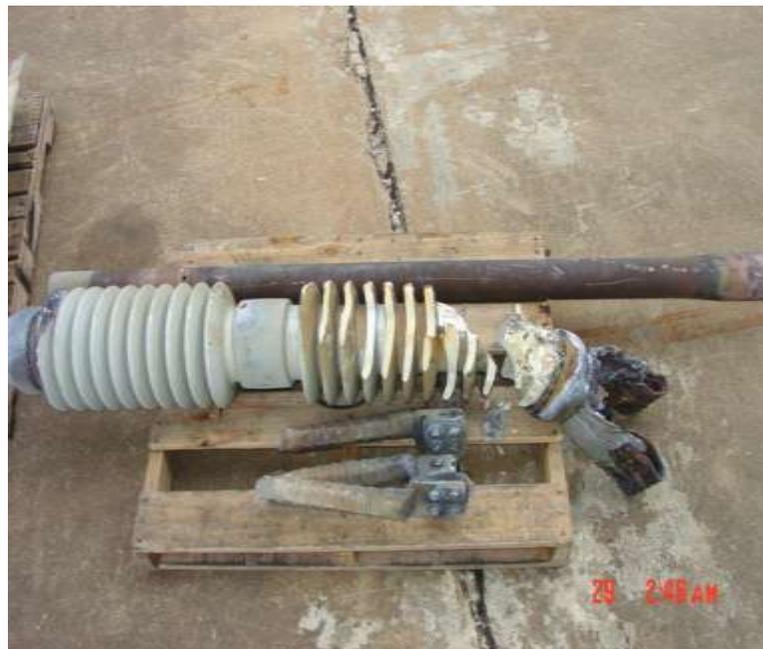
The root cause of the trip of Generating Station A Unit B was the failure of the main power transformer high-side 'C' phase disconnect switch. On June 23, 2010 at 15:19:46, a phase-to-ground fault occurred on the disconnect switch and lasted for 5.5 cycles before being isolated from generation and transmission systems. The amount of fault current measured by the Digital Fault Recorder (DFR) on the high-side was 16332 Amps rms. At the time of the fault, Generating Station A Unit B was producing 732 MW or roughly 1021 Amps per phase. The continuous rating of the 138kV switch was 4000 Amps per phase.

The high-side disconnect switch was installed in 1992, replacing the original switch installed when the plant first commenced operations in 1972. The switch was a vertical-break single-ended gang switch. Generator Operator N reported that the switch operated successfully a few days prior to the event. It appears that the connection point broke off the switch just before the jaw (see pictures in Appendix 1). The top portion of the standoff post insulator disintegrated due to the fault (see pictures in Appendix 1). The fault destroyed the switch and with it any evidence of metal fatigue, although that appears to be a likely cause of failure. Contamination was also a possible source given the plant's location in an industrial environment near saltwater.

Disconnect Switch "C" Phase After Fault

Generator Operator N's procedures required the company to inspect the switches every two years, from 1992 to 2007. In 2007, Generator Operator N changed its inspection interval to every 18 months. Recently, Generator Operator N stated it would now conduct switch inspections, testing, and cleaning on an annual basis during unit maintenance outages. They also plan to conduct monthly infrared inspections of these switches

- After replacing the failed disconnect switch on its step-up transformer, Generator Operator N attempted to analyze the disconnect switch failure but in the end determined that it would increase its monitoring intervals to annual reviews along with monthly infrared camera inspections.
