Texas Reliability Entity Event Analysis

Event:
August 20, 2010 DCS Event
Category 3 Event

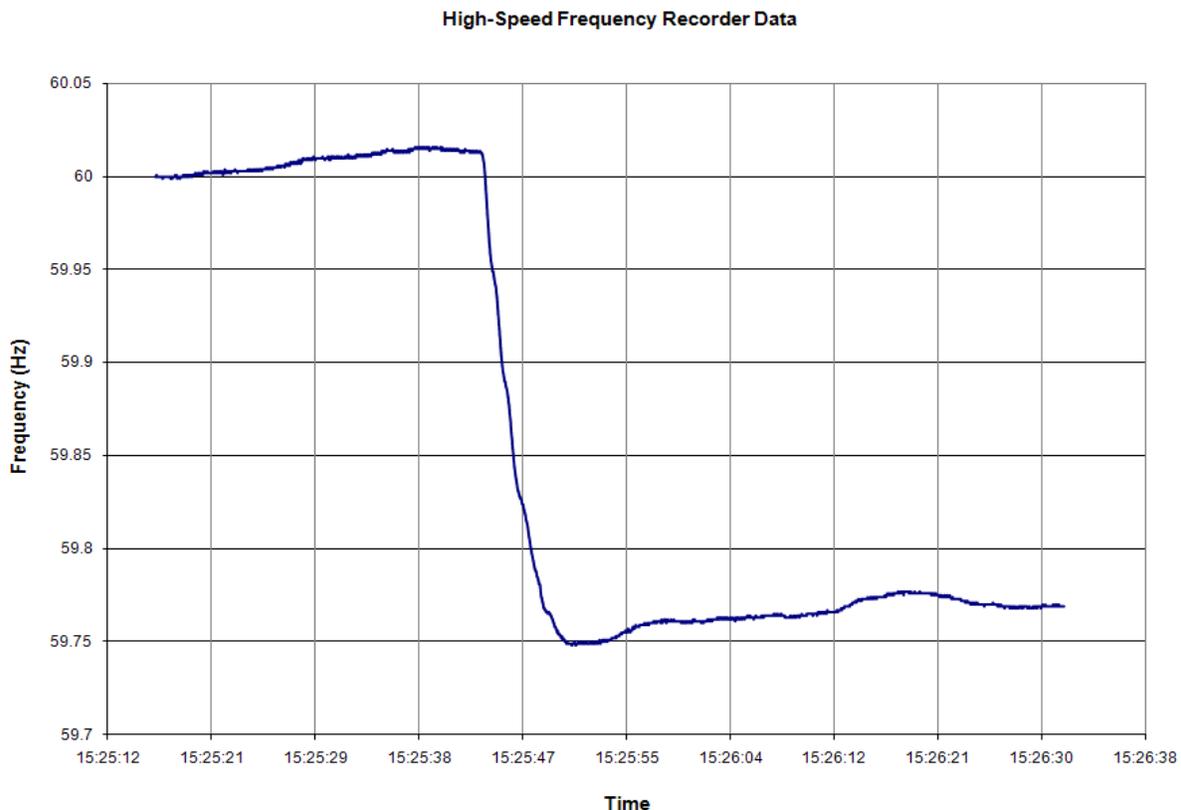
High-Speed Frequency Recorder Data on August 20, 2010.

- Generator governor response arrested the frequency decline, as analyzed by the Performance, Disturbance, Compliance Working Group (PDCWG) in its draft report. The initial calculated system frequency response, termed the “B” point, was 208.63 MW/0.1 Hz, which failed to meet the target of 420 established in ERCOT Protocols 5.9.2. The second calculated response point, termed “B+30” to denote that it measures how well response is sustained 30 seconds after the event, declined to 159.30 MW/0.1 Hz, which also failed to meet the minimum response target.
