# Texas Reliability Entity Event Analysis

**Event:**  
**November 3, 2010 DCS Event**  
**Category 3 Event**

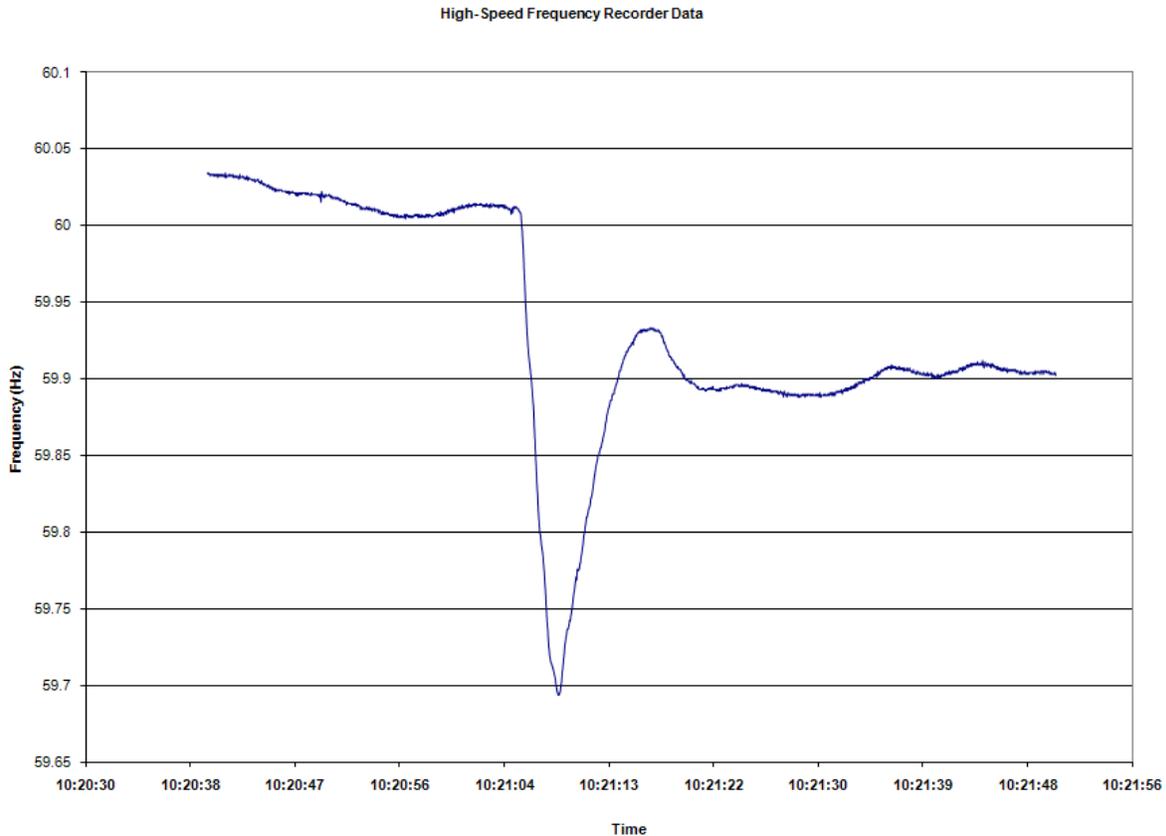
*High-Speed Frequency Recorder Data on November 03, 2010.*

- Generator governor response arrested the frequency decline, as analyzed by the Performance, Disturbance, Compliance Working Group (PDCWG) in its draft report. The initial calculated system frequency response, termed the “B” point, was 153.76 MW/0.1 Hz, which failed to meet the target of 420 established in ERCOT Protocols 5.9.2. The second calculated response point, termed “B+30” to denote that it measures how well response is sustained 30 seconds after the event, declined to 19.8 MW/0.1 Hz, which also failed to meet the minimum response level. The PDCWG also noted the following concerns:

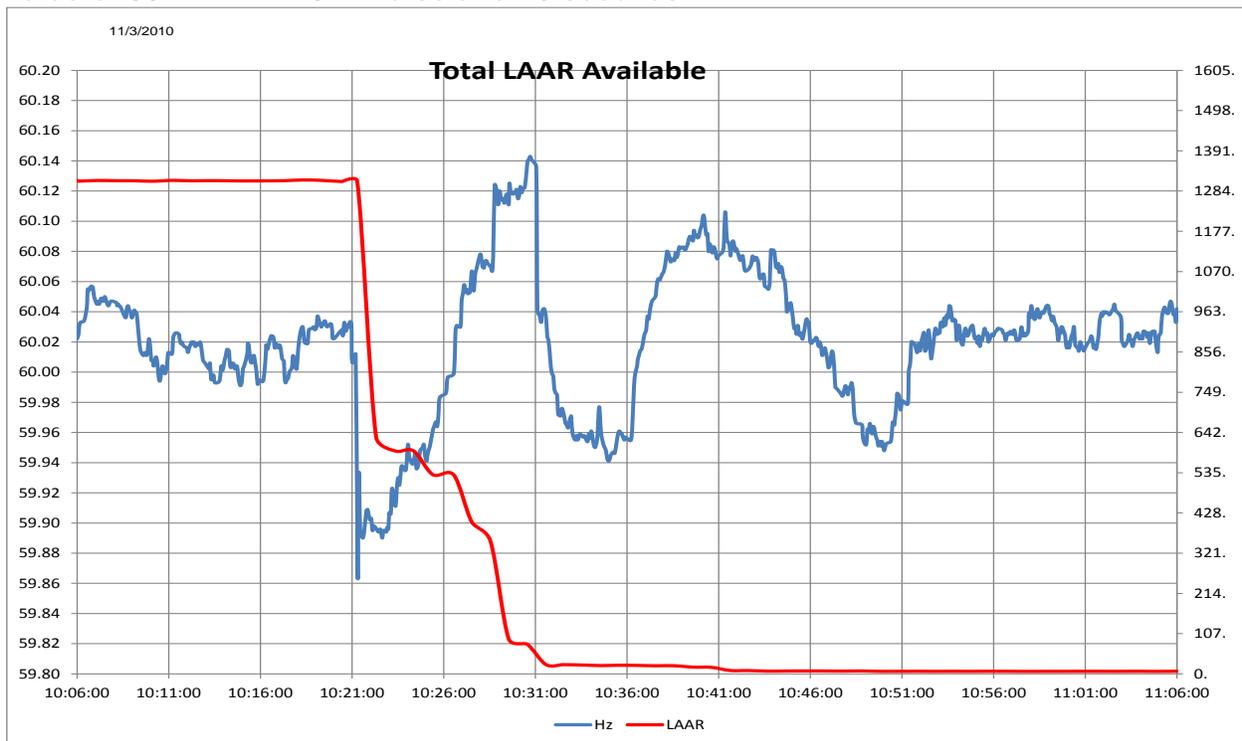
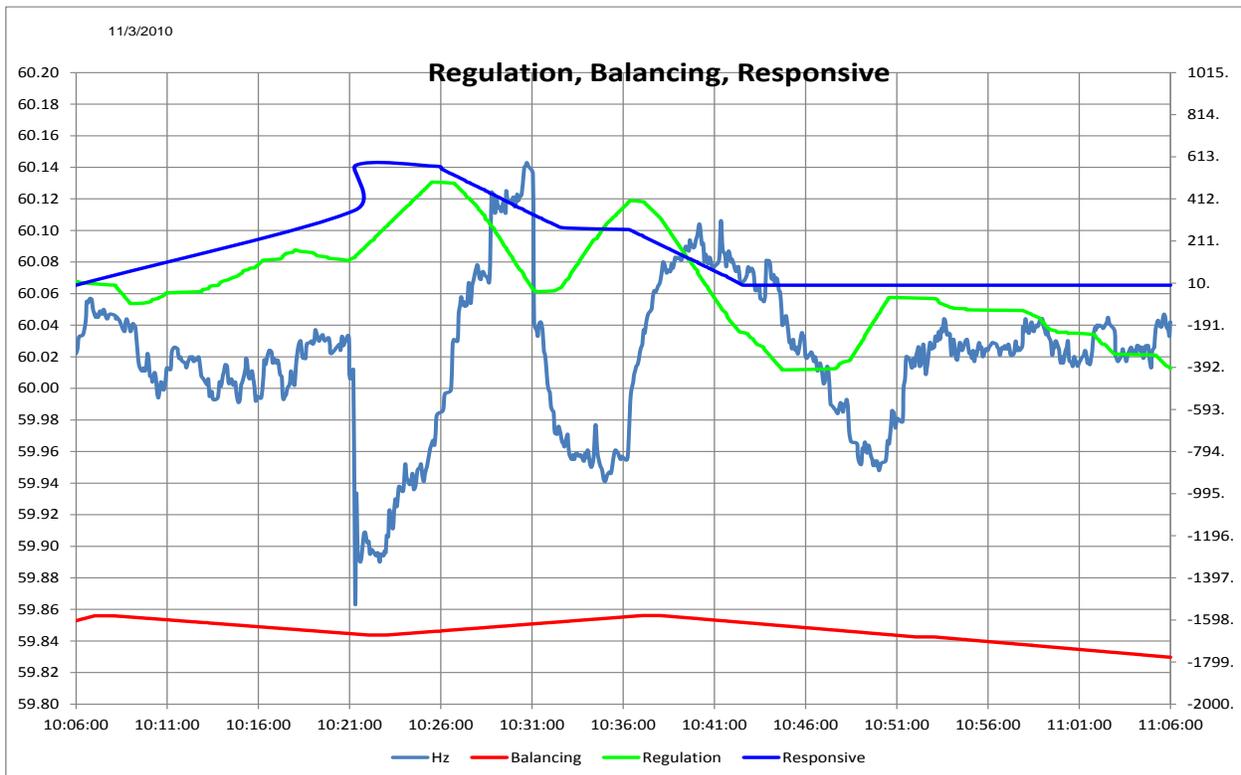
The result of these actions was that system frequency returned to its pre-disturbance value of 60 Hz within 5 minutes and 10 seconds.
