Texas Reliability Entity Event Analysis

Event:
December 11, 2010 Loss of Multiple Generators
Category 3 Event

Texas Reliability Entity
July 2011

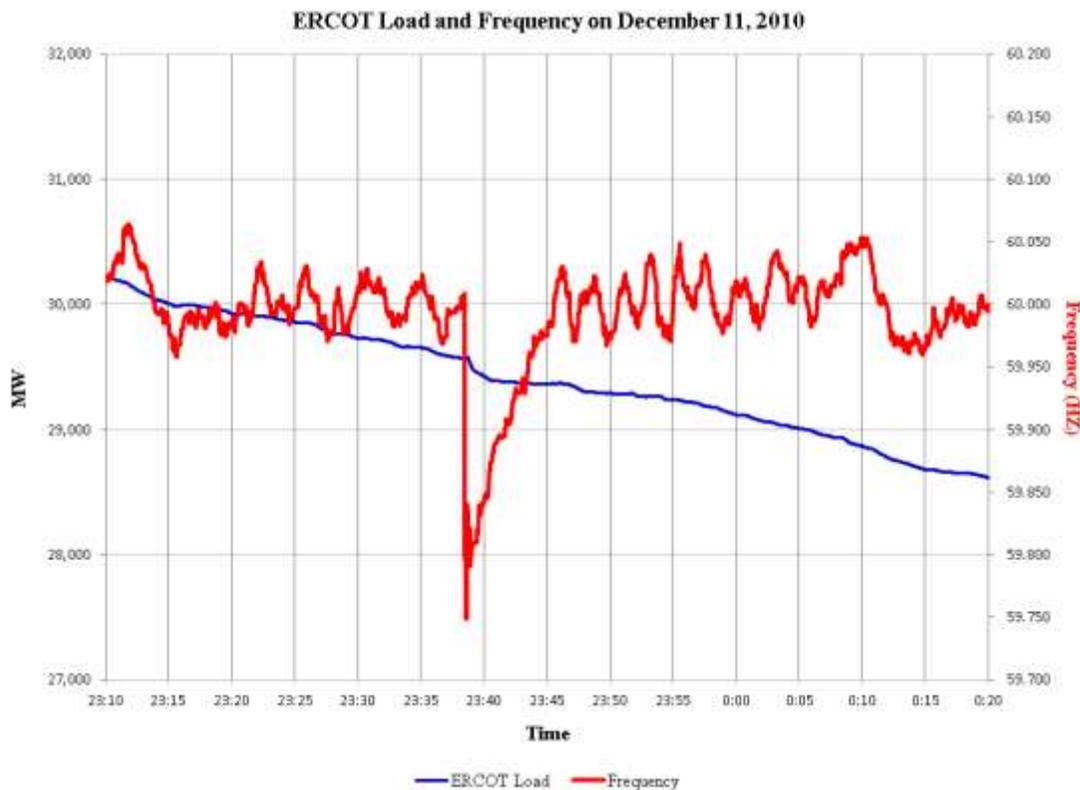
At 23:38:34 ERCOT Region load was 29,574 MW and total wind generation was 4933 MW.

ERCOT Region Load and Frequency on December 11, 2010.

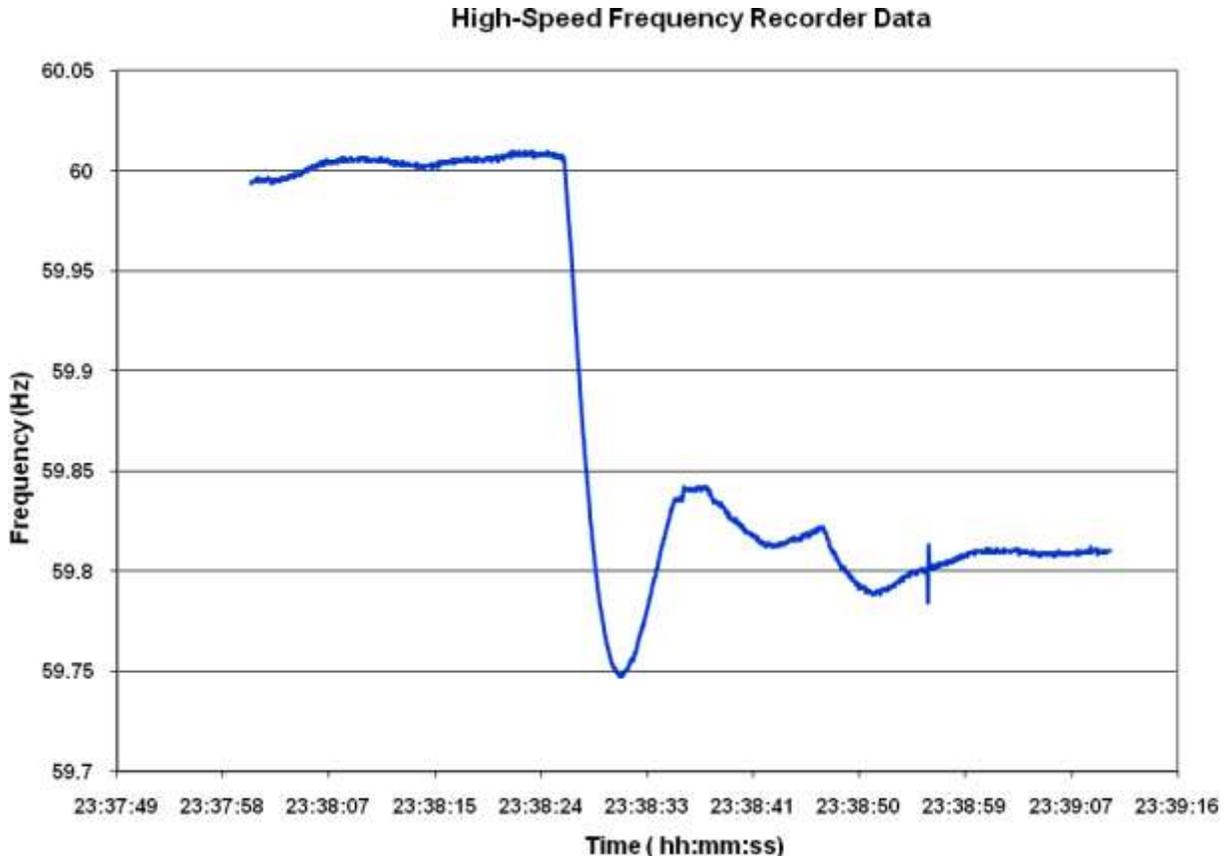
ERCOT Region frequency (measured at the RC control center) was at 60.009 Hz immediately prior to the disturbance. Immediately after the disturbance, system frequency dropped to 59.749 Hz. The following are among the actions that registered entities initially took to stabilize the system:

High-Speed Frequency Recorder Data on December 11, 2010.

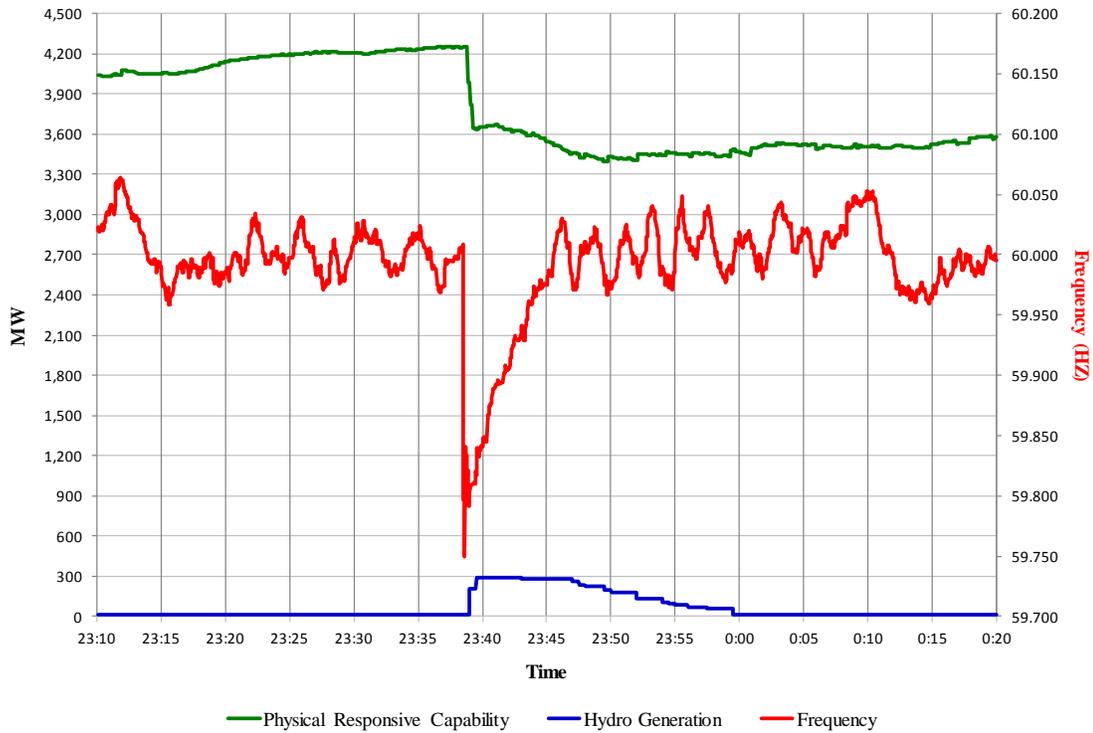
**Physical Responsive Capability, Hydro Generation & ERCOT Frequency
on December 11, 2010**

The recovery from the initial disturbance did not take ARR below 3000 MW, the point at which an "Advisory" is called for in ERCOT Protocols. The Physical Responsive Reserve remained above 3400 MW during the event and recovery.

*Physical Responsive Capability, Hydro Generation and Frequency on
December 11, 2010.*
