# Texas Reliability Entity Event Analysis

**Event:**  
**February 3-4, 2011**  
**Lower Rio Grande Valley Load Shed**  
**Category 2f.1 Event**

Texas Reliability Entity  
August 26, 2011

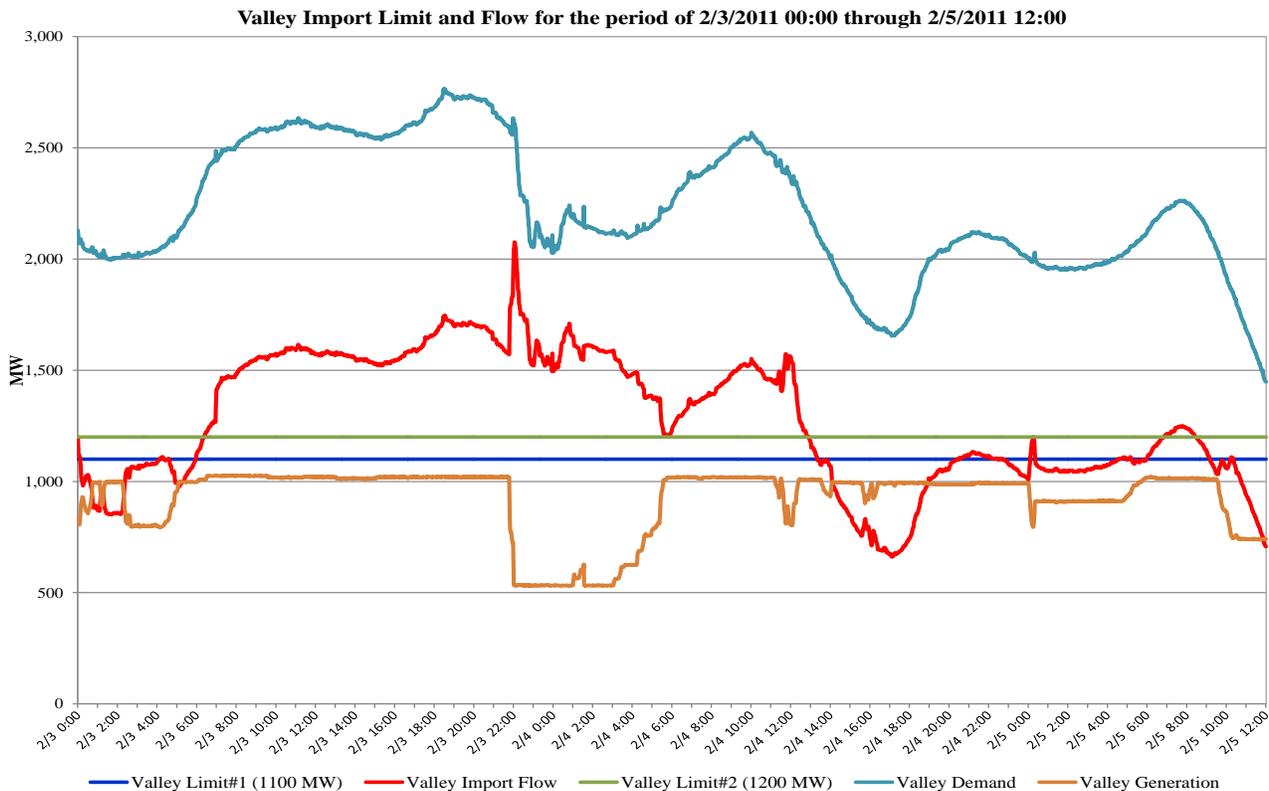
Figure 1: Valley Import Flow, Demand, and Generation

On February 3, 2011, the transmission import level into the LRGV exceeded the 1100 MW Valley Import Limit at 05:58 and remained above this level for over 31.4 hours until February 4, 2011 at 13:20. The import level into the LRGV exceeded 1200 MW at 06:22 and remained above this level for over 30.5 hours until February 4, 2011 at 12:55.

The following graphs show LRGV Area demand and generation in relation to the Valley Import Limit. As previously stated, the Valley Import Limit was exceeded from 05:58 on February 3, 2011 until 13:20 on February 4, 2011 due to the generation outages and high loads in the LRGV. The trips of the Generation Station A generation units from 21:37 to 22:00 caused the Valley import to reach a maximum flow of 2077 MW at 22:03. DC tie flows were unavailable due to transmission issues.

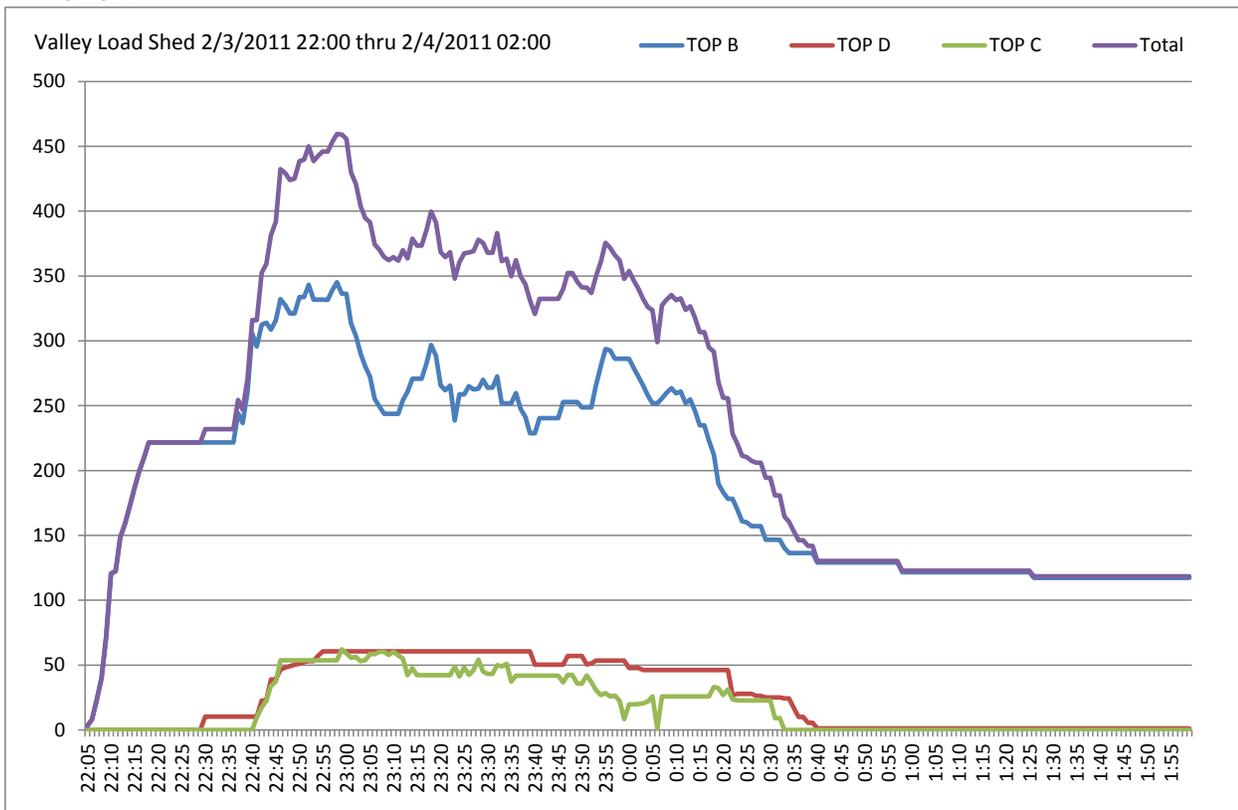
*Figure 3: Real-time Manual Load Shed Performance*

The following chart shows the real-time performance of the load shed actions that were taken.
