Texas Reliability Entity Event Analysis

Event:
**March 14, 2011 Loss of Multiple Elements
Category 1b Event**

Texas Reliability Entity
July 2011

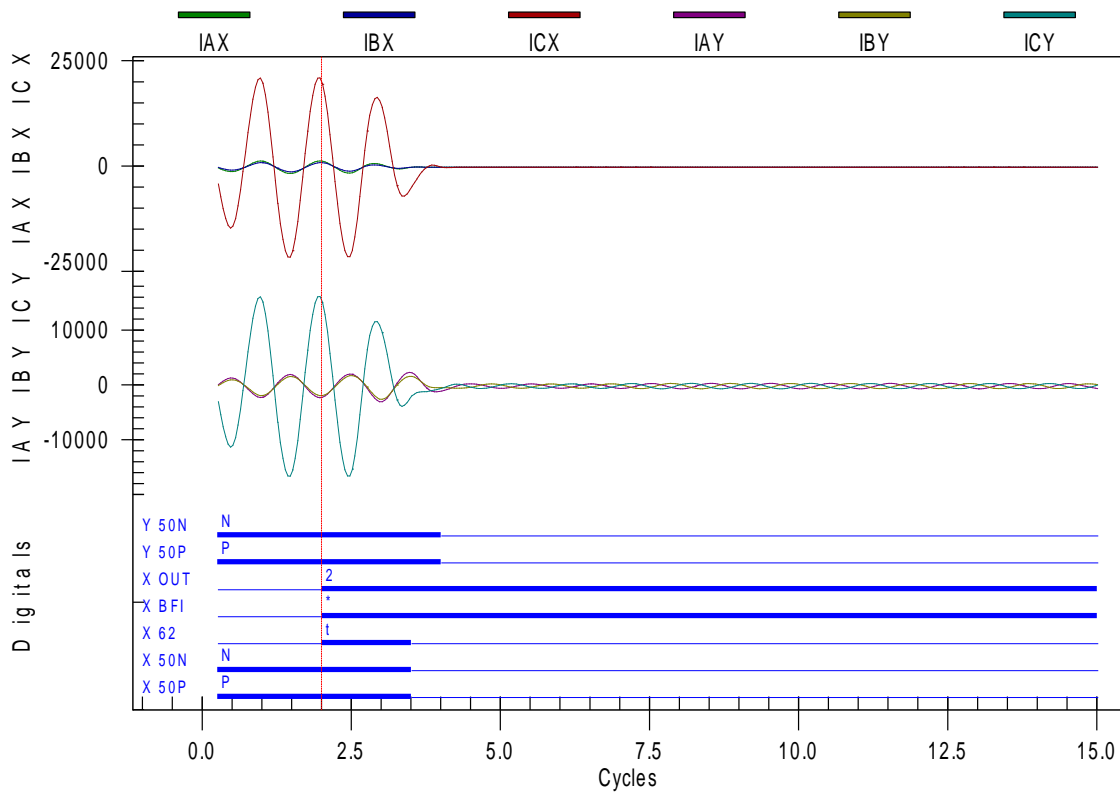
Figure 1: Initial fault at Generation Station A

A lightning strike hit the 345 kV bus B at Generation Station A. Initially the bus B differential tripped out. Transmission Owner A reported evidence of a phase to ground fault on the C phase of a Current Transformer (CT) near GCB XXX-1, which appears to be the cause of the bus B differential. Approximately 9 seconds later, the 345 kV bus C tripped out from a second fault due to a flashover across the “C” phase CT near GCB YYY-1. All faults were cleared by appropriate relay action in 3-4 cycles (Bus B differential, Bus C Differential and GCB YYY-1 breaker failure).

The 345 kV CT on GCB YYY-1 was replaced. The 345 kV CT on GCB XXX-1 was inspected and insulator was cleaned, but did not require replacement. Both breakers and CTs have been returned to service.

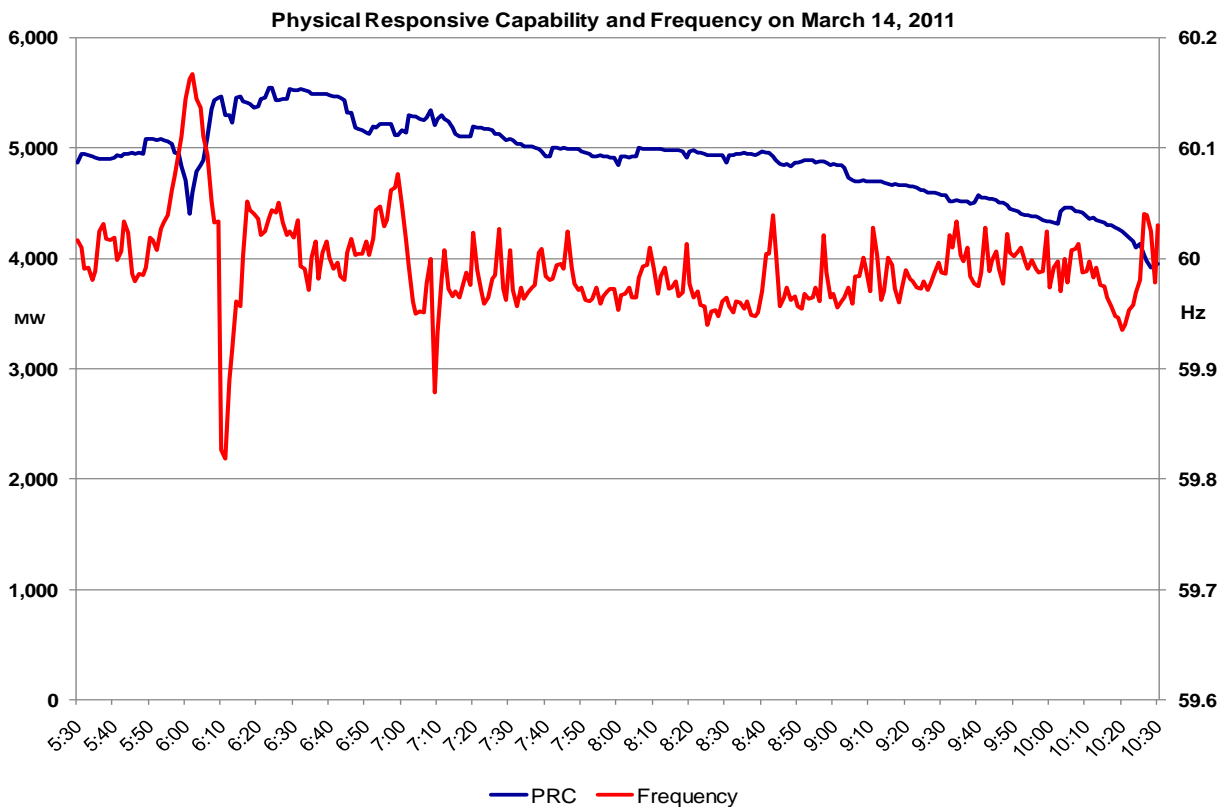
Figure 3: Physical Responsive Capability and Frequency on March 14, 2011.

The recovery from the initial disturbance did not take Physical Responsive Capability below 3000 MW, the point at which an “Advisory” is called for in ERCOT Protocols. The Physical Responsive Reserve capability remained above 5200 MW during the event and recovery.
