Texas Reliability Entity Event Analysis

Event: April 11, 2011 Loss of Multiple Elements Category 1b Event

Texas Reliability Entity
July 2011

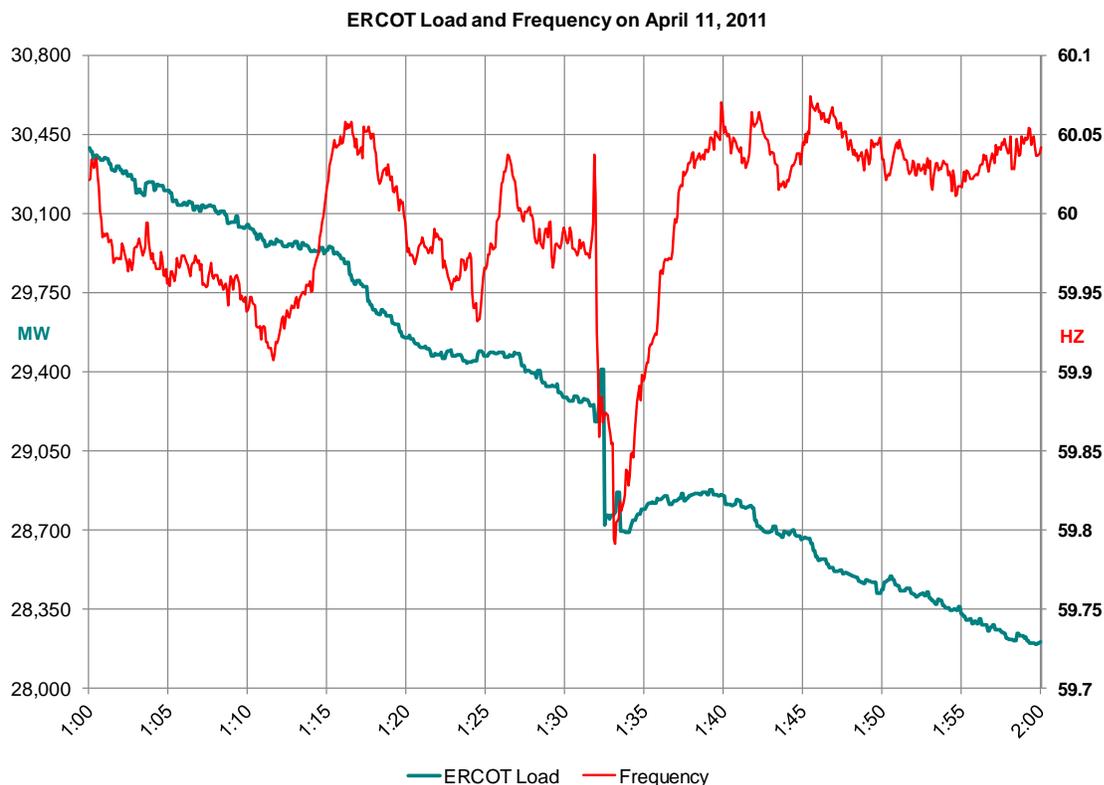
Figure 1 ERCOT Region Load and Frequency on April 11, 2011

System frequency dropped from 60.037 Hz to 59.791 Hz as a consequence of the loss of generation. The drop was arrested by governor action of ERCOT Region generators. These actions led to system frequency recovery within 4 minutes to the pre-disturbance value of 60 Hz (at 01:37:10). Balancing Authority (BA) Physical Responsive Capability (PRC) remained above minimum target of 2300 MW set by ERCOT Protocols for the

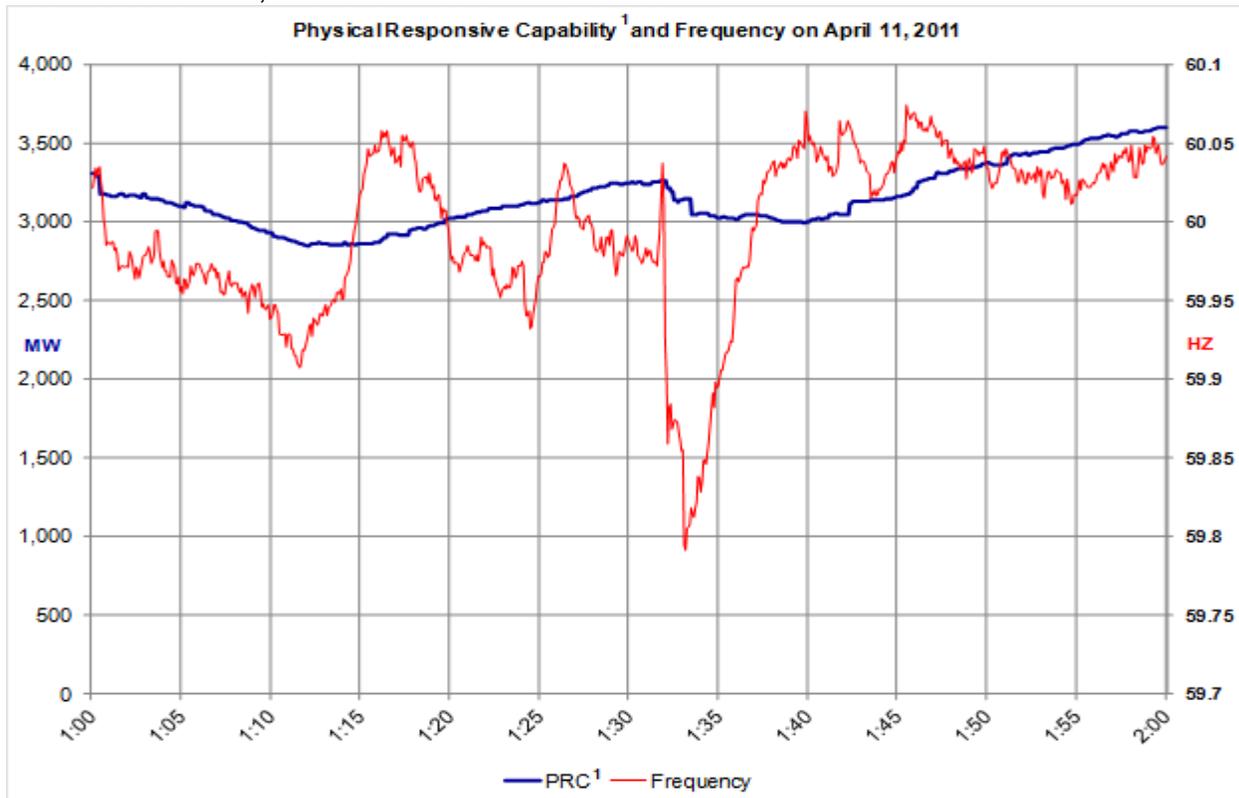
Figure 2: Physical Responsive Capability and Frequency on April 11, 2011.

The recovery from the initial disturbance temporarily dropped Physical Responsive Reserve capability below 3000 MW, the point at which an “Advisory” is called for in ERCOT Protocols, for one minute and 20 seconds.
