Texas Reliability Entity Event Analysis

Event:
**May 8, 2011 Loss of Multiple Elements
Category 1a Event**

Texas Reliability Entity
July 2011

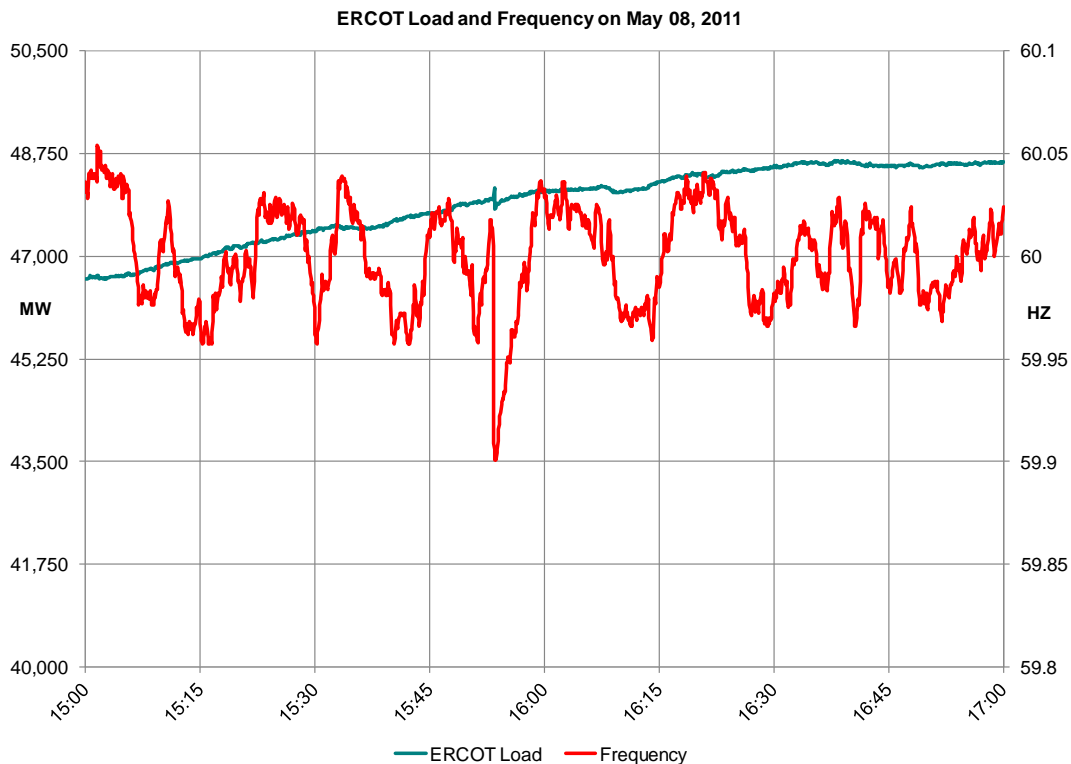
Figure 1 ERCOT Region Load and Frequency on May 08, 2011

System frequency dropped from 60.037 Hz to 59.901 Hz as a consequence of the loss of generation. The drop was arrested by governor action of ERCOT Region generators. Balancing Authority (BA) Physical Responsive Capability (PRC) remained above 4000 MW for the duration of the event.

ERCOT Region load was 47,795 MW and total wind generation was approximately 5,215 MW.

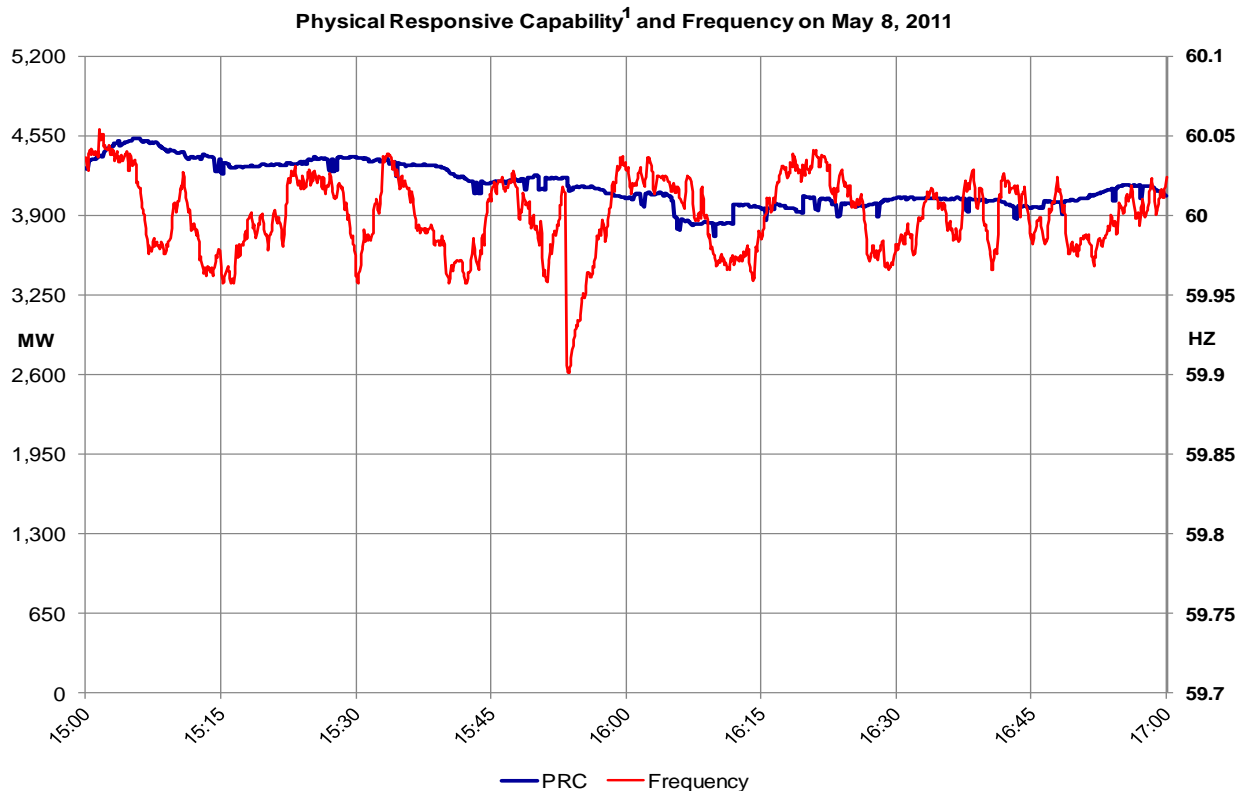
Figure 2: Physical Responsive Capability and Frequency on May 8, 2011

BA Physical Responsive Capability (PRC) remained above 4000 MW for the duration of the event.
