Texas Reliability Entity Event Analysis

Event:
November 29, 2011 DCS Event
Category 3 Event

Texas Reliability Entity
March 30, 2012

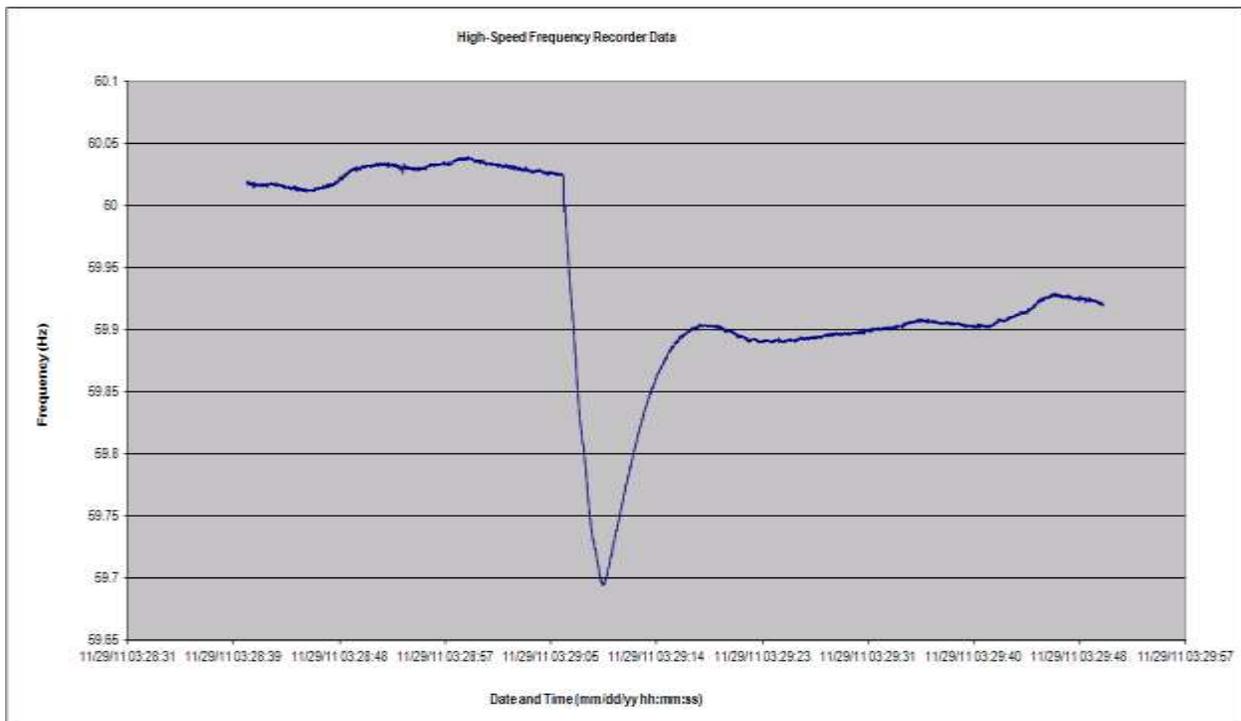
ERCOT region frequency was at 60.001 Hz immediately prior to the disturbance. Immediately after the disturbance, system frequency dropped to 59.732 Hz, based on 2-second scans. High-speed frequency recorders indicated that frequency dropped to 59.694 Hz. The following are among the actions that registered entities initially took to stabilize the system:

High-Speed Frequency Recorder Data on November 29, 2011.
