Texas Reliability Entity Event Analysis

Event:
March 19, 2012 Event
Category 1a(i) Event

Texas Reliability Entity
September 21, 2012

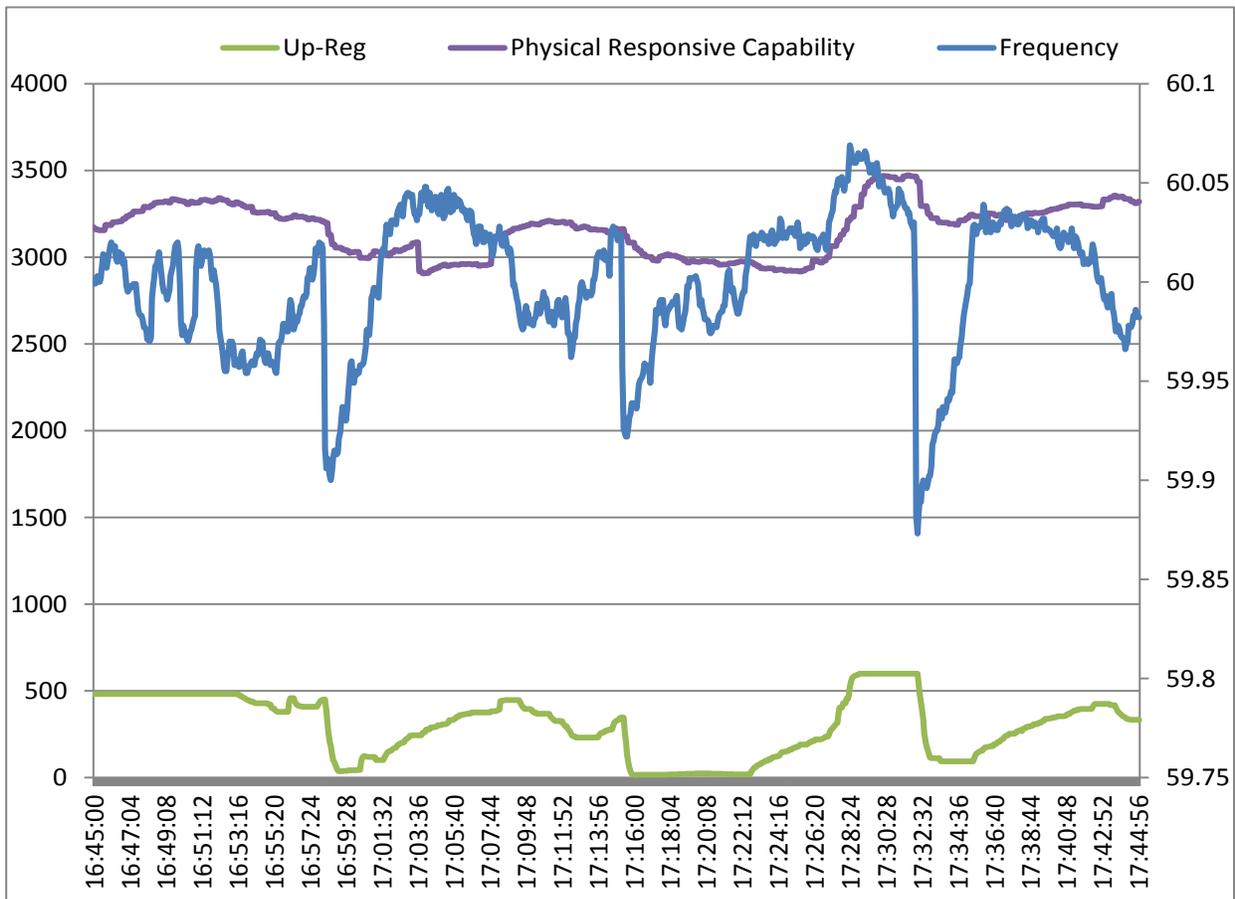
ERCOT region frequency was at 60.018 Hz prior to the disturbance. Immediately after the disturbance, system frequency dropped to 59.900 Hz, based on 4-second scans. The following are among the actions that registered entities initially took to stabilize the system:

- The BA's control center computer made a step deployment of 380 MW of generation regulation, within 10 seconds of the frequency bottom, modifying the setpoint sent to QSEs to accomplish this deployment. Texas RE did not identify any problems with this automatic deployment by ERCOT's system or the response from QSEs to ramp their generators output up within 10 minutes as required.
- As a result of these actions, system frequency returned to its pre-disturbance value of 60 Hz within 3 minutes and 15 seconds.
