# **Texas Reliability Entity, Inc. Event Analysis**

**Event:  
July 3, 2015  
Lower Rio Grande Valley  
Loss of Multiple Elements and Under-Voltage  
Load Shed (UVLS) Operation**

September 16, 2015

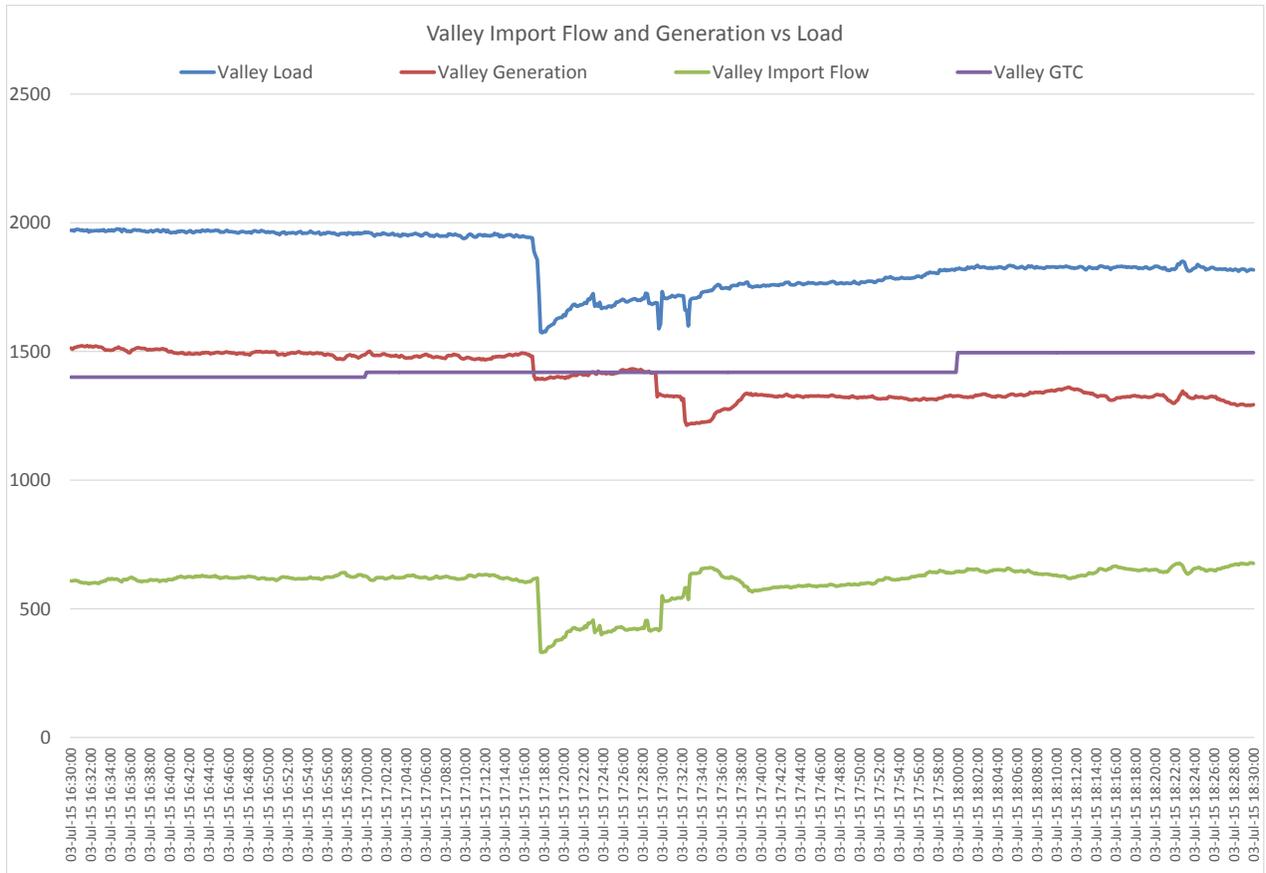
Figure 1: Valley Import Flow, Demand, and Generation

On July 3, 2015, the Valley load was approximately 1948 MW at the time of the event. Between 17:16 and 17:18, approximately 45,000 separate customers were affected as a result of the consequential load loss and UVLS relay operations. Telemetry data shows a loss of demand totaling 317 MW (16.3% of the total Valley load). UVLS relay operations and load loss consequential to the loss of the transmission equipment account for 187.5 MW (9.6% of the total Valley load) and end-use customer demand loss accounts for the remainder. See Figure 1 and Table 1.

The amount of load lost during the event that was not due to the UVLS relays tripping or due to the transmission line outages was 129.5 MW. This end-use customer demand loss could be the result of motor protective device action.

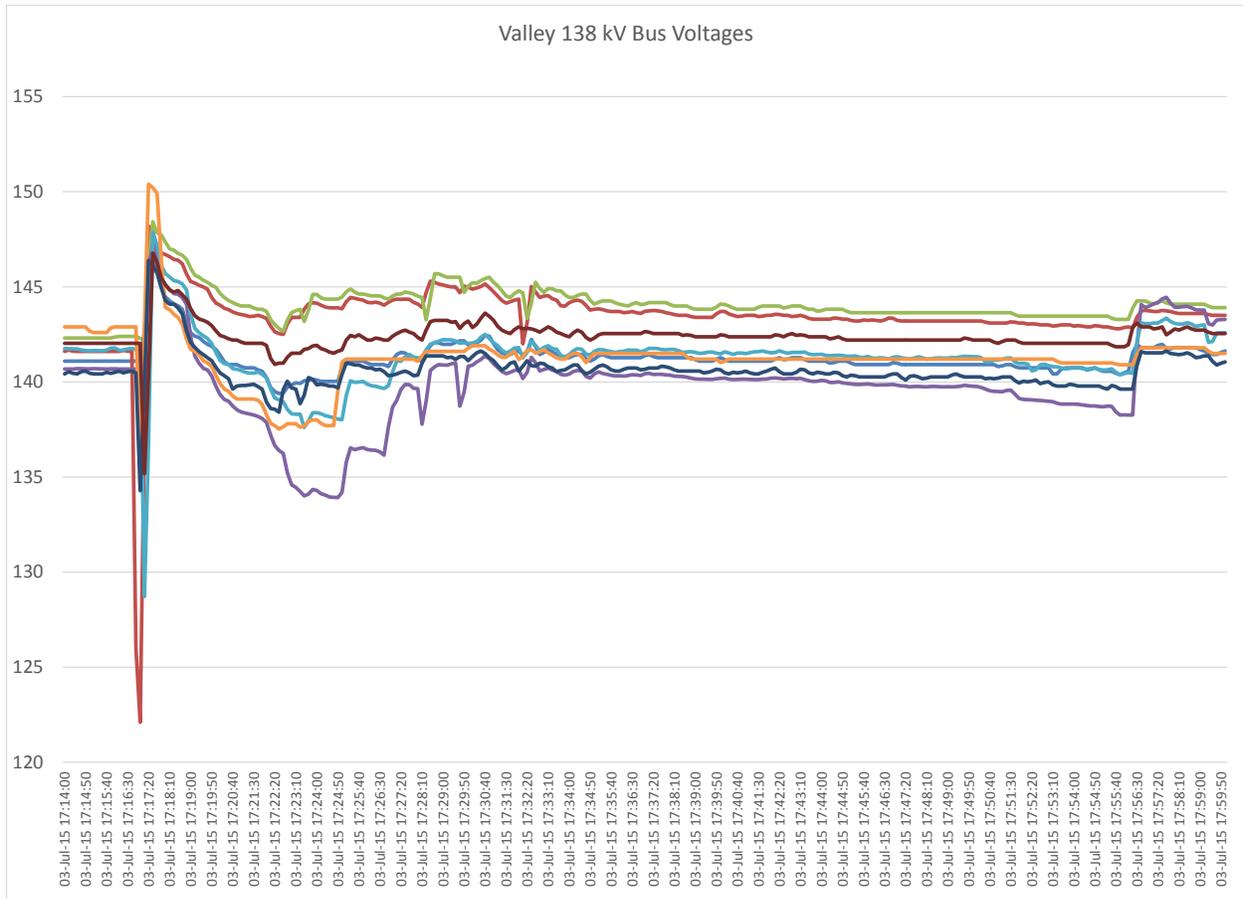
Figure 2: Rio Grande Valley 138 kV Bus Voltages July 3, 2015

Telemetry data shows area voltages momentarily dropping to 0.88 per unit at 17:17 on the 138 kV system and 1.00 per unit on the 345 kV system in the area. Following the loss of load by UVLS relays, 345 kV voltages peaked as high as 1.09 per unit and 138 kV voltages peaked as high as 1.08 per unit. Figures 9 and 10 show the trend for several 138kV and 345kV bus voltages in the area from 17:14 to 18:00 on July 3, 2015.

The loss of the STATCOM and capacitor bank was a key point in this event. Simulations conducted by Texas RE show that the loss of the STATCOM and capacitor bank created the extended low voltage condition which resulted in the UVLS relay operations in the area. The reactive power compensation of the STATCOM is a function of the voltage set point. The device is capable of providing +/- 150 MVAR. It is normally operated in voltage control mode with a typical setpoint of 1.03 per unit. The STATCOM unit tripped during this event with a cooling system trip indication. The auxiliary power to the STATCOM is critical to the operation of the cooling system. The cooling system has two pump motors that circulate coolant through the power electronics. During normal operation, one cooling pump is running and the other is on standby. If the power to the circulating pump is disturbed, the transfer switch will operate to switch to the backup feed and the backup pump. Both of the auxiliary power feeds to the transfer switch are fed from the same transmission source. If a major disturbance affects both feeds then the transfer switch does not have a good source to transfer to. This will cause the transfer to fail and the cooling system will trip off, interrupting the flow of cooling water. As a result, the STATCOM will trip off to protect the power electronics from loss of cooling. The preliminary investigation indicates that both power sources were affected by this event causing the auxiliary power transfer to fail. The capacitor bank tripped when the STATCOM tripped. The circuit breaker for the capacitor bank is interlocked with the STATCOM circuit breaker through a 52a contact in the trip logic. The loss of capacitor bank had the effect of removing an additional 57.6 MVAR of reactive support in the area and further reduced voltages in the area. The loss of the STATCOM and capacitor bank are modeled as separate, distinct contingencies in RTCA as well as the planning models; however, actual system design is set up to trip both elements which have a combined rating of 207.6 MVAR.

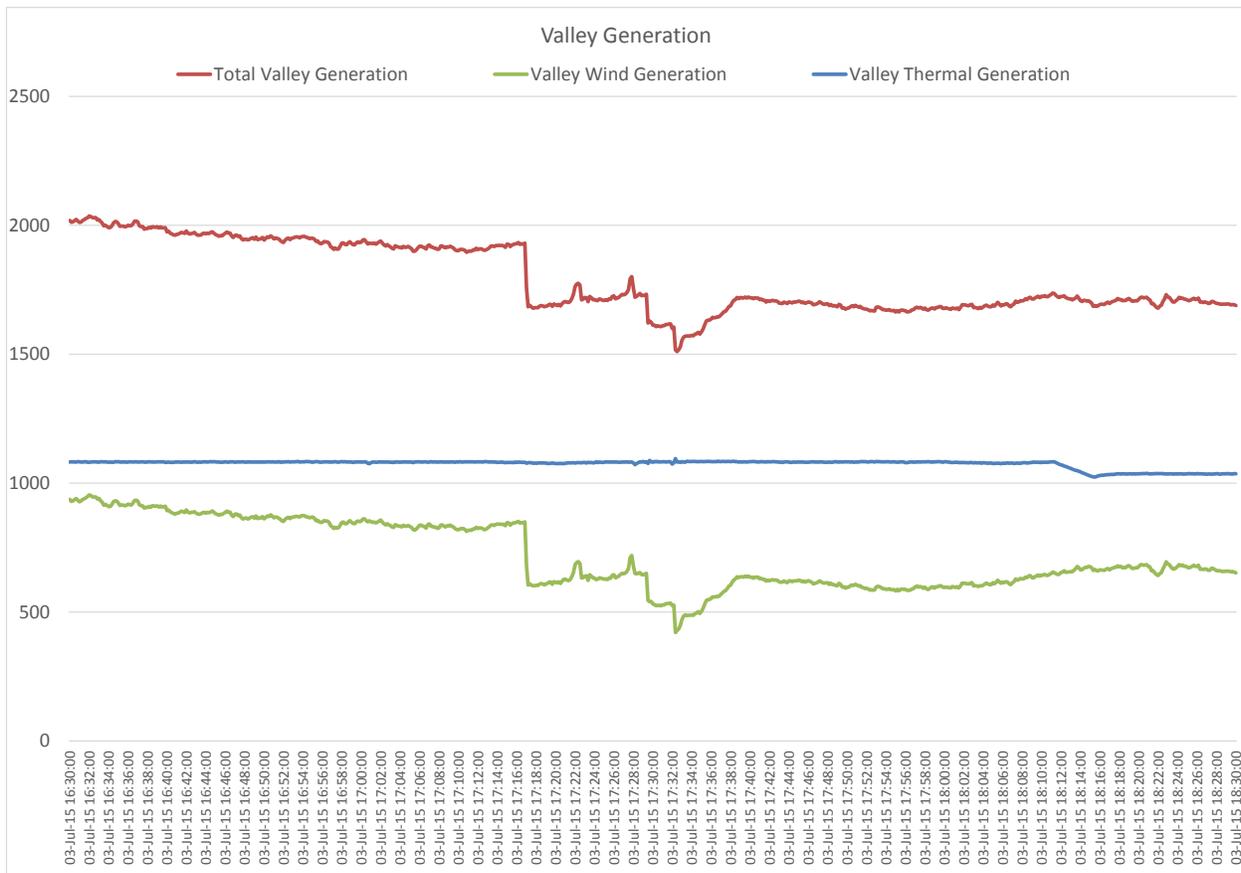
Figure 4: Valley Generation

A total of four wind plants at two sites are connected to the 138 kV transmission system in the area. Seven additional wind plants are connected to the 345 kV transmission system north of the area. These wind plants have a nameplate capacity of 1495 MW. The following graph shows the Valley generation during the event. The changes in the total Valley generation were due to changes in the wind generation output.

Multiple wind facilities exhibited a loss of MW output during the event. Approximately 475 MW of wind generation tripped at various times during the event. The loss of MW output appeared to be related to the voltage disturbance(s) that occurred on the system due to the initial fault and subsequent faults that occurred during attempts to re-energize the failed 138 kV circuit.

- (3) Wind generators should review their voltage ride-through settings to ensure the units remain on-line during transient voltage conditions. Impacts of low voltage event counters on wind unit operation should be examined and shared with the transmission operator.
