# **Texas Reliability Entity Event Analysis**

**Event:  
July 29, 2015 Loss of Multiple Generators  
Category 3 Event**

September 17, 2015

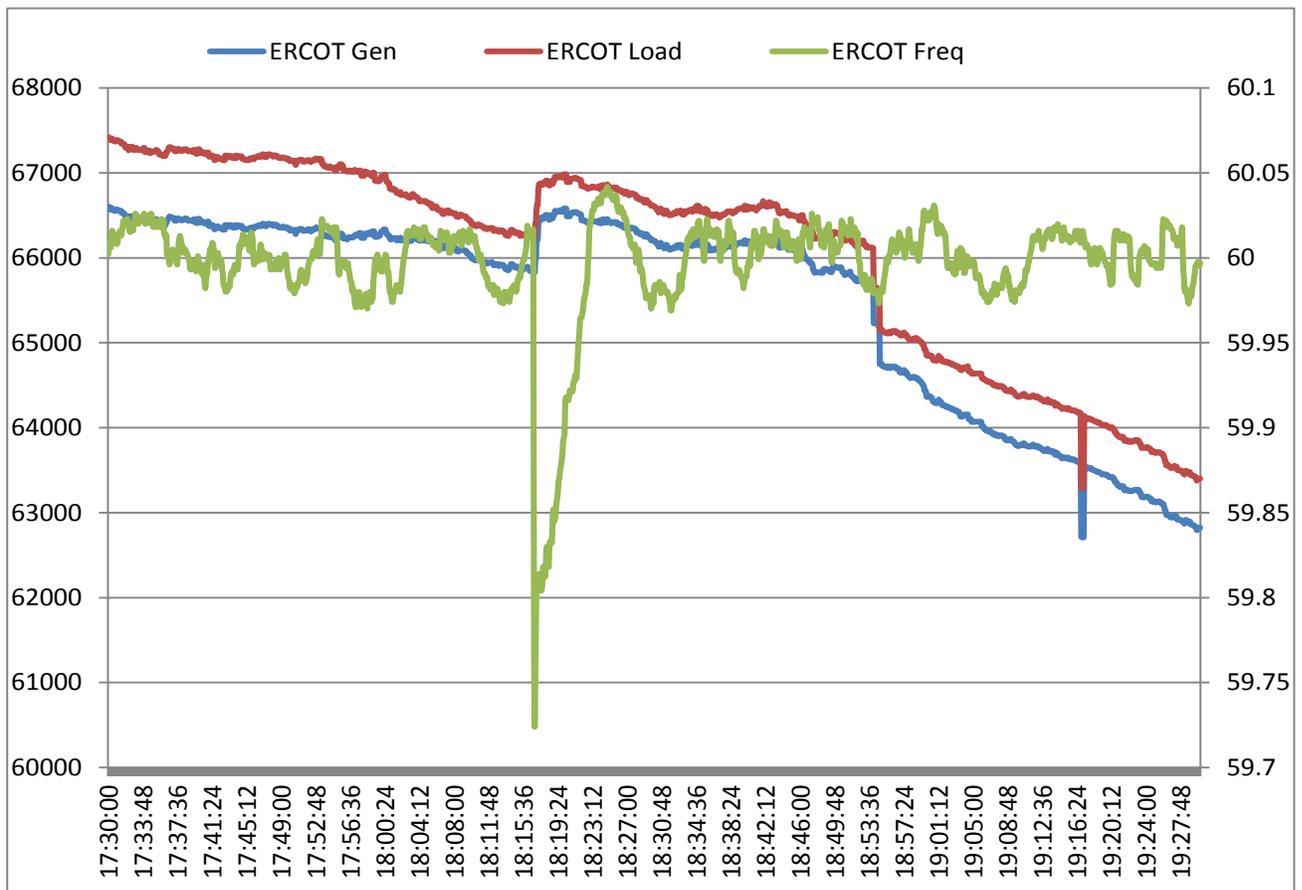
Figure 2: ERCOT System Generation, Load, and Frequency 7/29/2015

System frequency measured at ERCOT's control center dropped from 60.017 Hz to 59.723 Hz, based on 4-second scans, as a consequence of the loss of generation. The

drop was arrested by governor action of ERCOT region generators, aided by automatic deployment of 1341 MW of generation responsive reserve as well as 317 MW of regulation. These actions led to system frequency recovery within 6 minutes and 6 seconds to 60 Hz (at 18:22:46).

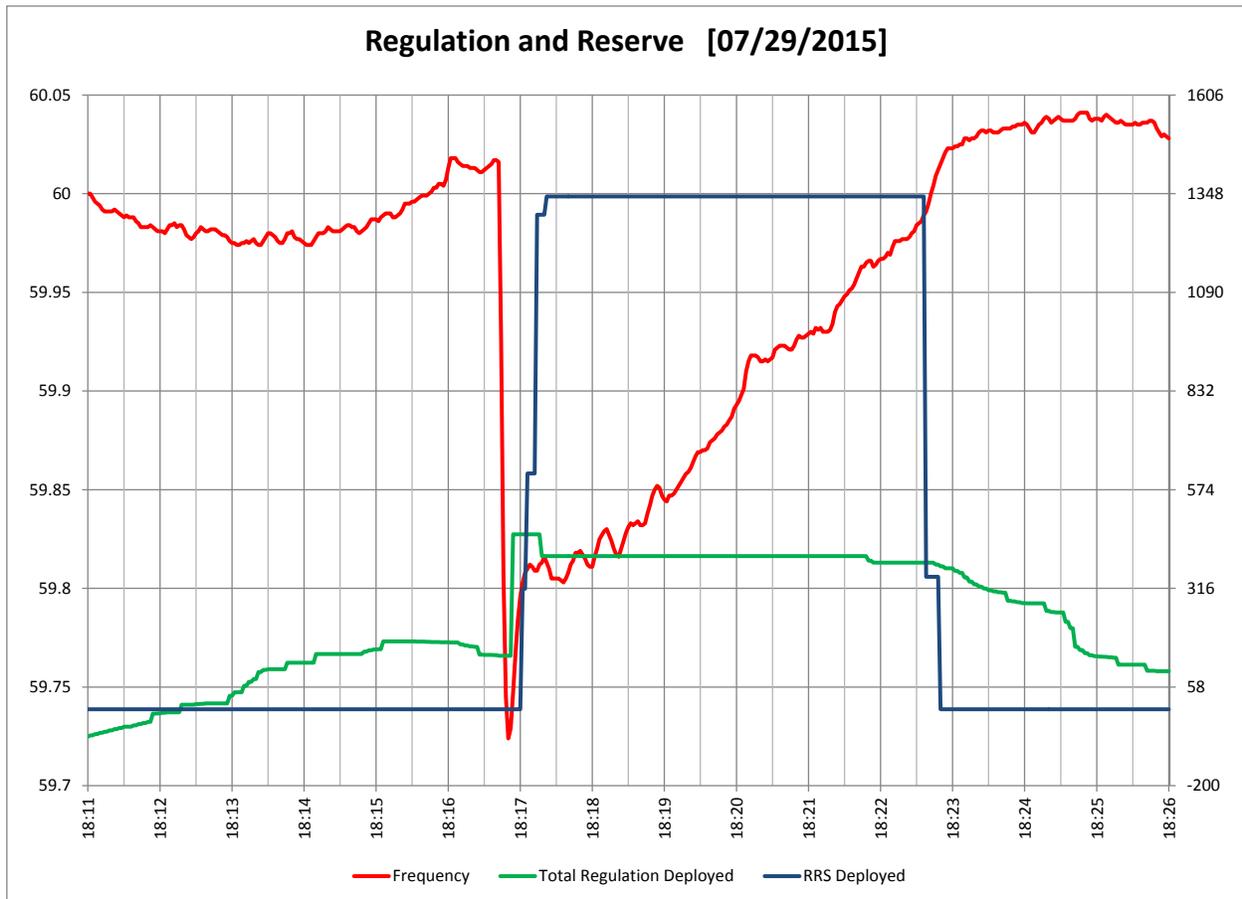
Figure 5: ERCOT Responsive Reserves and Regulation Deployments

- Generator governor response arrested the frequency decline, as analyzed by the Performance, Disturbance, Compliance Working Group (PDCWG) in the Frequency Measureable Event (FME) report. The initial calculated system frequency response was 789 MW/0.1 Hz, which exceeds the target of 471 MW/0.1 Hz established in NERC Reliability Standards. The response was due to the governor action from the on-line generation resources. The FME report also noted that 41 out of 60 units (units running that were not excluded) (68.3%) passed the initial governor response measurement and 45 out of 60 (75.0%) passed the sustained governor response measurement for this event.

The result of these actions was that system frequency returned to its pre-disturbance value of 60 Hz within 6 minutes and 6 seconds.

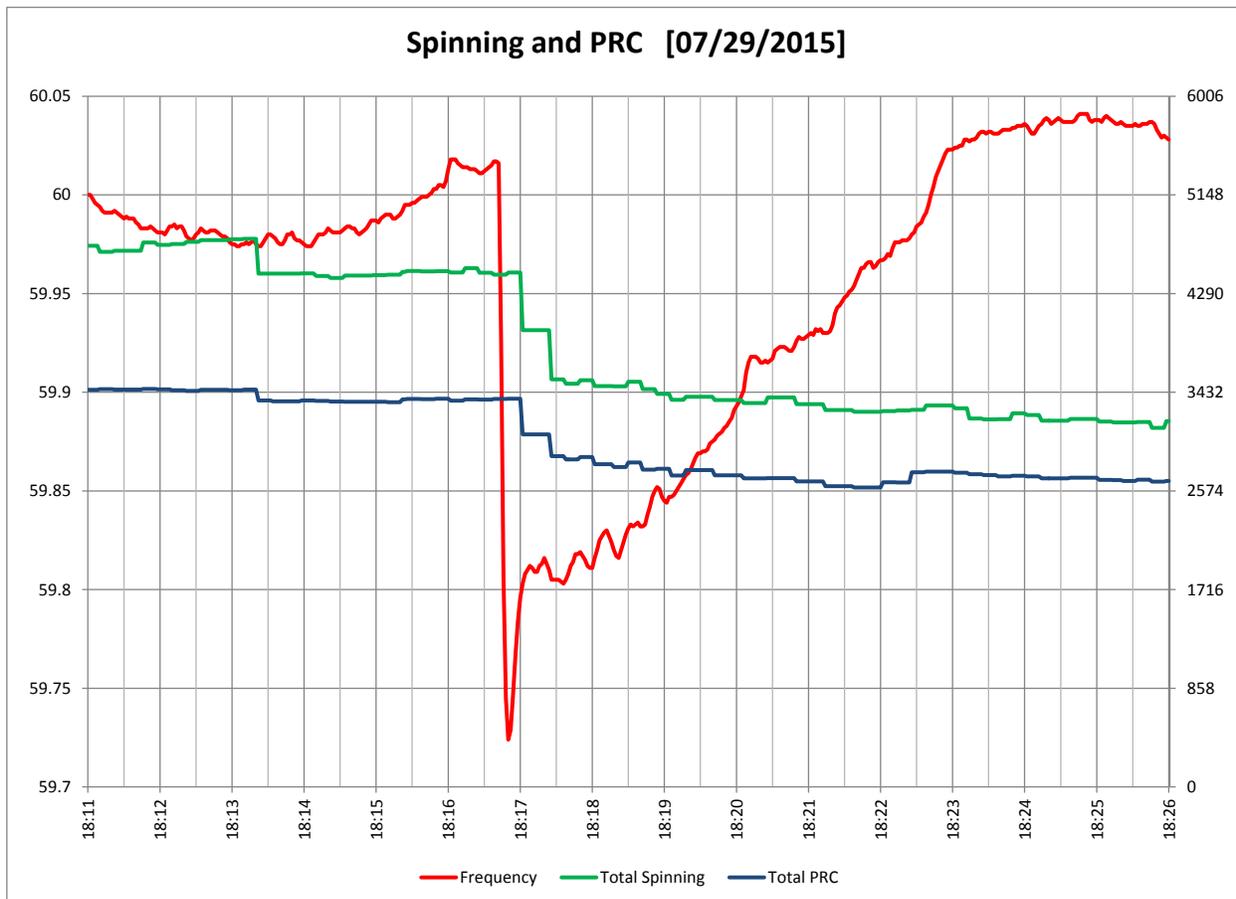
Figure 6: ERCOT Spinning Reserves and Physical Responsive Capability

The Physical Responsive Capability (PRC) dropped to a low point of 2603 MW at 18:21:48. After the loss of generation, an advisory was issued for PRC being below 3000 MW. The advisory was cancelled at 18:50.
