**Texas Reliability Entity, Inc.
Protocol Compliance Report
to Public Utility Commission of Texas
For The October 8, 2014, Lower Rio Grande
Valley Load Shed Event**

January 21, 2015

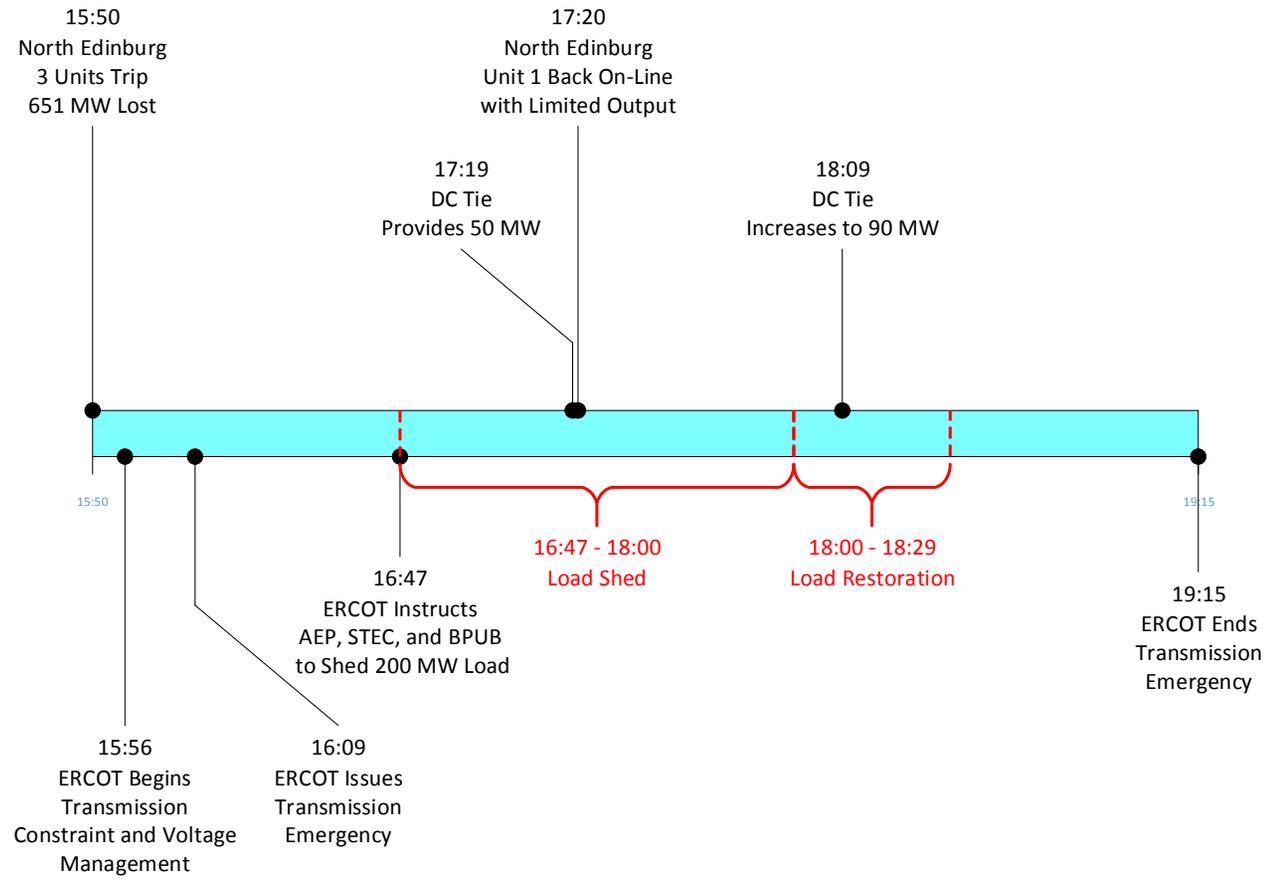
Figure 2: Overview of Emergency

The Transmission Emergency was triggered by the forced outage of North Edinburg Generation Resource (North Edinburg) at 15:50. The total generation lost was 651 MW within one minute, which comprised approximately 38% of the generation capacity in the Valley at that time. As required by Protocol §§ 3.1.4.4 and 6.5.5.1, North Edinburg's QSE notified ERCOT within minutes of the plant tripping off line and updated the plant's telemetered Resource Status Code.

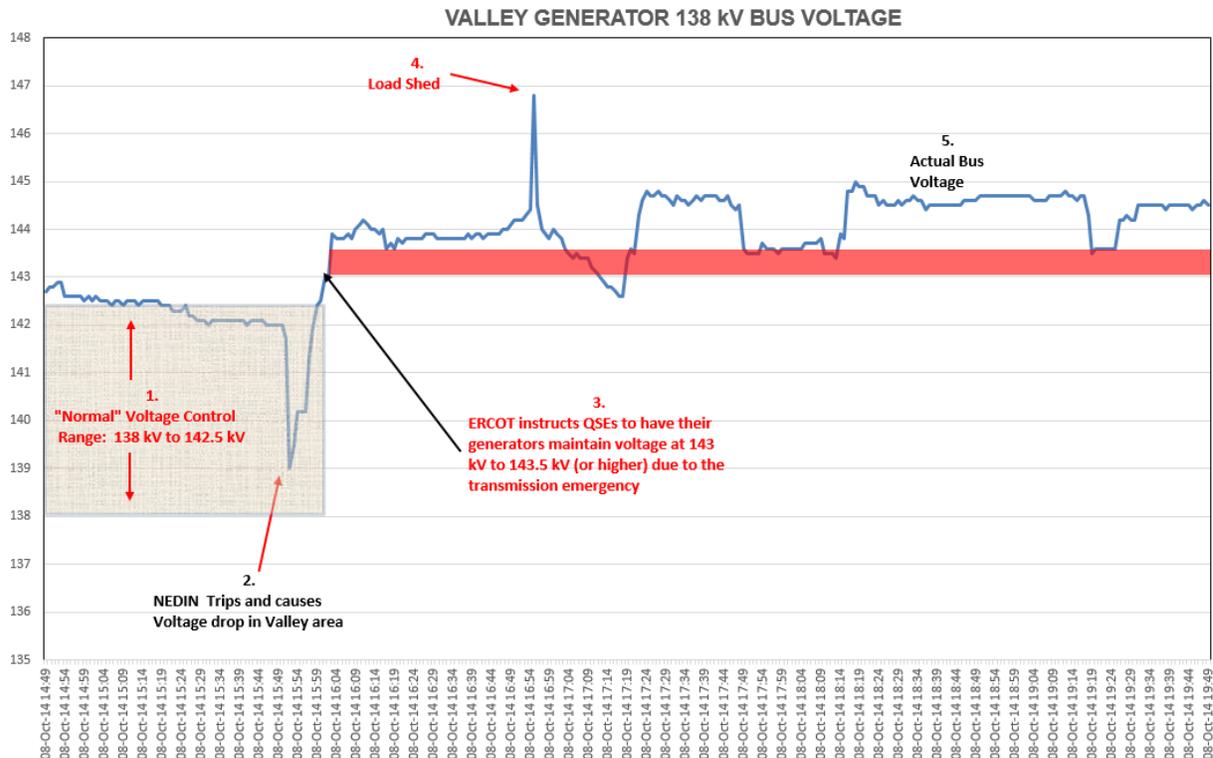
Figure 3: Example of Voltage Impacts

Figure 3 shows the voltage at one of the Generation Resources in the Valley area during the Emergency. The effects of the North Edinburg plant trip and load shed can be seen, but in general voltage is maintained near the target specified by ERCOT.

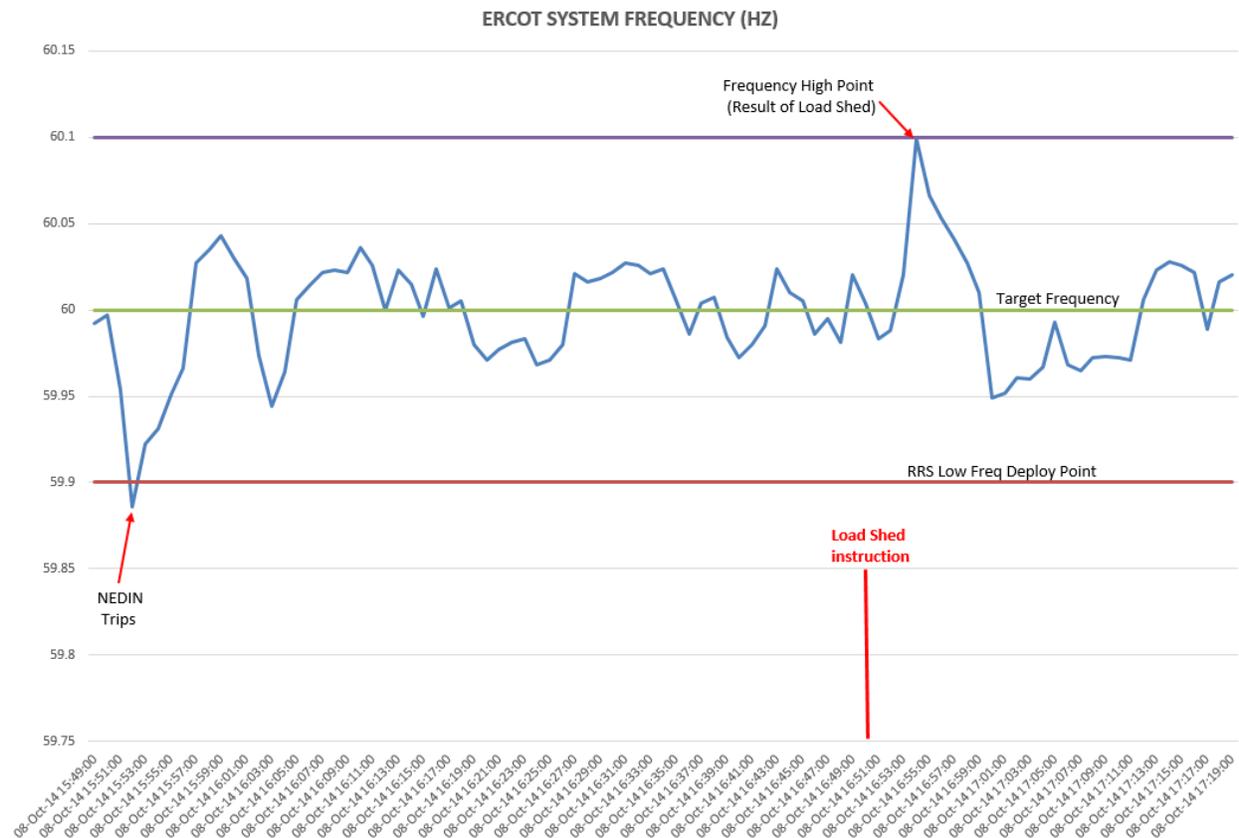
Figure 4: System Frequency Impacts

The impact of the loss of the North Edinburg units is shown below. System Frequency (ERCOT-wide) dropped when the North Edinburg units tripped but quickly recovered and remained in an acceptable range during the event. ERCOT deployed Responsive Reserve Service (RRS) and Regulation-Up Service (Reg Up) in response to the drop in System Frequency. Generators responded initially and automatically with Primary Frequency Response and then in response to ERCOT's RRS and Reg Up deployments, and System Frequency was recovered in about six minutes.

System Frequency also momentarily spiked (high) to 60.123 Hz when the initial load shed occurred. Overall, the Emergency did not significantly impact system frequency.

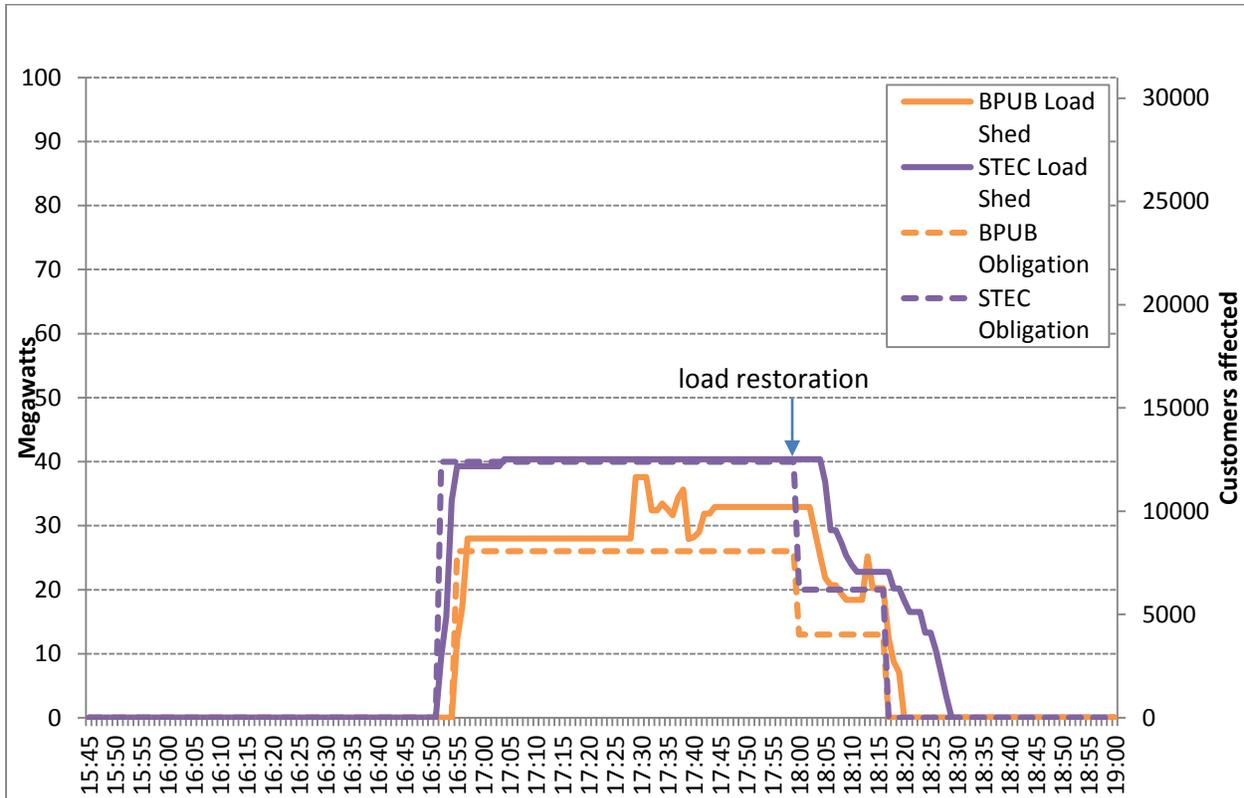
Figure 5: Brownsville PUB and STEC Load Shed Performance

Each of the TOs responded immediately and reported back to ERCOT within approximately 10-15 minutes. Brownsville PUB's and STEC's load shed amounts were reasonably close to the targets. However, AEPTC's initial response to ERCOT's load shed instruction greatly exceeded the target amount.

Figure 5 shows Brownsville PUB's and STEC's load shed performance as compared to their obligations. The left vertical axis shows MWs, and the right vertical axis shows approximate number of affected customers.

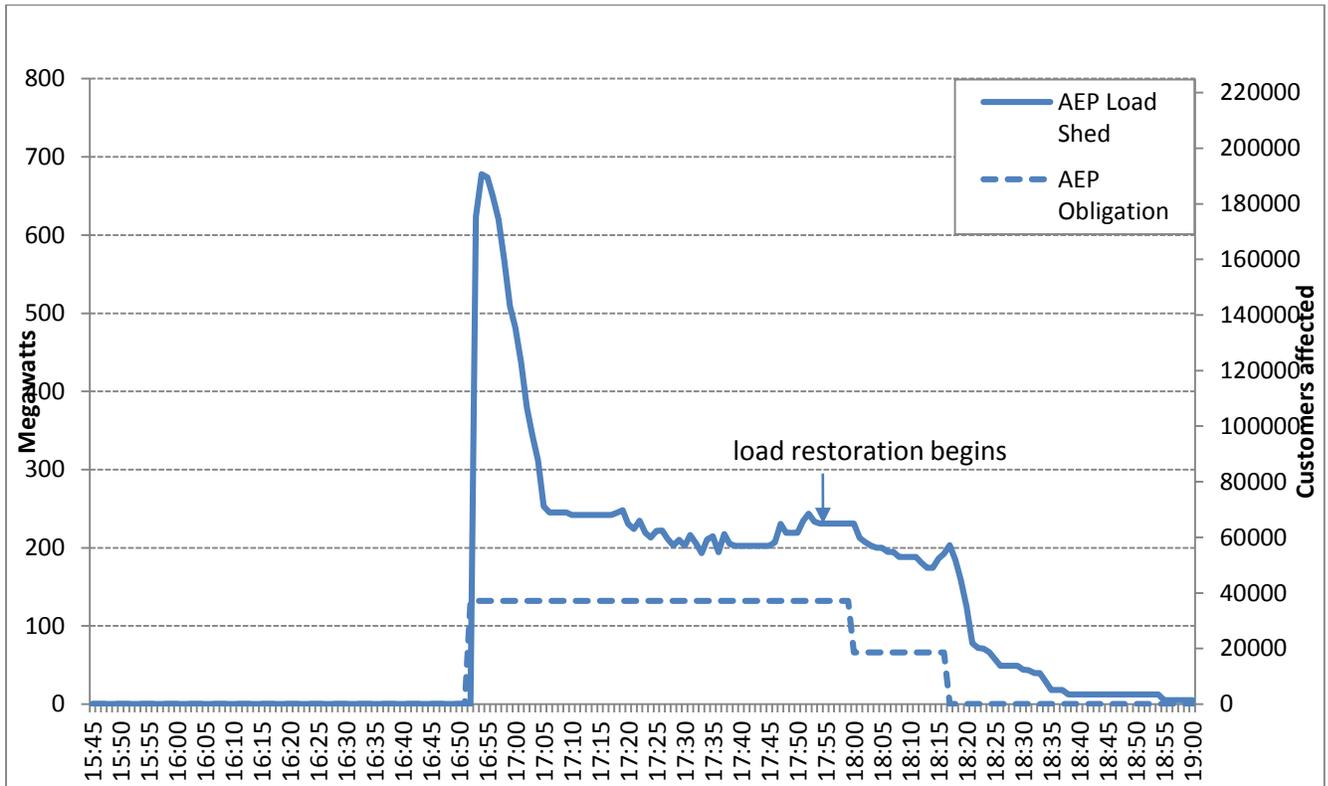
Figure 6: AEPTC Load Shed Performance

Figure 6 shows AEPTC's load shed performance as compared to its obligation. The left vertical axis shows MWs, and the right vertical axis shows approximate number of affected customers.

The reason for AEPTC’s excess load shed appears to have been largely due to operator error. Since the time of the last manual load shed in 2011, AEPTC installed an automated load shed program which had not been used prior to the October 8 Emergency. In response to ERCOT’s load shed instruction, the AEPTC operator selected an incorrect program option which resulted in the automated system attempting to interrupt all the feeders for the Valley. AEPTC quickly realized it had exceeded the instructions and promptly took steps to restore the load that was shed in excess of the instructions. Within about ten minutes, AEPTC was able to restore 370 MW of the excess load shed, but 180 MW in excess of the target amount remained interrupted until ERCOT released all load to be restored.

AEPTC’s load shed in excess of ERCOT’s instruction caused a brief frequency spike, which was corrected through Primary Frequency Response and ERCOT’s deployment of Regulation Down Service. AEPTC’s actions also caused a much larger number of end-use customers to experience power interruptions than would otherwise have been the case.

Texas RE will further investigate AEPTC’s actions during the load shed and report to the PUCT for further action, as appropriate.
