NERC Activities, the Polar Vortex and Continuing Regulatory Interest

Generator Winter Weatherization Workshop

September 1, 2015

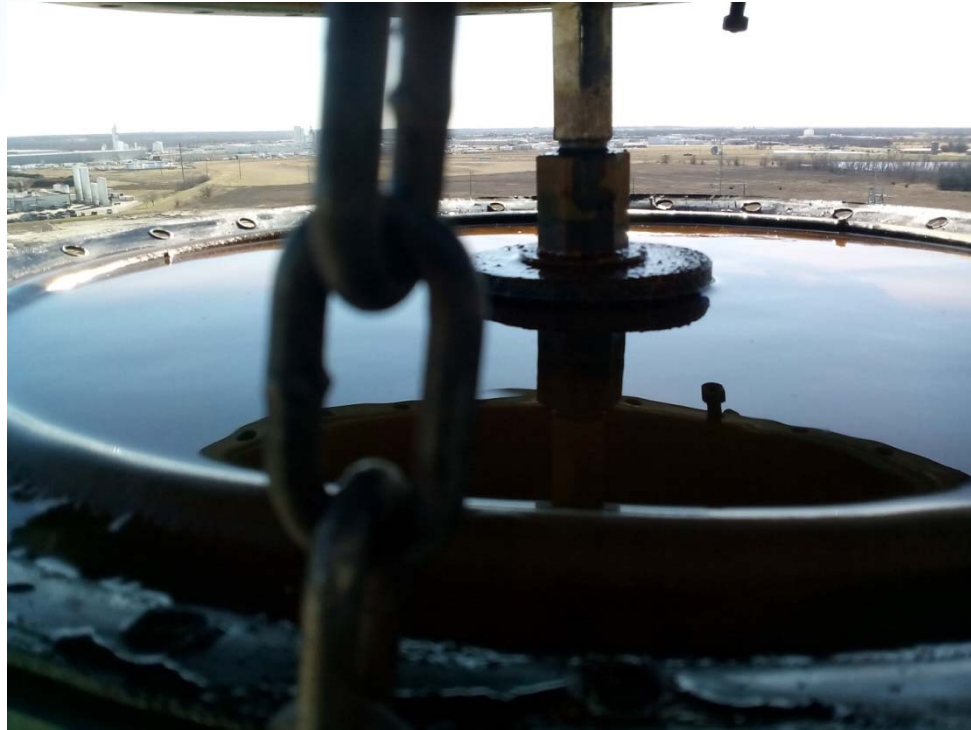
Fisher Actuator IP Drum Level

- Rain water was penetrating the IP drum level control valve. After investigating it was determined the rain cap was missing which helped allow the ingress of water into the actuator which froze due to the extreme temperatures

- Action taken - 19 actuators were overhauled and rebuilt and rain caps added.

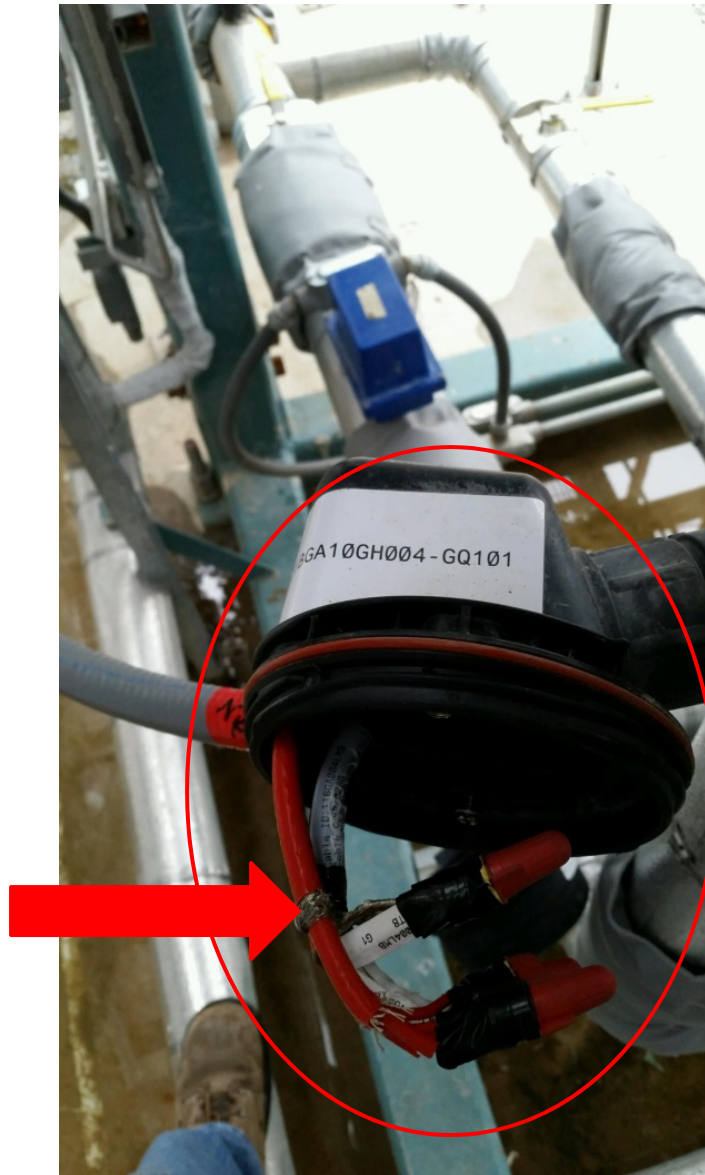
Heat Trace Deficiency Example 1:

Power
Connector
Wires not
Shielded
resulting in
shorting to
the case.

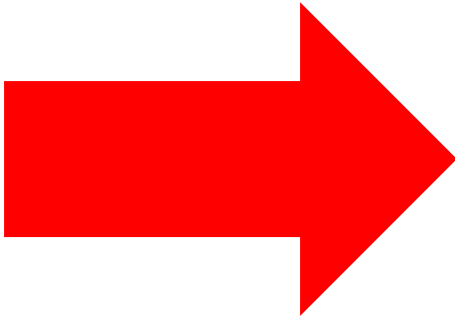
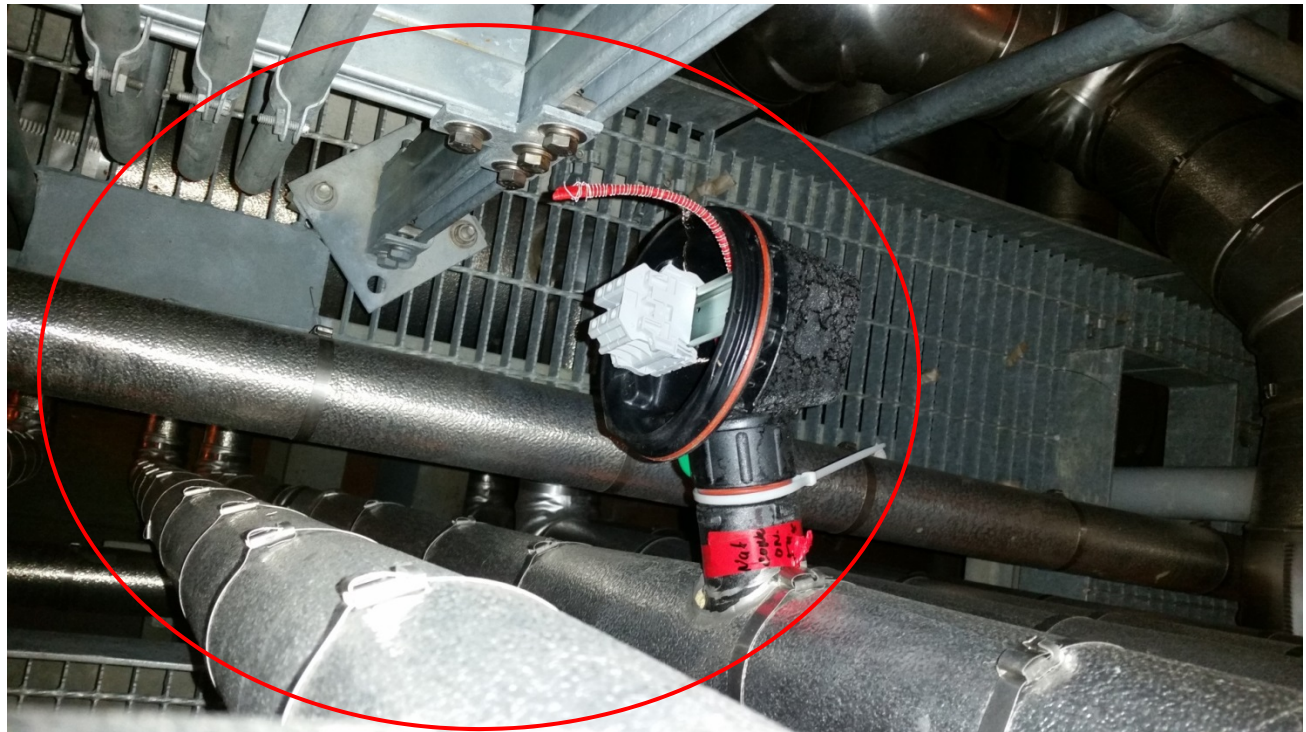
Heat Trace Deficiency Example 2:

Heat Trace
Power
Connector not
Terminated
(No Wires
Landed)

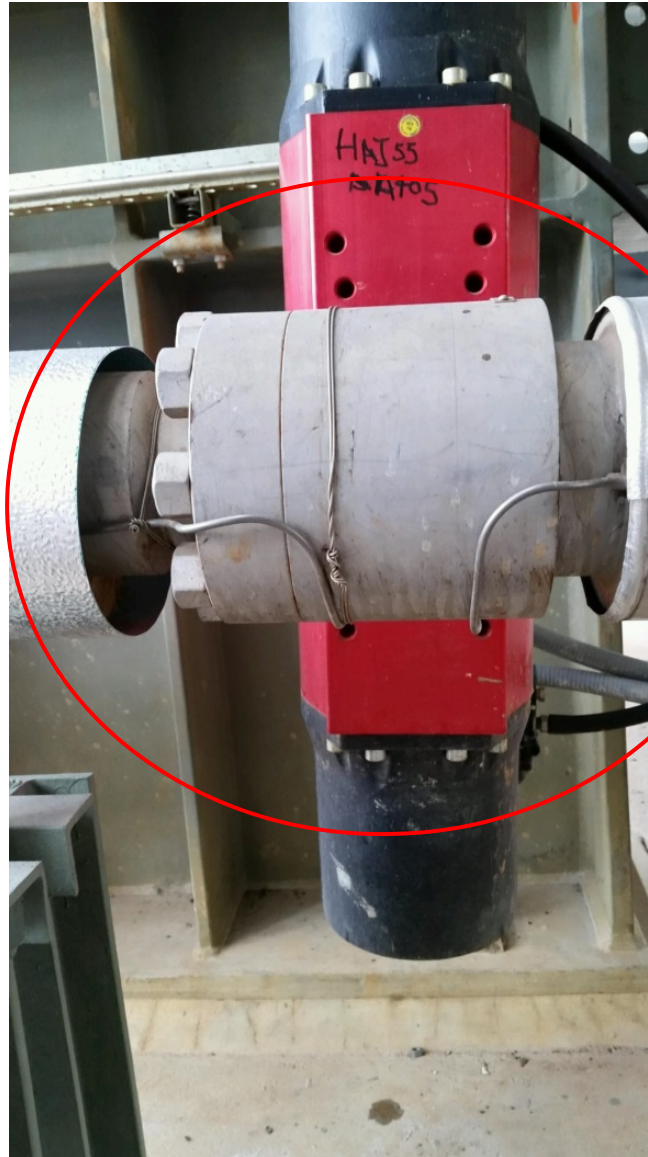
Insulation Deficiency Example 1:

Insulation
Around the
Heat Trace
line Not
Complete

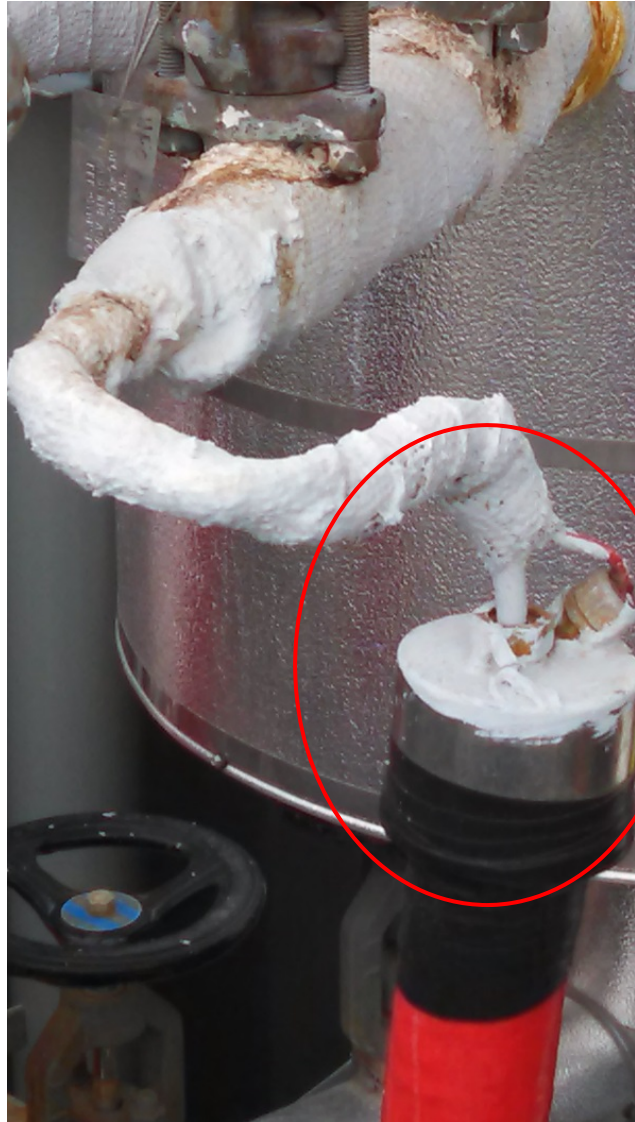
Insulation Deficiency Example 2:

Insulation Taping Not complete

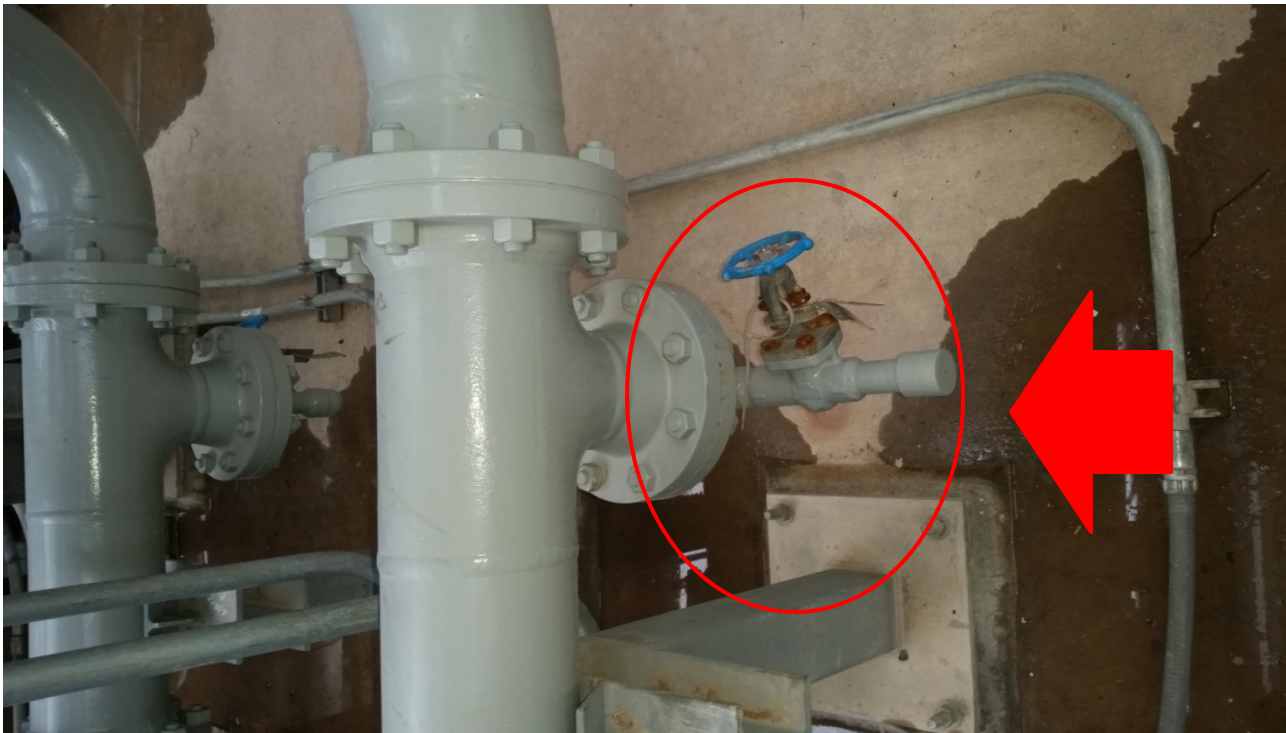
Insulation and Heat Trace Deficiency Example:

This is a sump drain line (~1") not insulated or heat traced.

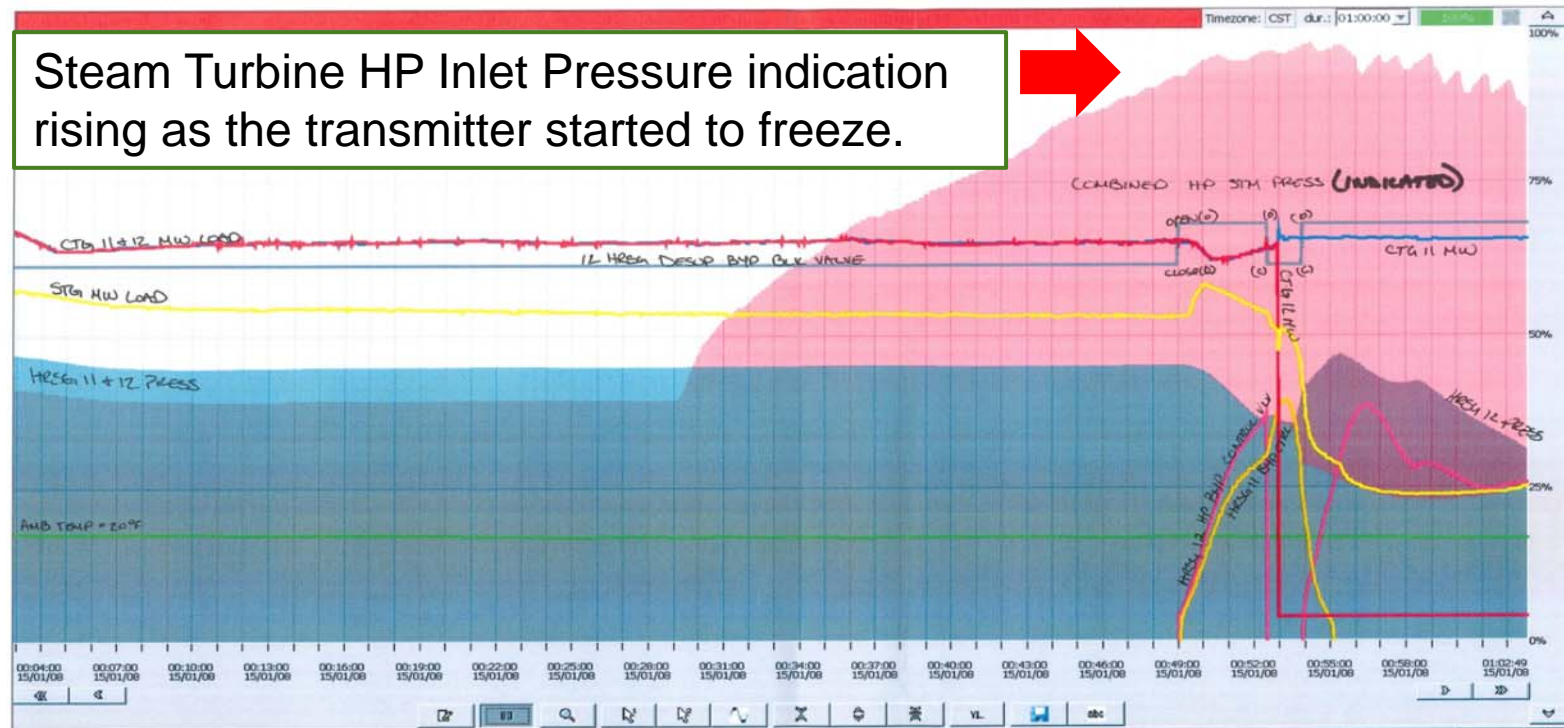
01/08/15 TIME 1 (0004-0102 HRS)

Steam Turbine HP Inlet Pressure indication rising as the transmitter started to freeze.

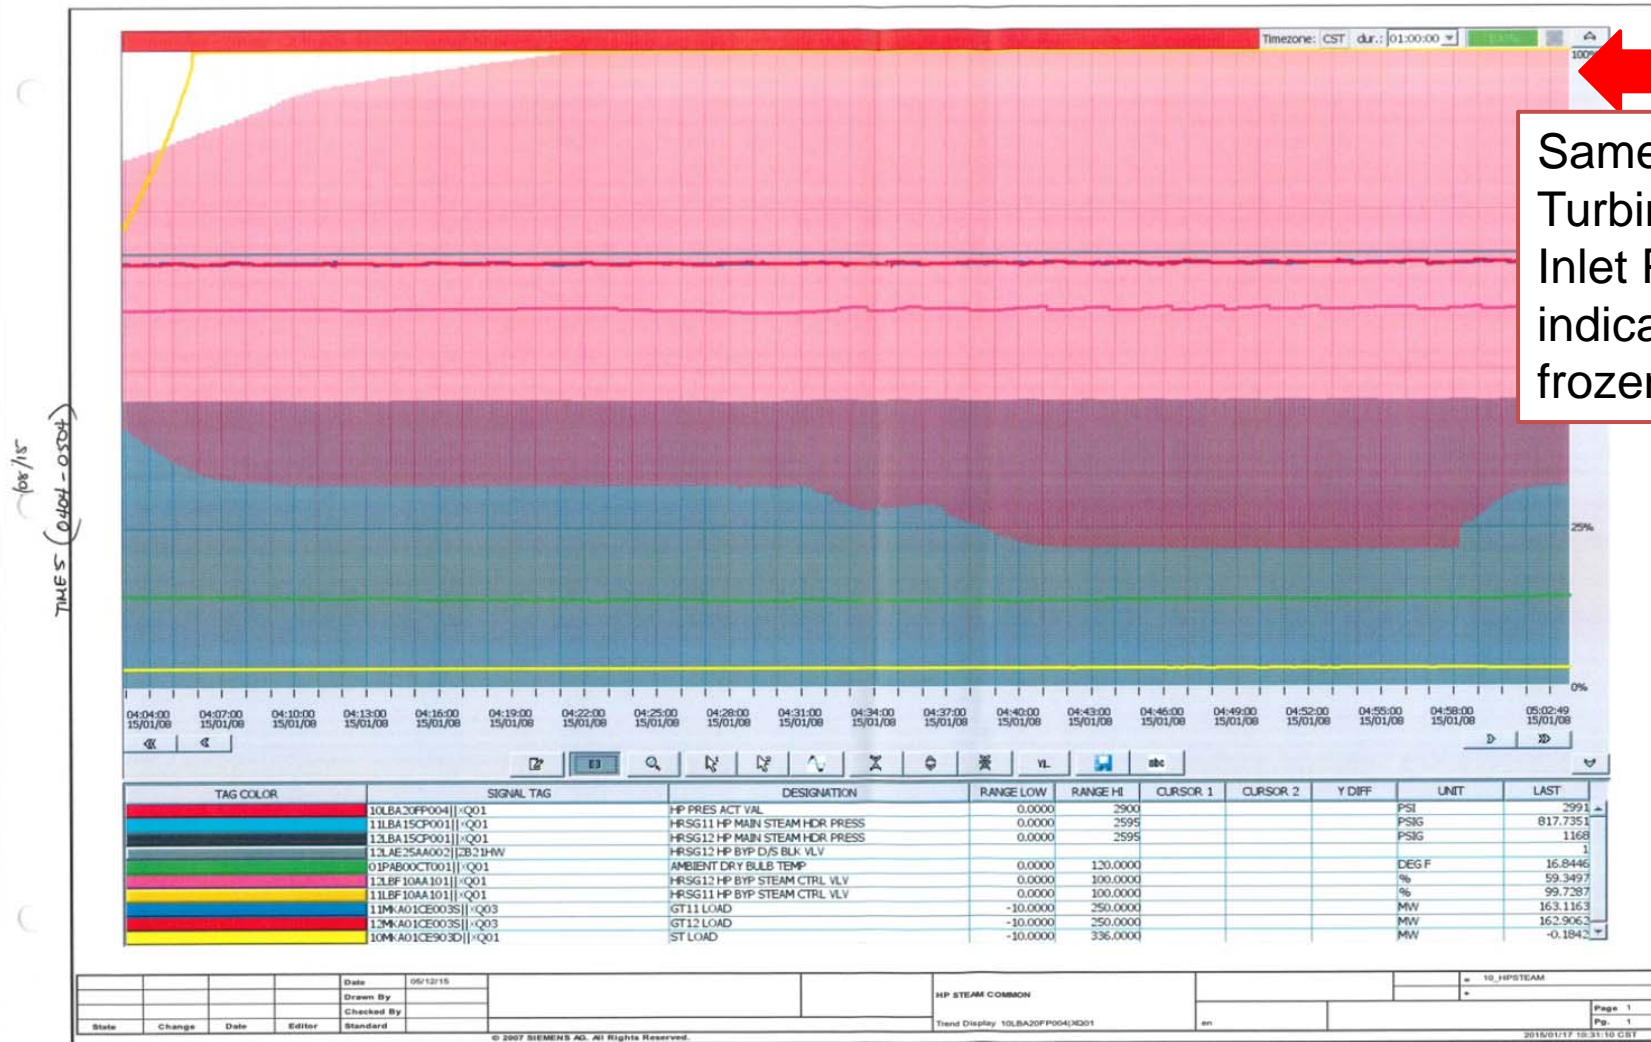
Indication of frozen transmitter with excessive scaling:

Same Steam Turbine HP Inlet Pressure indication now frozen.

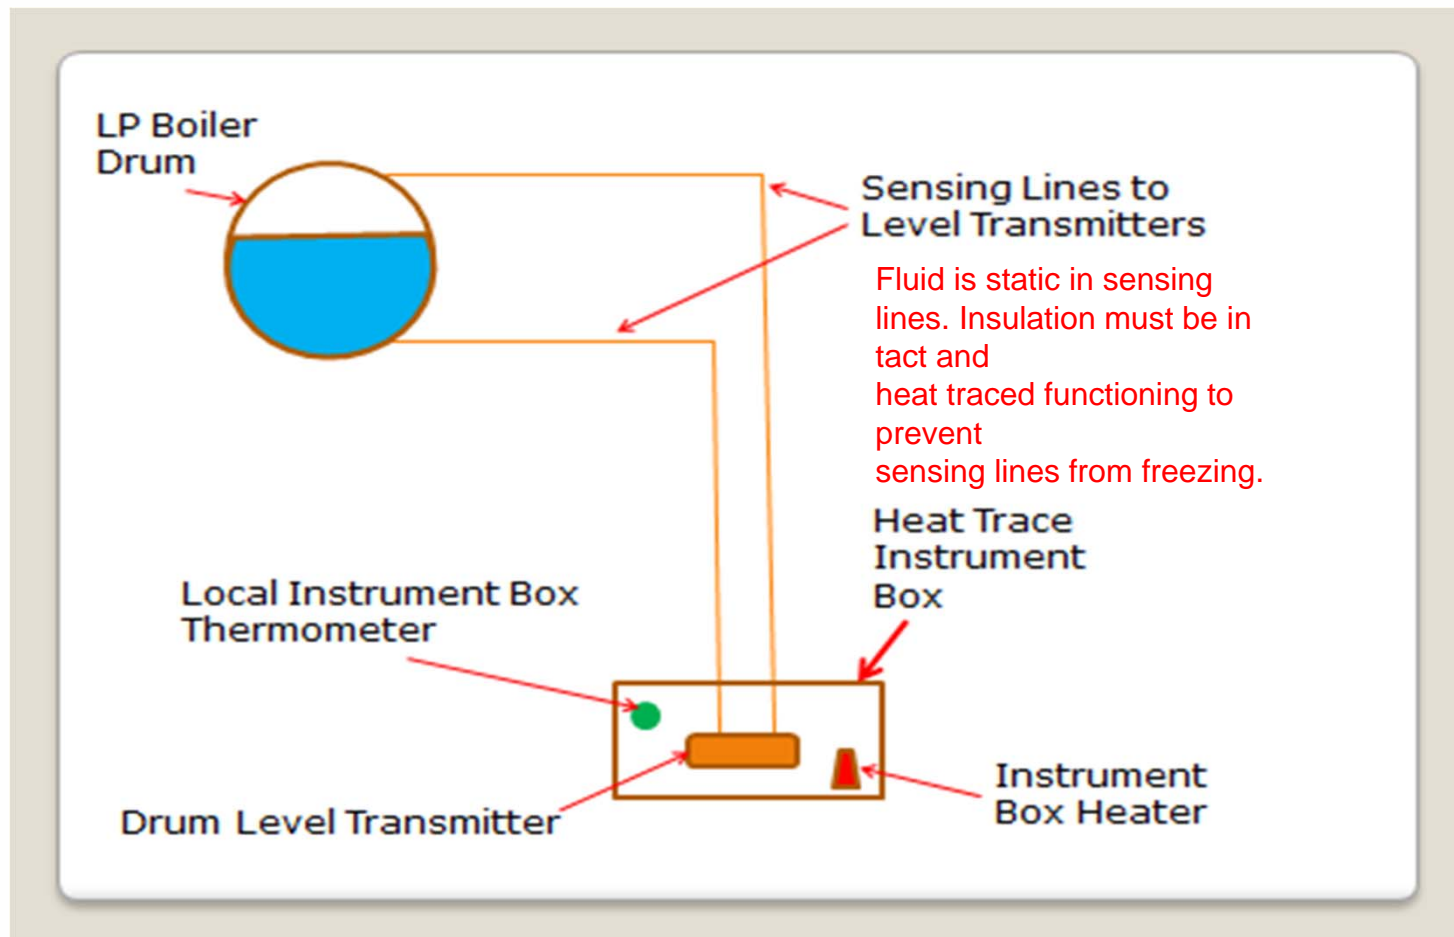
Drum level transmitter manifolds and sensing lines freezing are the leading cause of a unit trip or derate

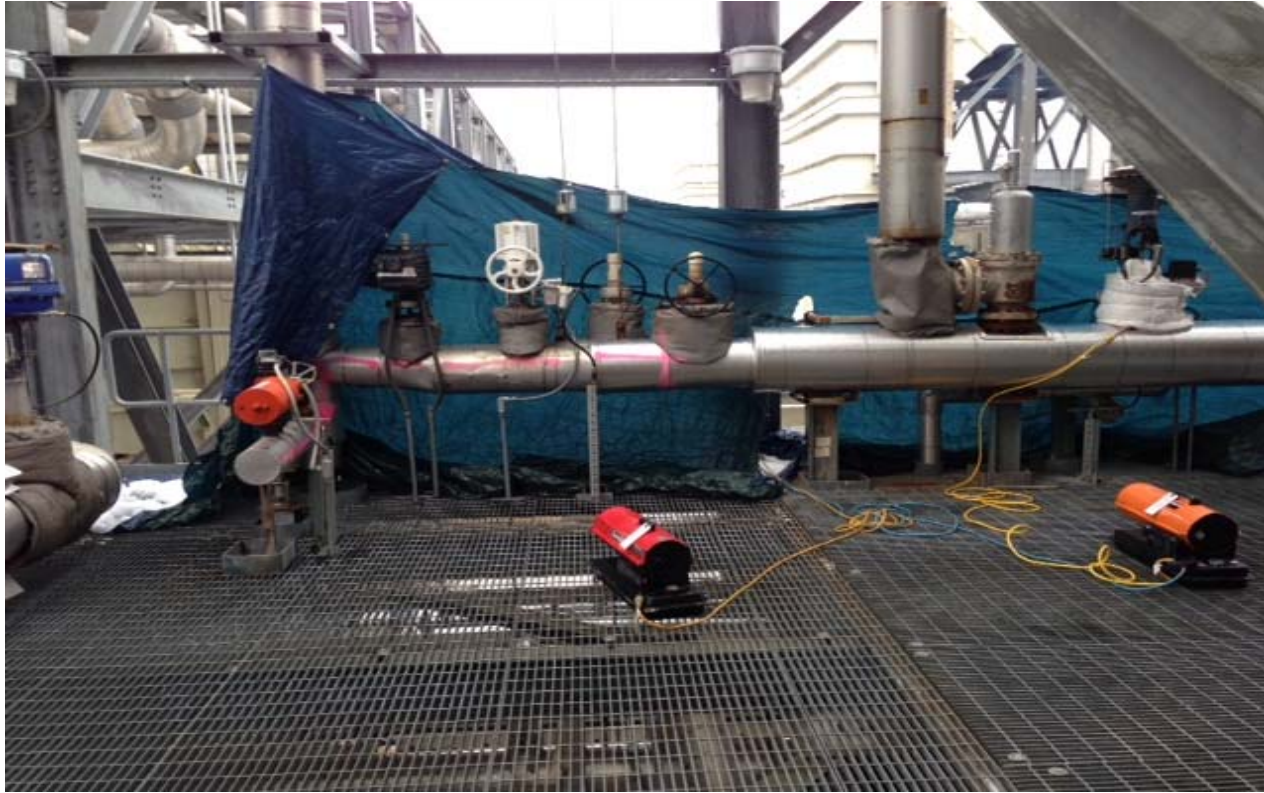
Plant 1 - wind break measure after 1/6/14 event

Steam seal line froze delaying startup – **first** occurrence, lessons learned

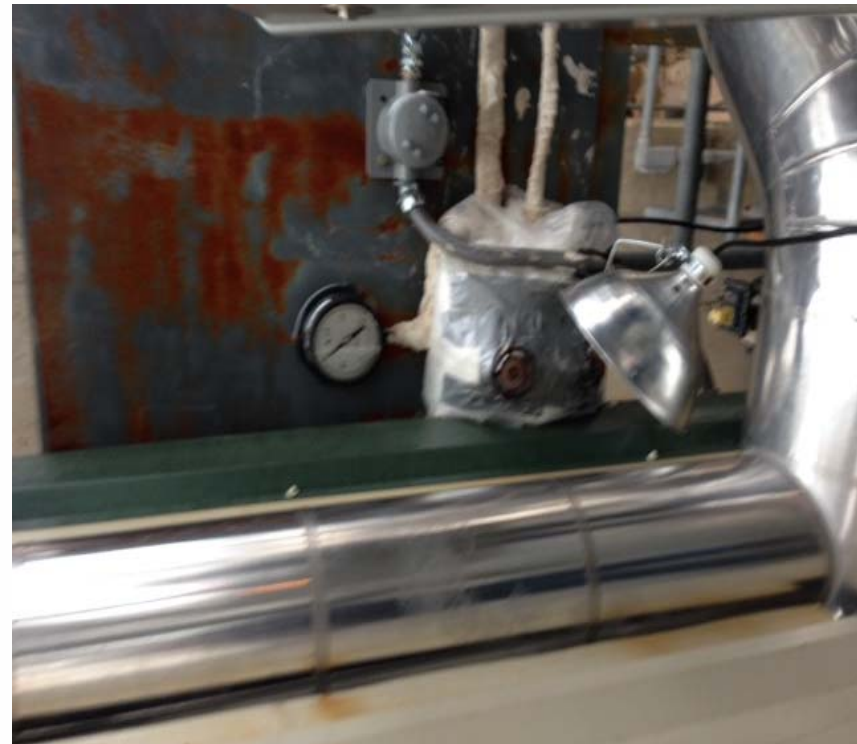
Plant 2 – contractor error – lessons learned

January 6, 2014 derate.
Heat trace left exposed by
insulating contractor on steam seal
pressure regulator transmitter.

Mitigation action for remainder
of winter 2014.

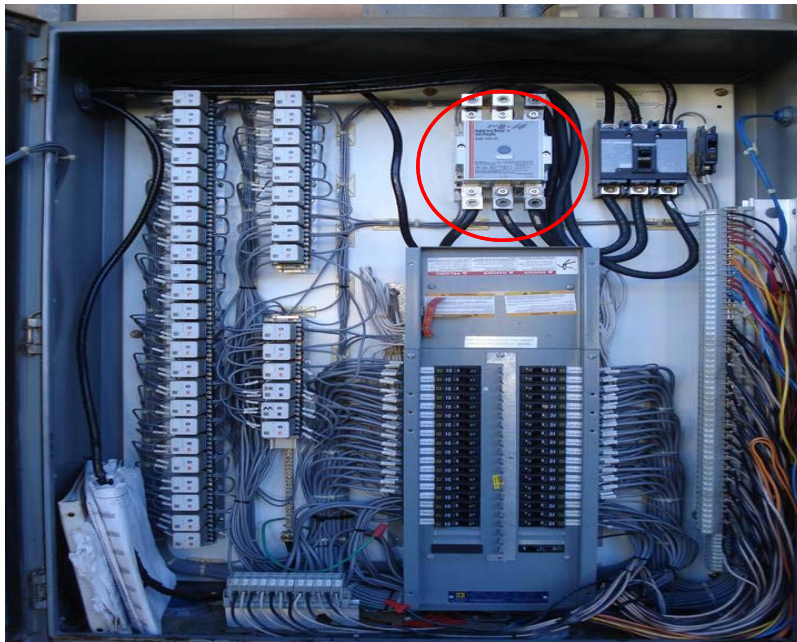
Plant 3 – heat trace panel, three phase contactor – lessons learned and best practice

Spot check after 1/6/14 event. One phase failed to close resulting in auxiliary cooling water transmitter freezing, which tripped plant. Contactor scheduled for annual replacement.

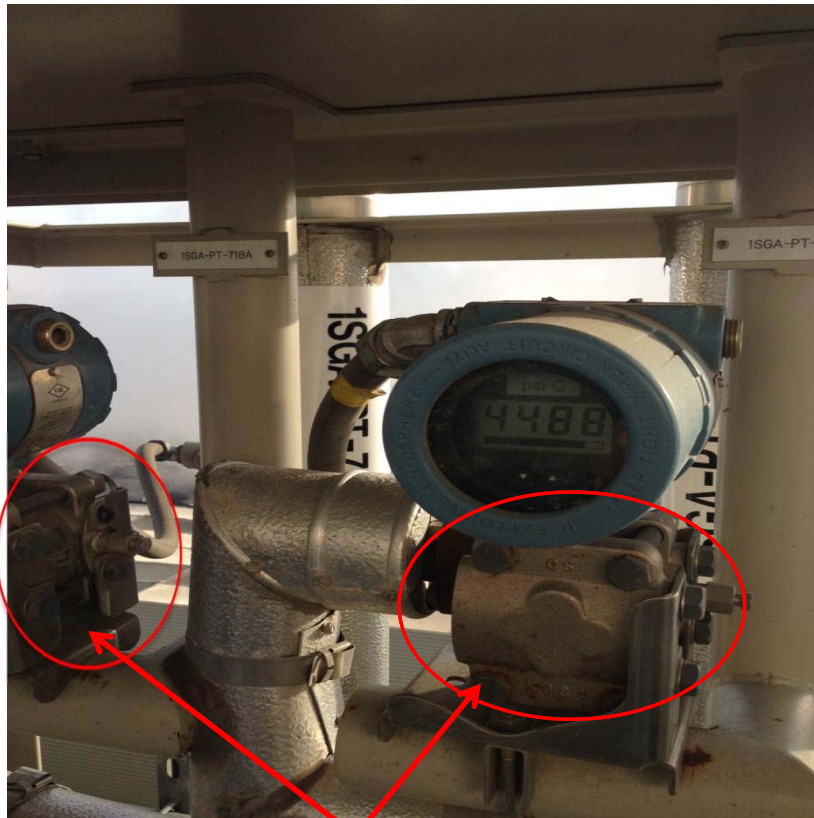
January 6, 2014 – lessons learned

Plant 4 – superheat steam transmitters that caused trip on 1/6/14 with boiler logic set to OR. Uninsulated transmitter manifolds.

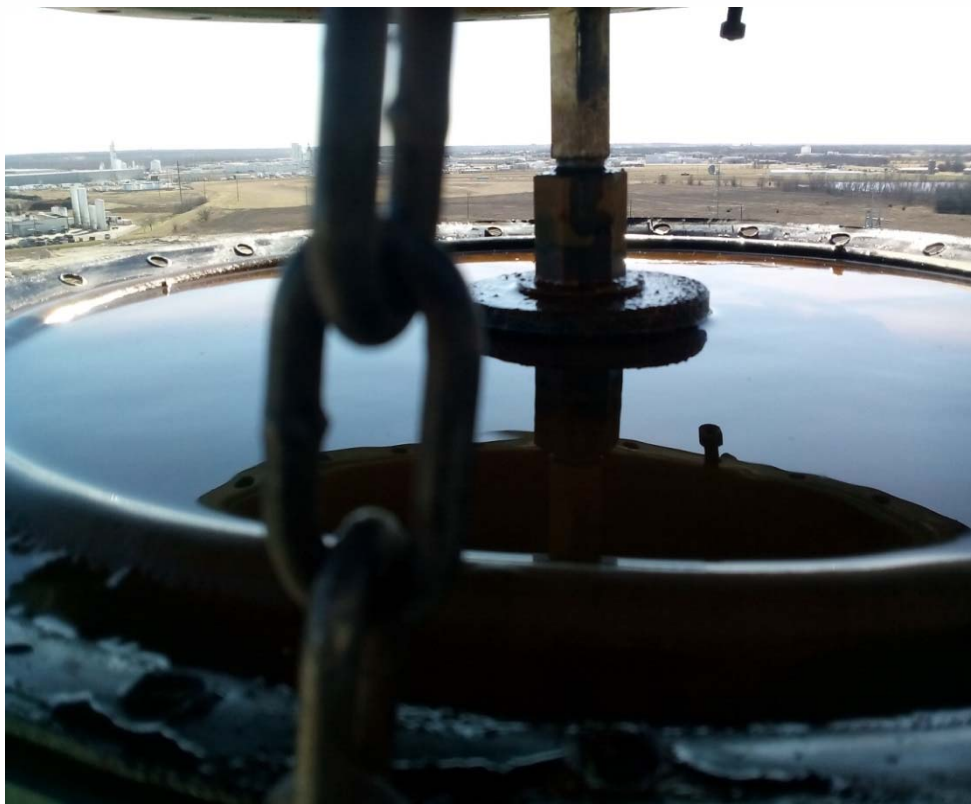
Inspection discovered valves with water that freeze up during extreme temperatures

Plant 5 - regulating valve improvements. Nineteen valves rebuilt with rain caps installed.

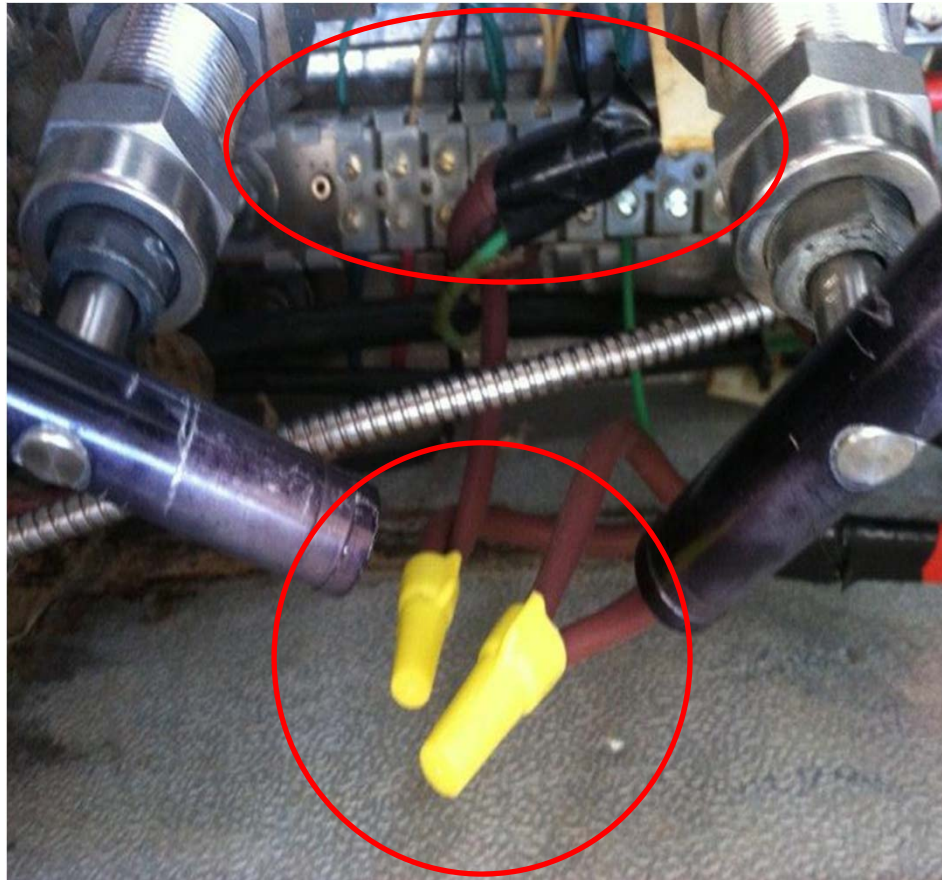
Plant 6 - 1/6/14 unit trip. Contractor error resulting in heat trace not functioning – lessons learned

Drum level transmitter cabinet: Wires should have been connected on the terminal strip at the back of the box.

Parallel constant wattage heat trace was connected in *series*, not in *parallel*.

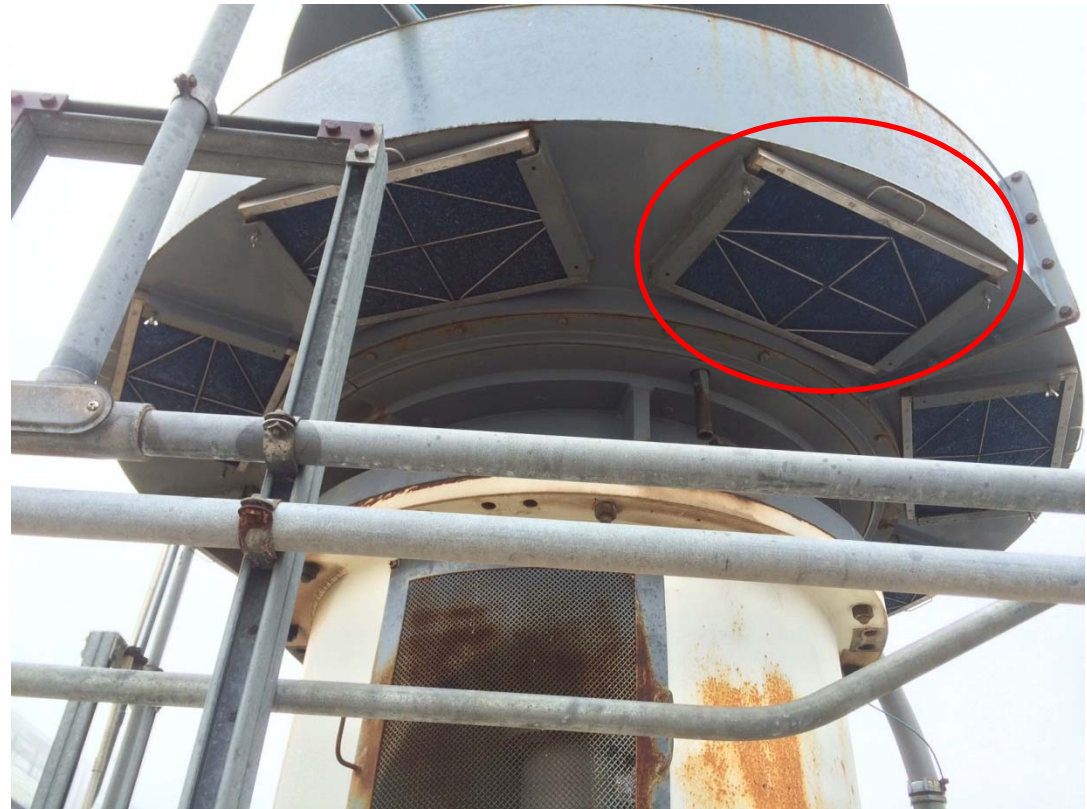
Plant Trip 2/25/15 – lesson learned

Snow and ice blocking the cooling air filters on the circulating pump motor #1 resulting in inadequate cooling of the stator windings. This resulted in a high temperature on the motor and a trip of the pump. When pump #1 tripped the resulting turbulence tripped pump #2 on high vibrations. This resulted in plant trip due to inadequate cooling of stator windings.

- ✓ **Added** physical inspection of the motor filters to plants cold weather rounds sheet.
- ✓ **Added** the motor temperature readings to the operator cold weather rounds.
- ✓ **Added** Spare filters to stores stock for the motors allowing for filter replacement if they start to show ice, or snow build-up.
