NERC and Texas RE Update

**ERCOT/Texas RE Generator Winter Weatherization
Workshop**

September 6, 2018

Sand Hill Energy Center

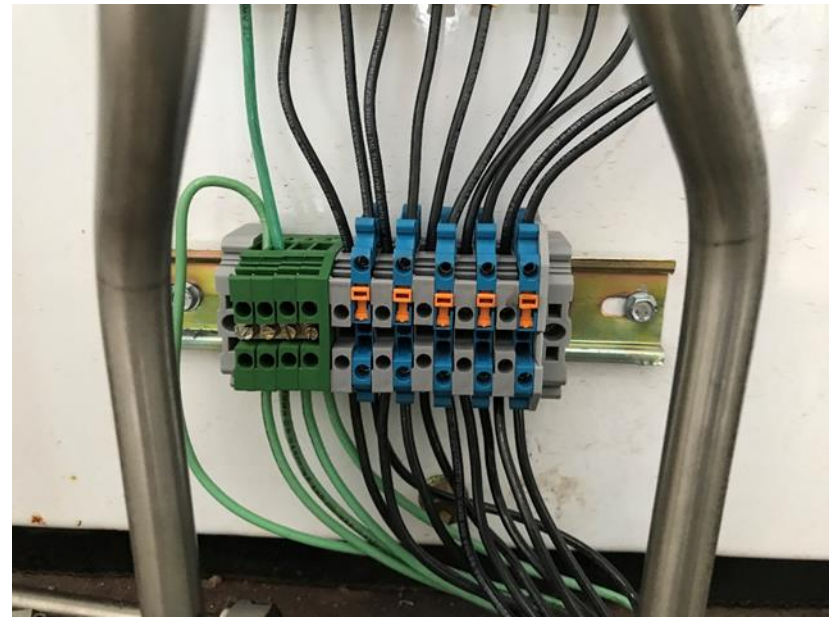
Improvements - Heat Tracing

- Pre-winter check heat trace circuits check (several heat trace lines to each circuit)
- Method could not verify all heat trace lines on circuit correctly working

- Added knife switches to heat trace wiring circuits
- Enables testing individual heat trace lines rather than circuits

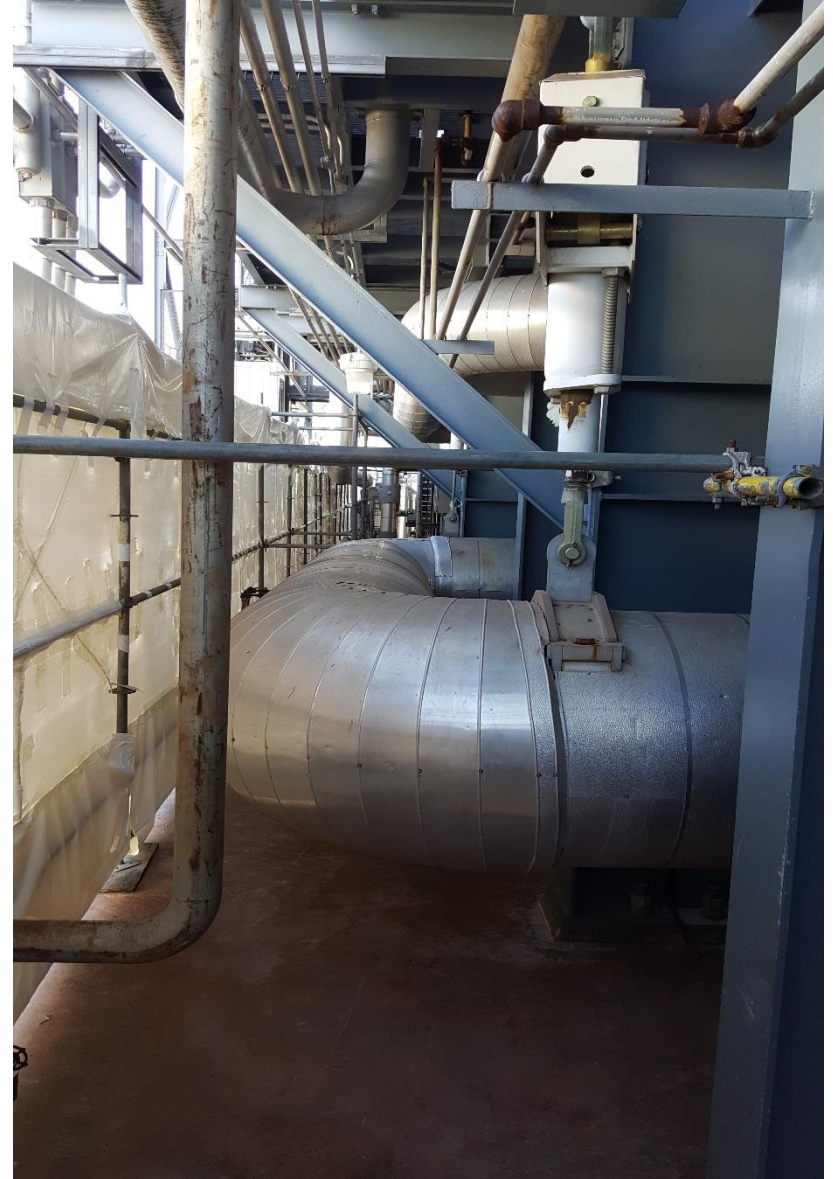
Improvements - HRSG Wind Wall

- **Loss of heat trace on critical equipment:**
 - “A” Feed pump suction strainer heat trace failed
 - “B” feed pump suction strainer inadequate for conditions
 - Sustained wind chill temperatures below 10° F for several hours
 - Direction of wind from north east
- **Communications**
 - Maintenance to Operations
 - Crew to crew — shift turnover
 - Plant operations crew to management
- **Continuity from night shift to day shift**

- Develop a pre-event checklist
- Use reliable wind breaks for vulnerable areas (example: boiler feed pumps)
- Verify critical heat trace circuits are functioning prior to each extreme cold weather event

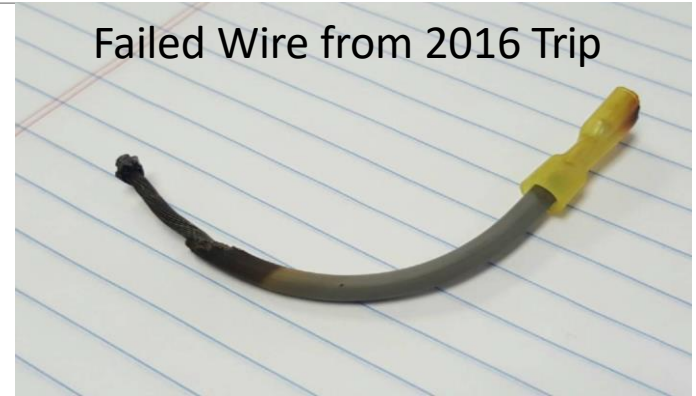
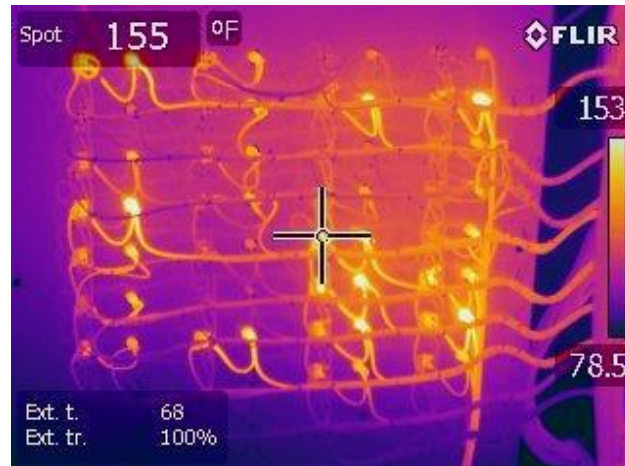
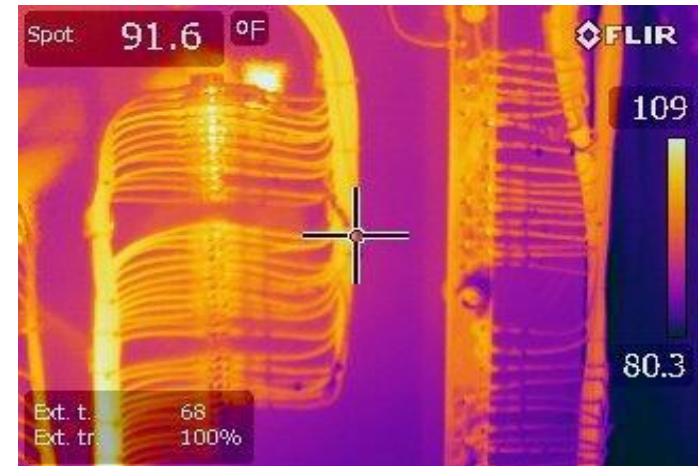
Failed Wire from 2016 Trip

- Cause – deaerator heat trace circuit failure due to corrosion on termination to fuse block.
 - Contributing factor – control room operator was not aware that the deareator level was in single element control.
- Corrective action – Update heat trace inspection to include connections to fuse block, verify critical heat trace is functioning before every extreme cold weather event.
- Corrective action – Provide additional training to control room operators.

- Thermography of the heat trace panels annually
- Helps with failing connections and can identify bad circuits

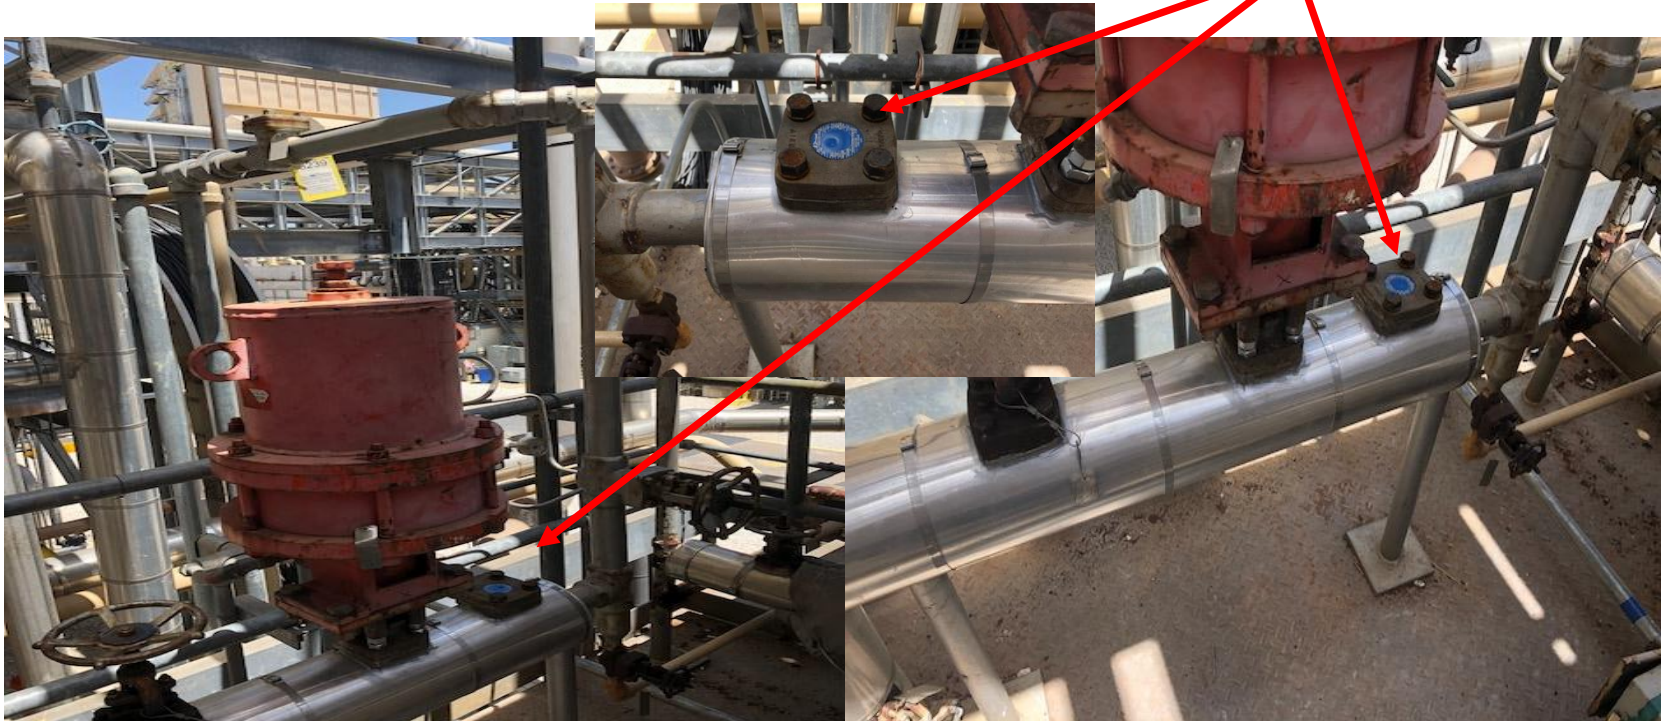
Steam side check valves for CT's

- *Plant A_CC1 tripped – loss of instrument air to main gas supply valve due to moisture freezing in instrument air line.*
 - *Root cause; steam side and air side check valves failed.*
- *Plant B_GT1 tripped – one of two rotor cooling air heat exchanger transmitter froze, which caused a low level condition.*
 - *Root cause; lack of transmitter cabinet heater.*
 - *Corrective action; plant to install cabinet heater.*
- *Plant C_G1 tripped – sensing line level transmitter froze.*
 - *Root cause; insulation missing.*
 - *Corrective action; plant to install flexible wrap insulation. Heat trace is not an option for this section of line.*

Replaced steam side check valves
on both units during Spring 2018 outage
