Primary Interest Groups

Overview

The failure of a generator step-up transformer high-side disconnect phase connection caused the generator to be taken off line.

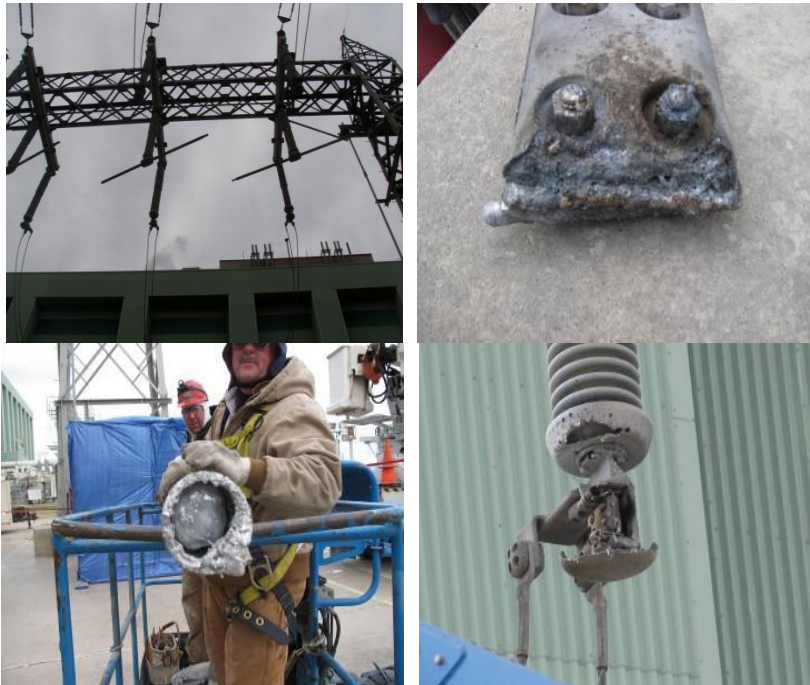
An Entity reported a generator step-up transformer high-side disconnect phase connection started to arc. The plant control room was notified immediately and operations manually tripped the turbine and took the generator off line. It was found that the arc originated toward the pivot point of the switch just inside the contact region. The disconnect switch did not arc in the contact area of the switch. Once electricians removed the disconnect switch arm it was found to be full of ice. Water ingress in the disconnect arm froze during the cold weather causing the weld on the end of the arm to crack, which reduced the current carrying capabilities of the arm. This added heat to the area, which progressed to an arc.

To prevent reoccurrence, all three disconnect switch arms were replaced. The transformer side contacts were replaced as well as the corona ring between the contacts and the insulators and the bottom corona ring. Each contact was verified for proper contact with a visual inspection

and an electrical test. The insulators on the transformer side connection were tested. The insulators on the center pivot, which supports the switch arm, were also tested. Research of available industry technical documentation and did not find any documentation on similar occurrences. The Entity contacted the manufacturer, who also had not seen this type of failure. The manufacturer recommended drilling holes into the switch arm to eliminate water collection.

All plant electrical disconnect equipment should be inspected for areas where water could collect and freeze – especially in geographic areas not accustomed to freezing temperatures. Any areas found with the potential to retain moisture should be modified as prescribed by equipment manufacturer or an engineered design.
