Two Protection System Misoperations occurred during a transmission event causing the loss of approximately 198 MW of local generation and 145 MW of firm load (approximately 16,500 customers).

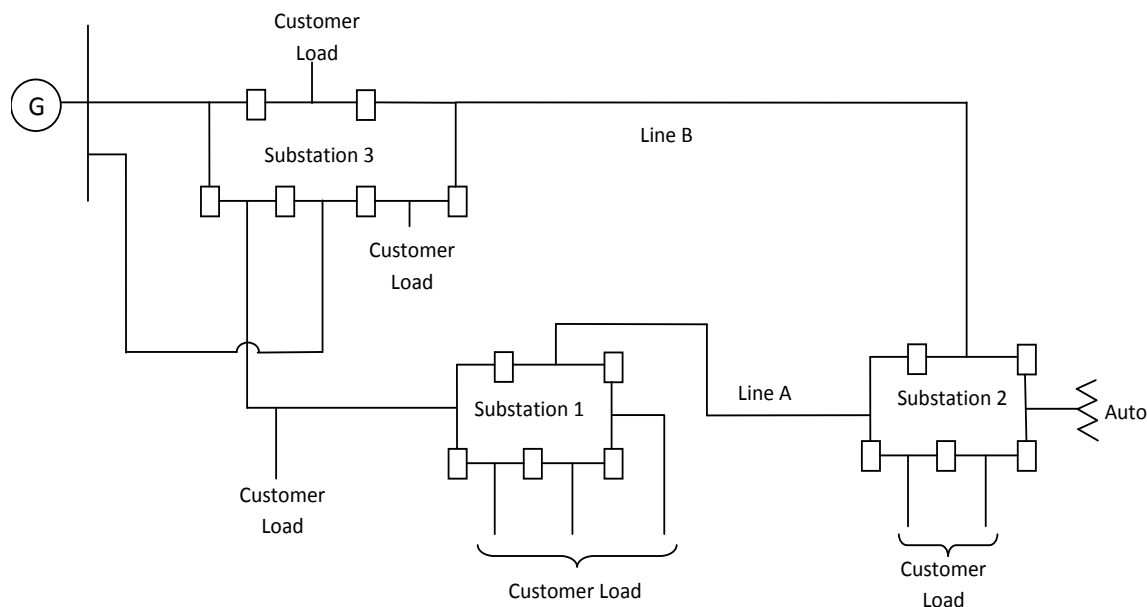
A permanent phase-to-ground Fault occurred on Line A, which is a two-terminal line. Both ends correctly operated on the initial Fault with high speed clearing. Simultaneously, the back-up relay on the line panel for Line B tripped the local breakers at Substation 3. The operation by the back-up relay occurred because the communications channel for the backup relaying was not in service at the time of the fault. The protection scheme in place was set for instantaneous trip setting for the loss of communication.

The Line A panel at Substation 1 transmitted breaker failure initiate logic to adjacent line panels. However, the adjacent line panels, due to wiring errors, incorrectly received breaker failure trip signals which resulted in unnecessary trips of additional breakers at Substation 1. During the investigation, it was found that the panels at Substation 1 had relay breaker failure *initiate* outputs tied to breaker failure *trip* inputs. Construction prints issued by a contract engineering firm were not reviewed by relay personnel, resulting in a wiring error by a construction contractor.

- The line protection scheme was modified at all substations to place a time delay to prevent overreach for faults outside of the zone of protection.
- The operation of all breaker failure contacts were blocked until breaker failure circuits on all transmission panels in service area were reviewed and, if needed, corrected.

- The settings and protection scheme have been reviewed and the company's system protection manual has been modified to incorporate a time delay on the back-up elements to allow close in faults to clear before the back-up element reacts.
- The scope of work for contract engineering for relay projects will have a hard stop for the issuance of construction prints until they have been reviewed and approved.
