Agenda for the Fifth Annual ERCOT and Texas RE Generator Weatherization Workshop For winter 2017/2018

September 7, 2017

Winter Weatherization Review

Weatherization Program

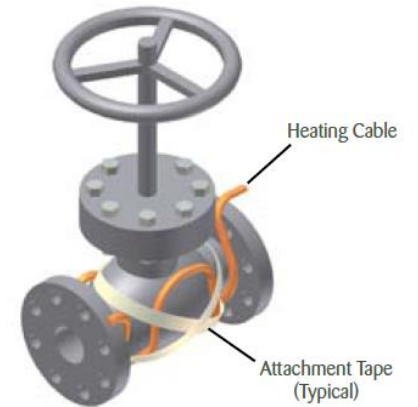
- Inspection of heat tracing installations covered by insulation
 - Extra cable length specified by the designer meant to be bunched at valves and supports, not applied as a constant-pitch spiral over the length of the line.
- Require heat tracing calculations from the **contractor**
 - Reference to heat tracing calculations IEEE Standard-515
 - Valve bonnets, actuators and pipe supports should reflect actual insulation conditions; they may not be fully encapsulated with insulation, which could lead to mismatch.

Heating Cable Serpentine on Valve

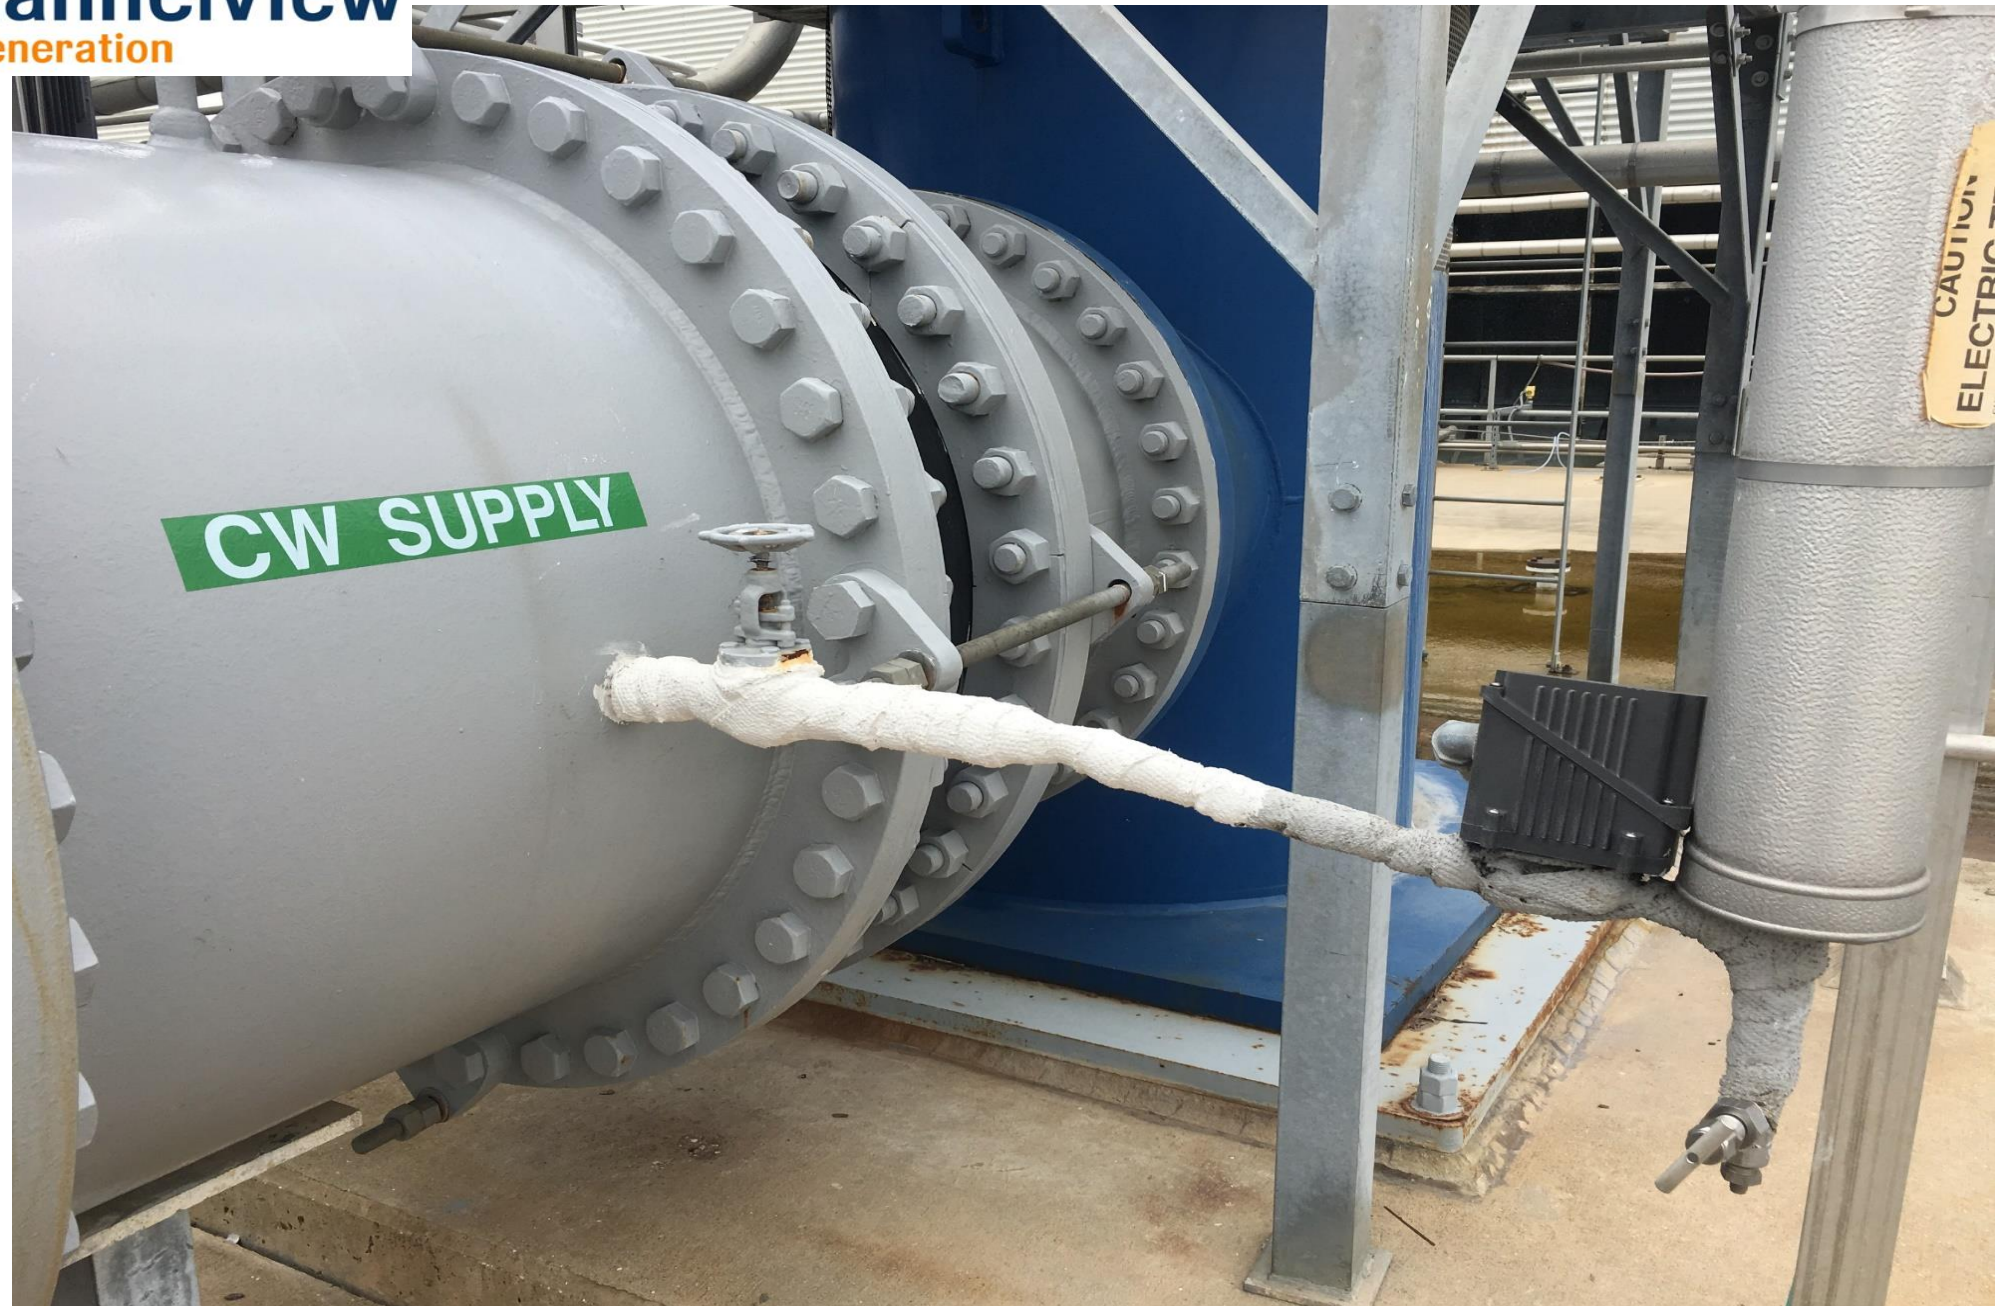
- ▶ Wrong type of Tarps & Blankets
- ▶ Heat Trace panel screens were unreadable
- ▶ Heat Trace not functioning properly (open circuits)
- ▶ Exposed Heat Trace cables (uninsulated)
- ▶ Gaps in insulation
- ▶ Plant Procedure needed work

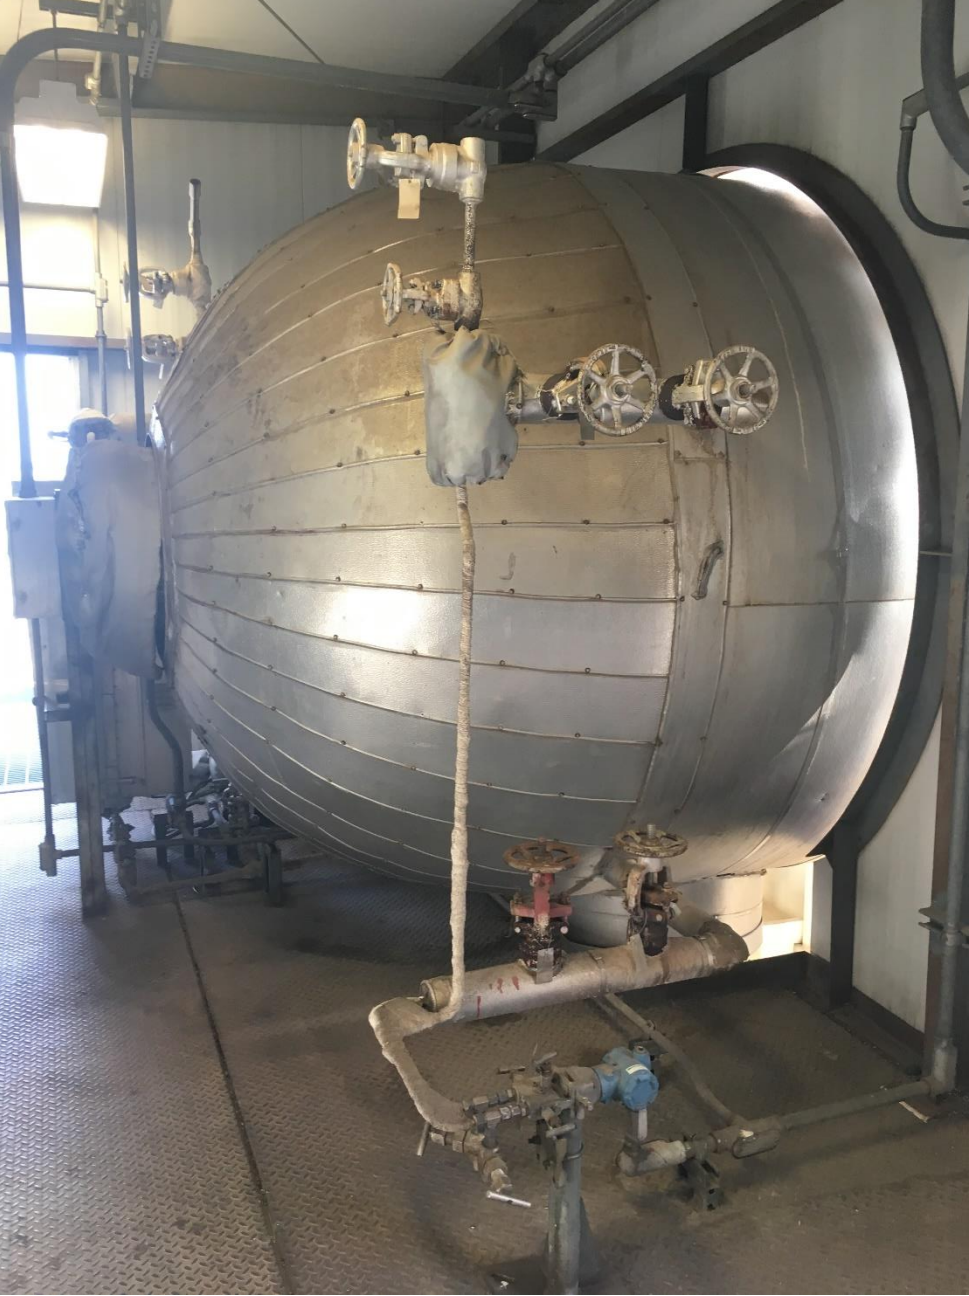
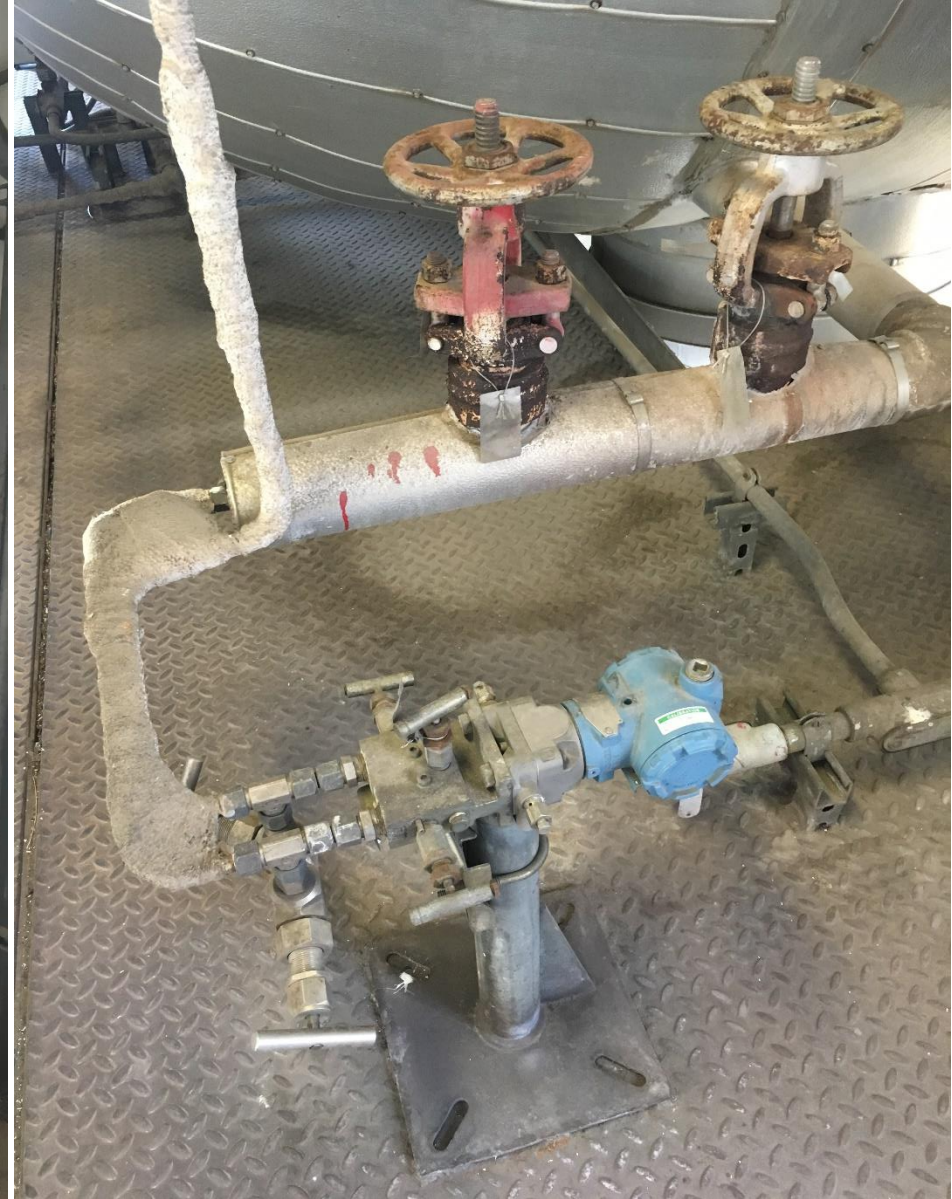
HP, IP & LP Drum LT 'A' & 'B'

- IP BFW PT - Original cloth tape & plaster on the sensing lines needs newer insulation to be tightened up. Add layer of new insulation & weak solution of antifreeze to sensing lines. Complete.
- HP drum LT 'C' - Insulation is not made up in 2 places along sensing line at transmitter allowing cold air to enter. Recommend sensing line & transmitter with weak solution of antifreeze. Long term replace tubing with larger pipe.
- LP SH outlet PT- Pipe is plugged & needs replacement. Add new heat trace, insulation & diluted antifreeze solution after replacement. Complete.

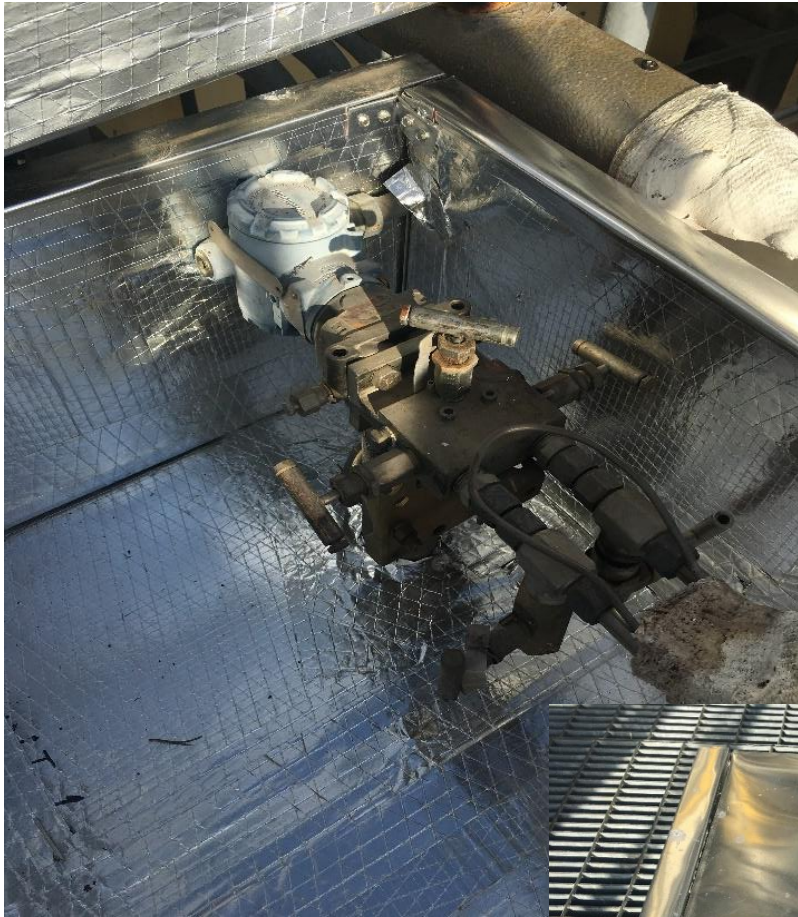
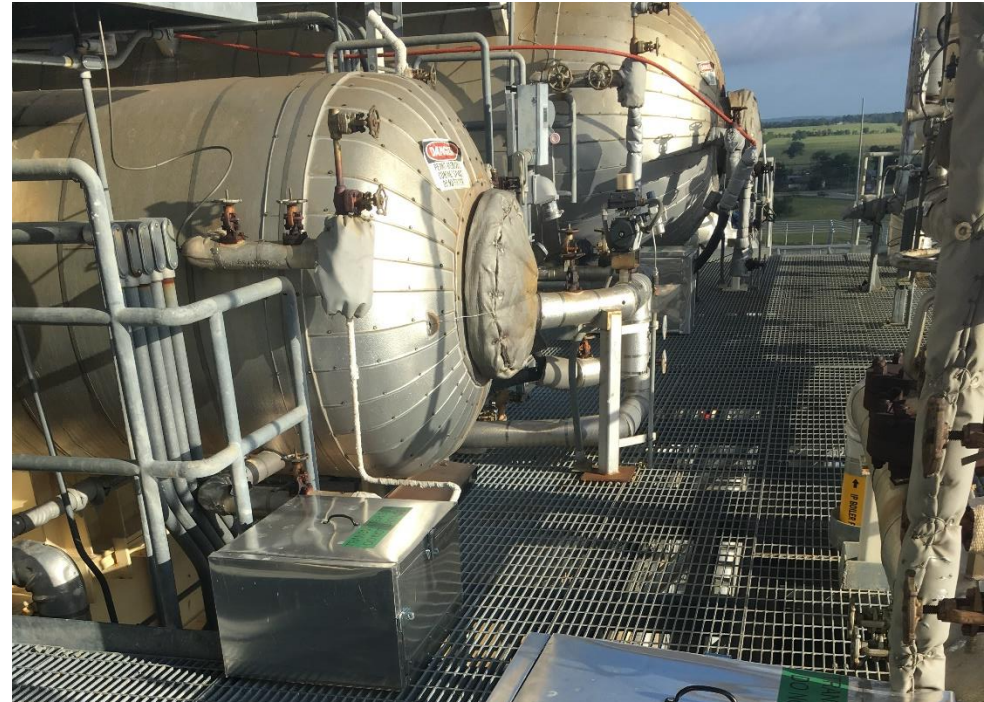
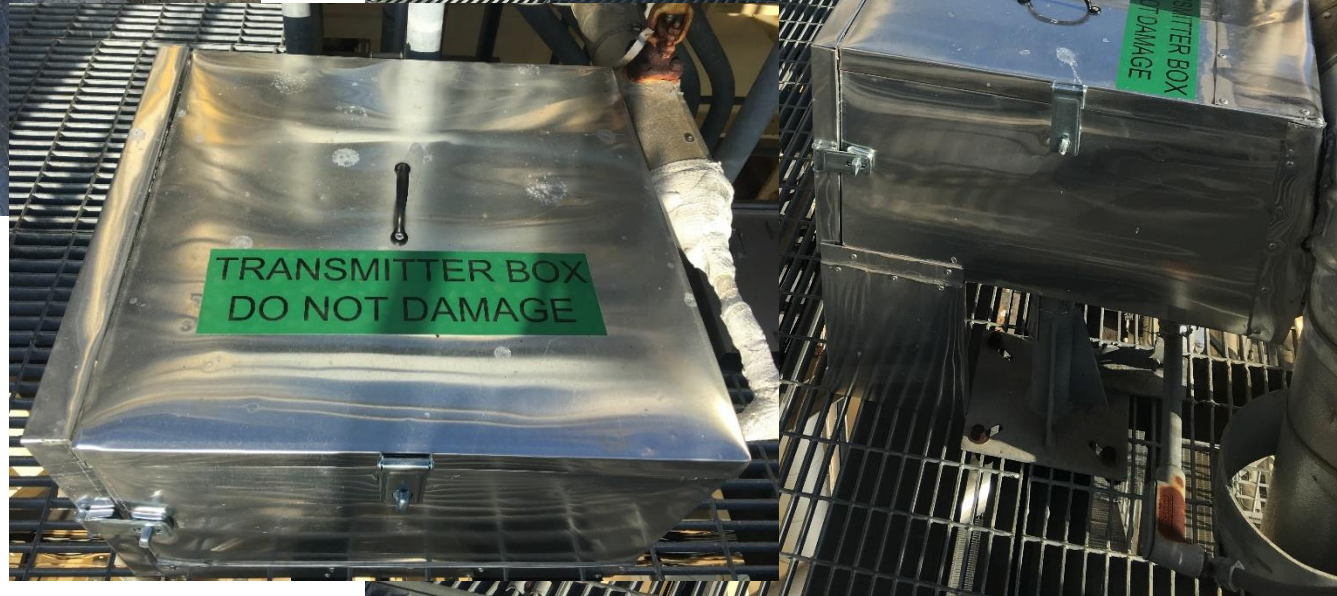
HP, IP & LP
Drum LT 'C'

& IP BFW FT
to drum

After Jan.7th event

- IP SH outlet FT- No heat trace (HT). Recommend new heat trace & insulation. Antifreeze at transmitter. Complete.
- IP BFW flow to drum - Operators have covered with tarp & installed a temporary lamp. Long term replace tape insulation with thicker new insulation. Antifreeze at transmitter. Complete.
- HP drum PT 'C' – Limited insulation. Removed to examine small steam leak. Fix leak & replace insulation. Complete.
- Condensate to LP economizer FTs – Insulation missing at bottom of mezzanine on west side. Complete.

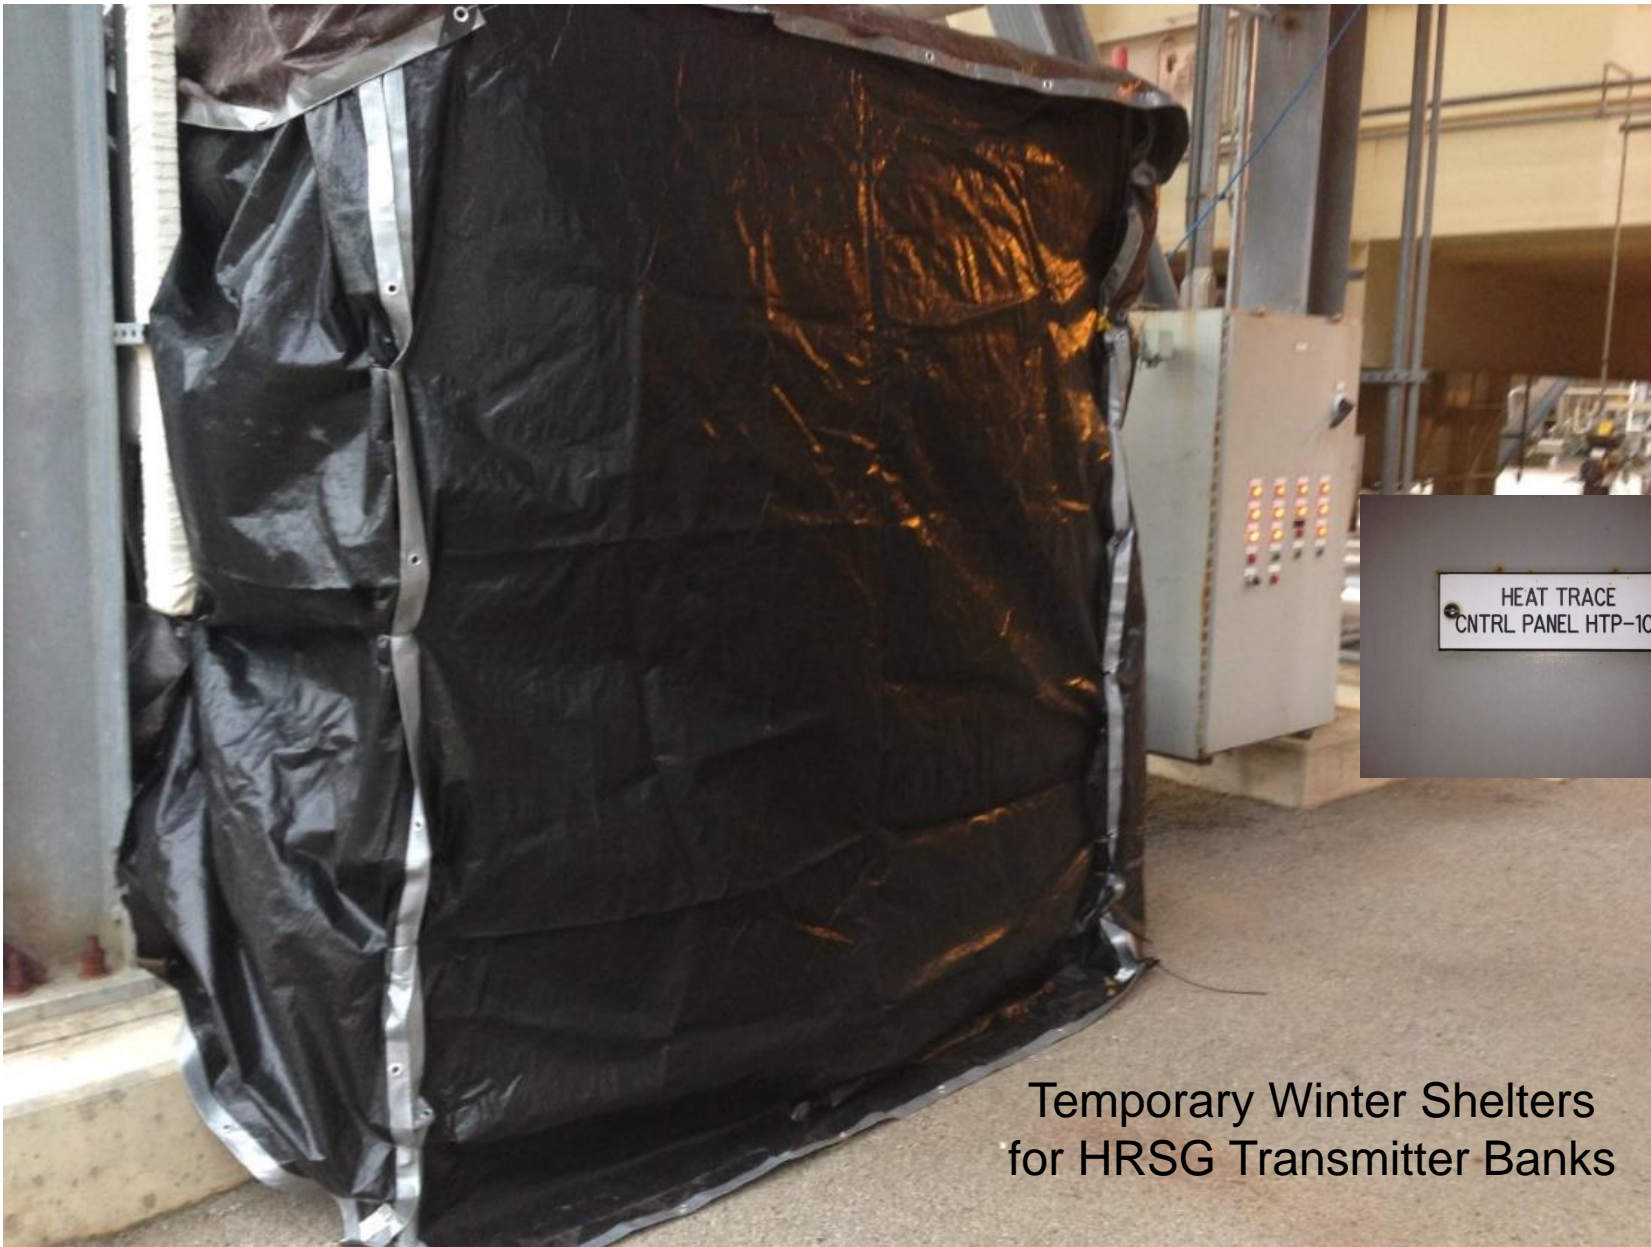
Temporary Winter Shelters
for HRSG Transmitter Banks

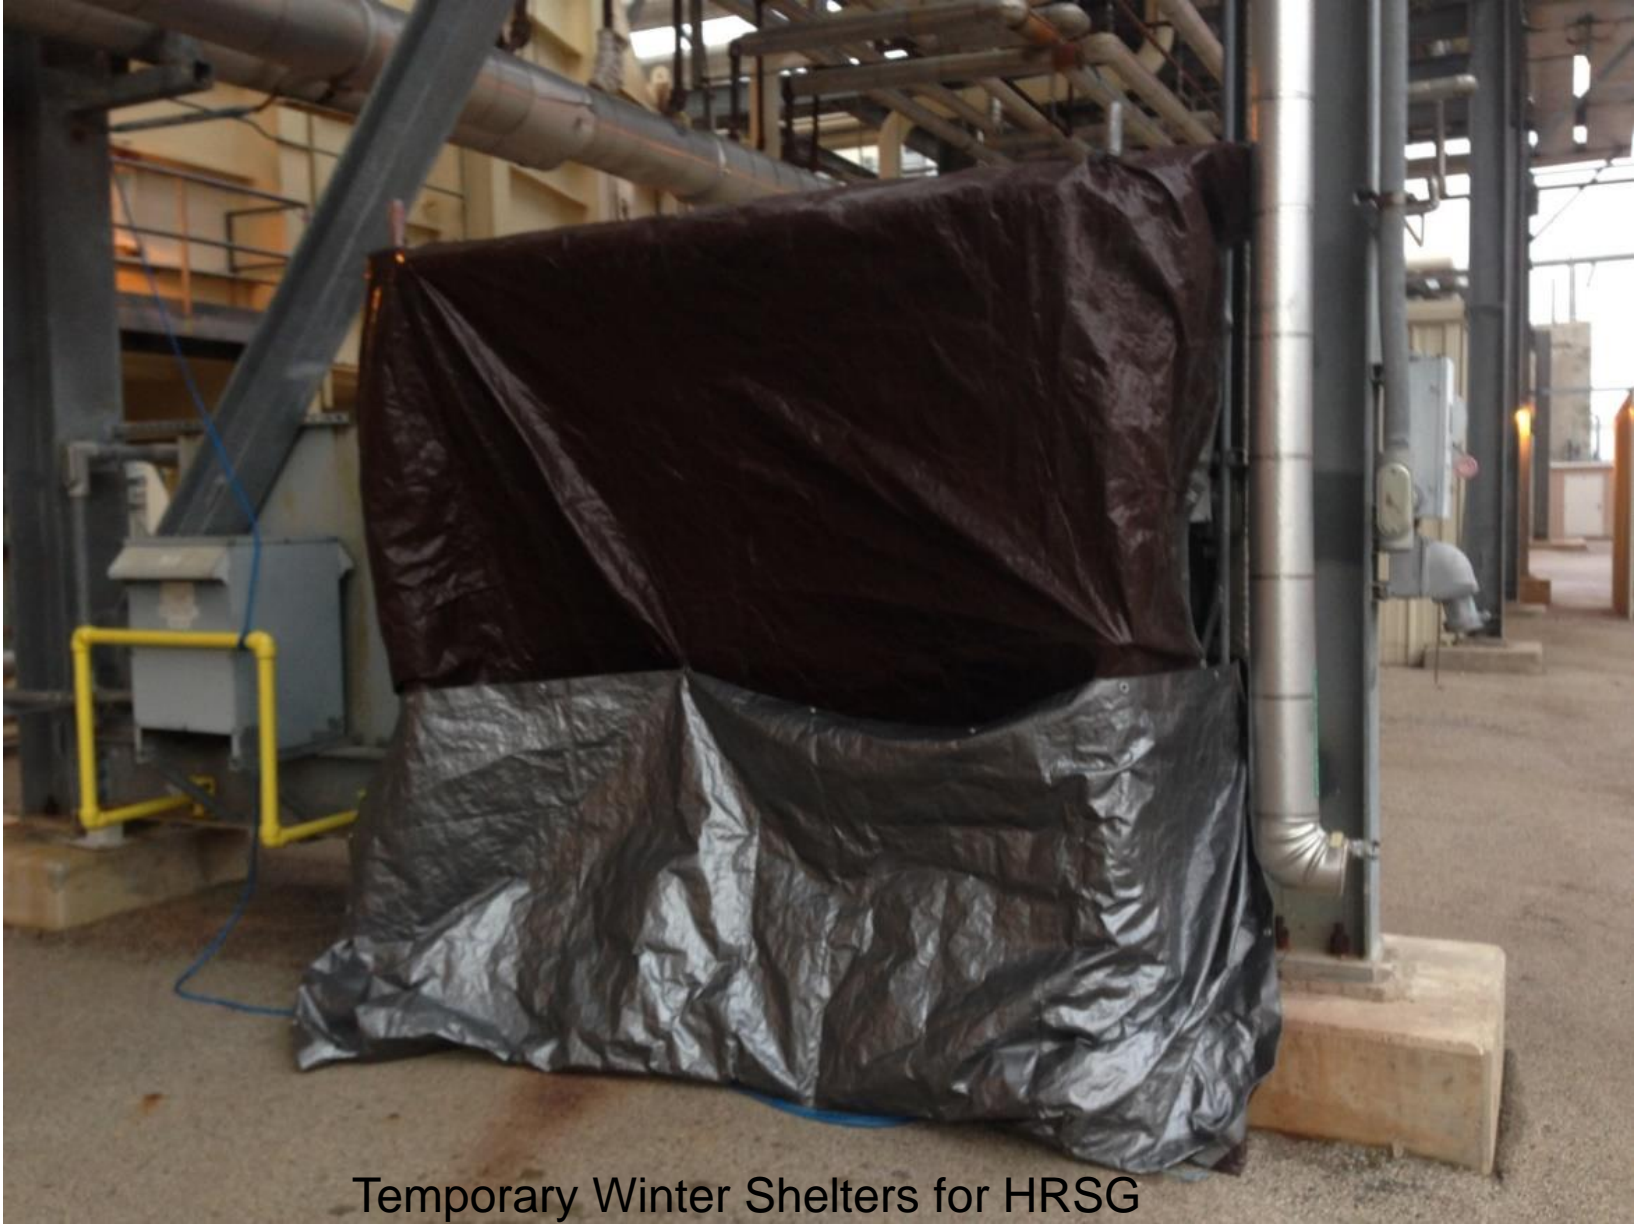
Temporary Winter Shelters
for HRSG Transmitter Banks

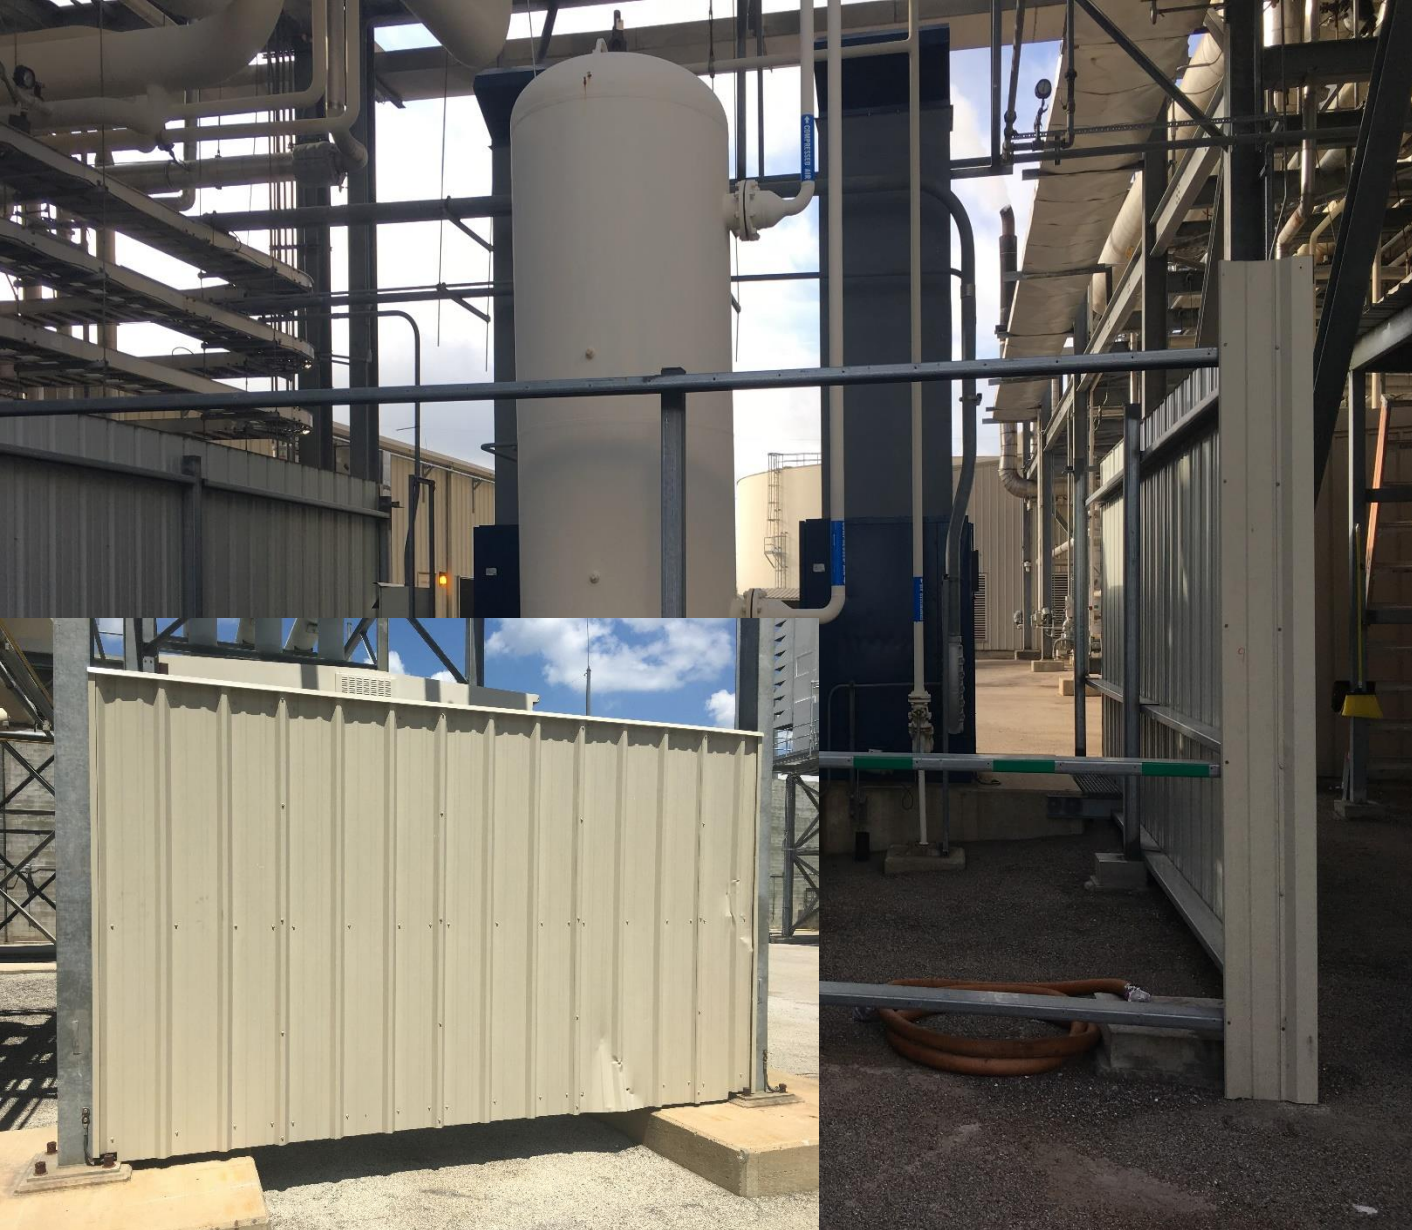
Temporary Winter Shelters for HRSG
Transmitter Banks with heat lamps inside
