Texas Reliability Entity Event Analysis

Event:
August 20, 2010 DCS Event
Category 3 Event

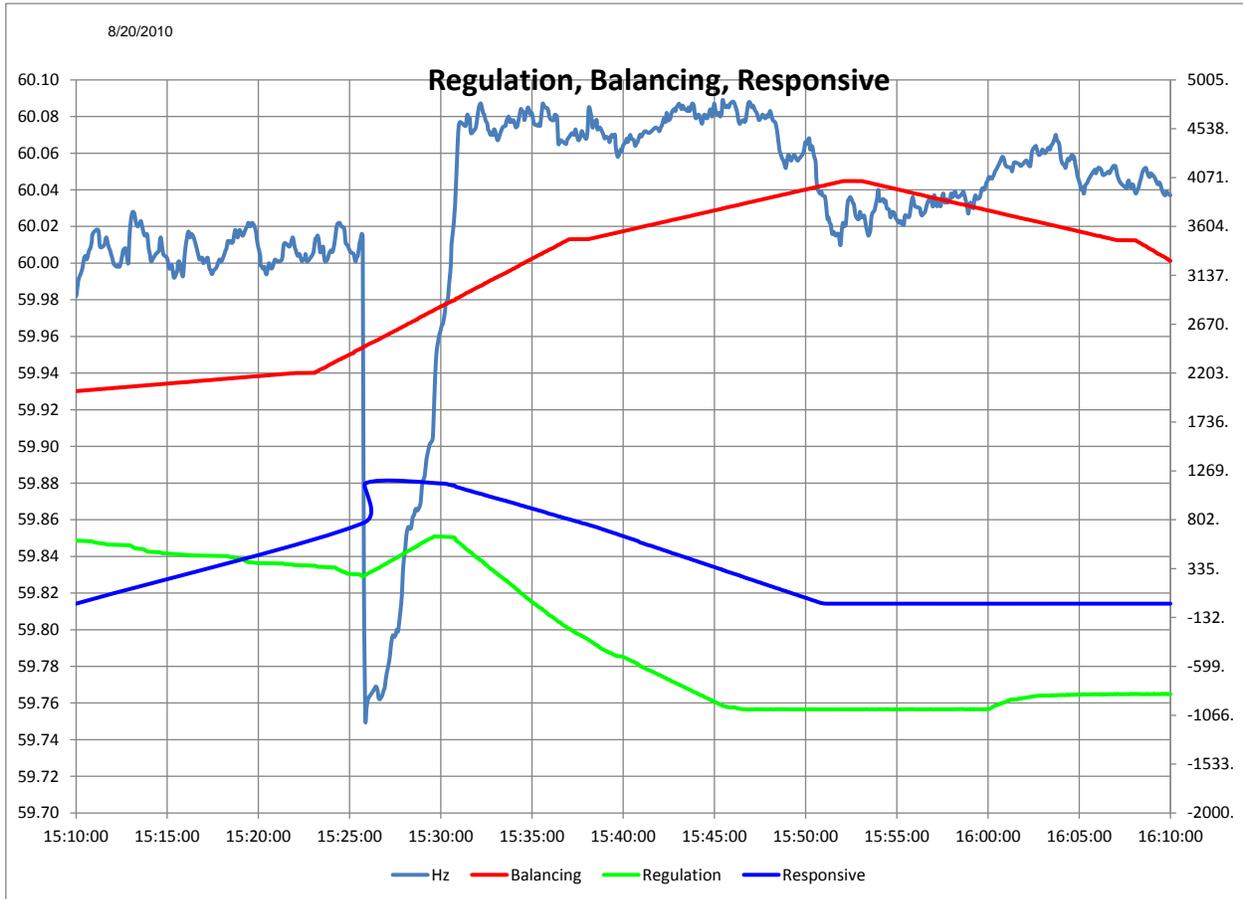
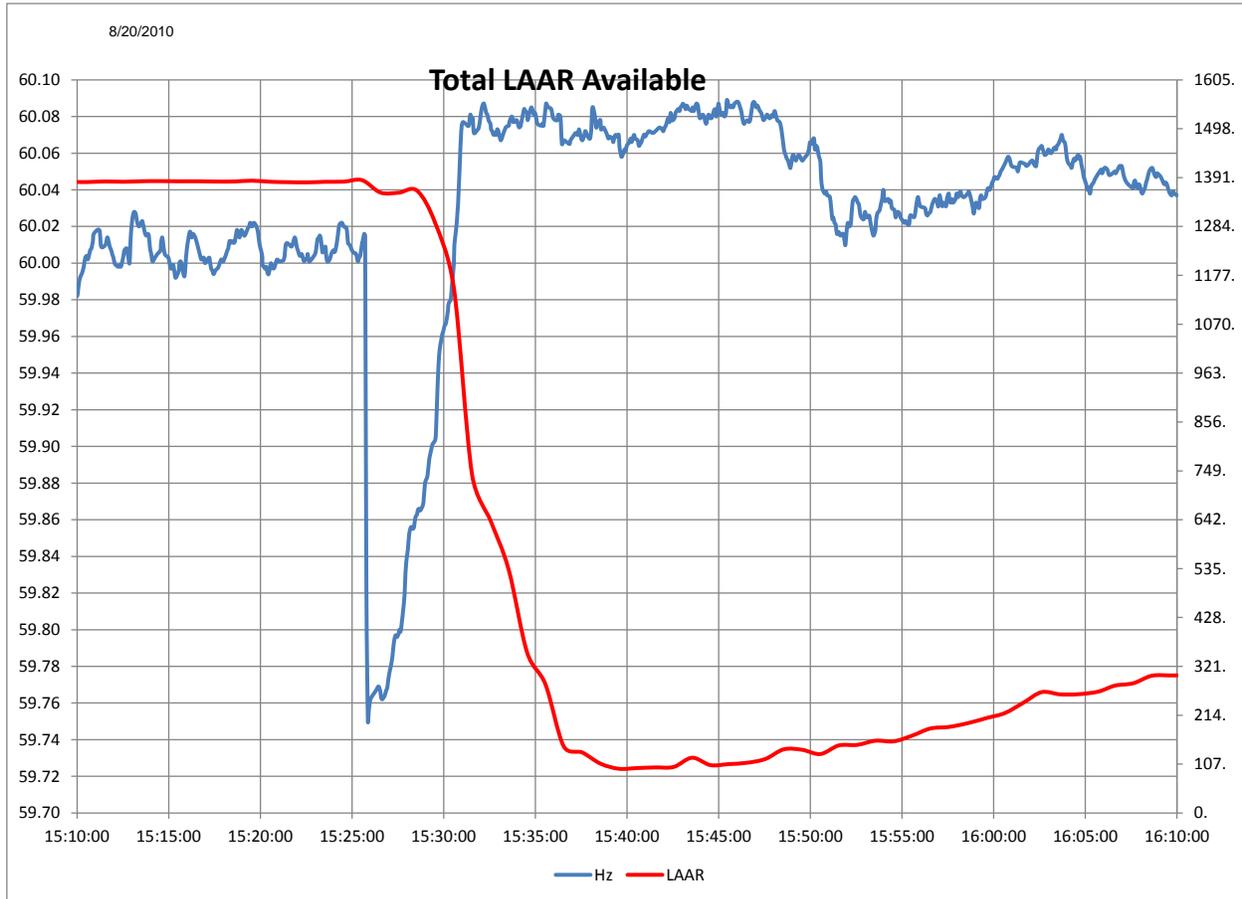
- Generator governor response arrested the frequency decline, as analyzed by the Performance, Disturbance, Compliance Working Group (PDCWG) in its draft report. The initial calculated system frequency response, termed the “B” point, was 208.63 MW/0.1 Hz, which failed to meet the target of 420 established in ERCOT Protocols 5.9.2. The second calculated response point, termed “B+30” to denote that it measures how well response is sustained 30 seconds after the event, declined to 159.30 MW/0.1 Hz, which also failed to meet the minimum response target.

- Manual deployment of LaaR reduced load by 1329 MW (vs. target of 1150 MW required under ERCOT Protocols) within 10 minutes after the BA issued Verbal Dispatch Instruction (VDI) at 15:28:56, approximately three minutes after the initial disturbance. Only 20 MW LaaR tripped automatically. Since the RC’s control center frequency measurement indicated a minimum frequency of 59.749 Hz, above the target of 59.7 (this limited response is expected due to minor variations in frequency across the system coupled with LaaR underfrequency relay sensitivities). One LaaR provider with approximately 22 MW of load experienced a telemetry failure but still deployed.

The result of these actions was that system frequency returned to its pre-disturbance value of 60 Hz within 4 minutes and 42 seconds.
