Texas Reliability Entity Event Analysis

Event:
December 11, 2010 Loss of Multiple Generators
Category 3 Event

Texas Reliability Entity
July 2011

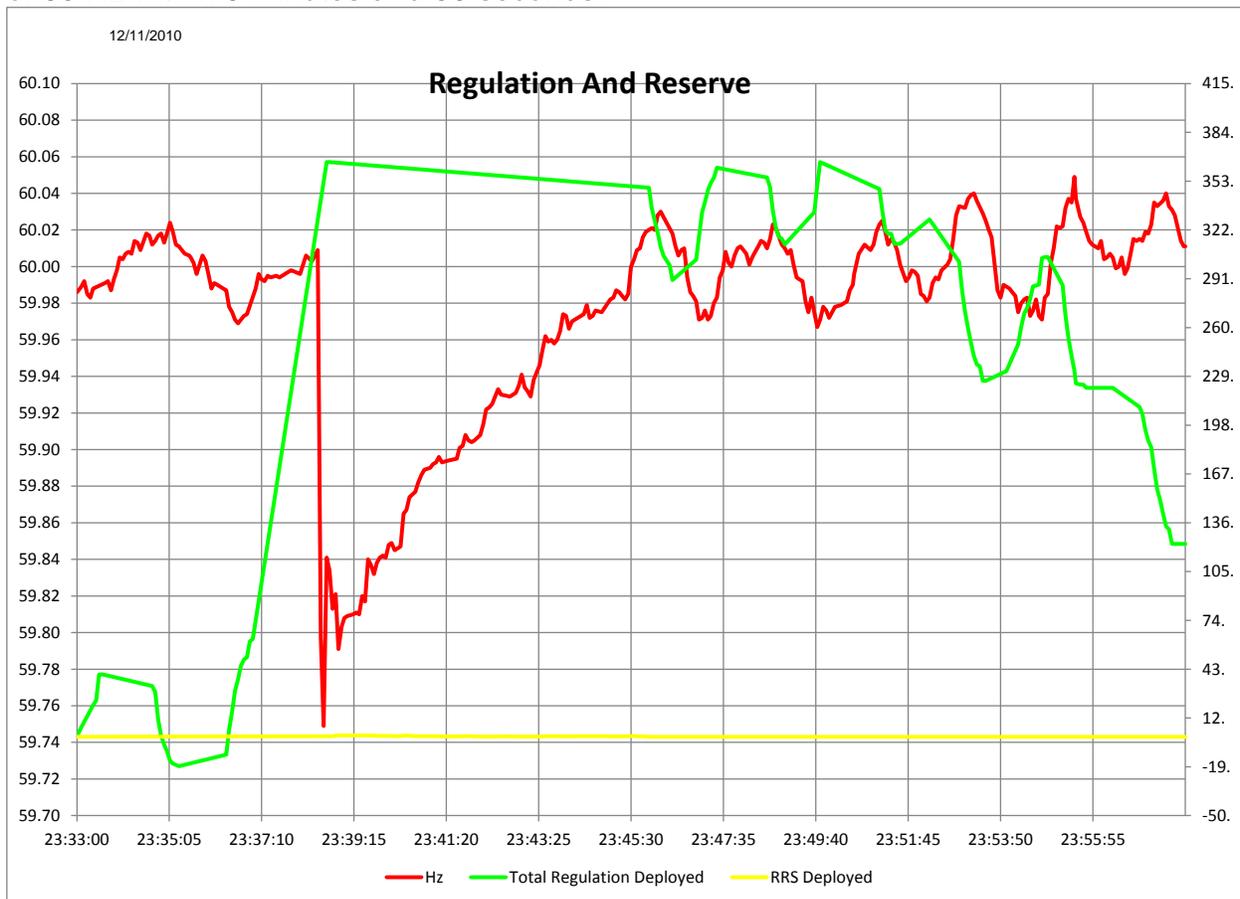
- Generator governor response arrested the frequency decline, as analyzed by the Performance, Disturbance, Compliance Working Group (PDCWG) in its draft report. The initial calculated system frequency response, termed the “B” point, was 468.34 MW/0.1 Hz, which met the target of 420 established in ERCOT Protocols. The second calculated response point, termed “B+30” to denote that it measures how well response is sustained 30 seconds after the event, declined to 336.18 MW/0.1 Hz, which failed to meet the minimum response level. The PDCWG also noted the following concerns:
 - 107 out of 151 units (units running that were not excluded) (70.9%) sustained governor response for this event.

- The BA control center computer made a step deployment of 290 MW of hydro generation RRS, within 90 seconds of the frequency bottom. Per the RC, hydro generation was made available as Responsive Reserve Service (RRS) deployed when frequency dropped below 59.90 Hz. This was independent of Nodal RRS deployment calculations and criteria. At 59.91 RRS was activated to determine if RRS was required. RRS action assessed SCED (Security Constrained Economic Dispatch) to determine if adequate capacity was available. Since SCED had sufficient capacity, RRS was not deployed. Texas Reliability Entity (Texas RE) did not identify any problems with this automatic deployment by the BA or the response from Qualified Scheduling Entity's (QSEs) to ramp their generators output up within 10 minutes as required.

The result of these actions was that system frequency returned to its pre-disturbance value of 60 Hz within 6 minutes and 56 seconds.
