NERC Activities, the Polar Vortex and Continuing Regulatory Interest

Generator Winter Weatherization Workshop

September 1, 2015

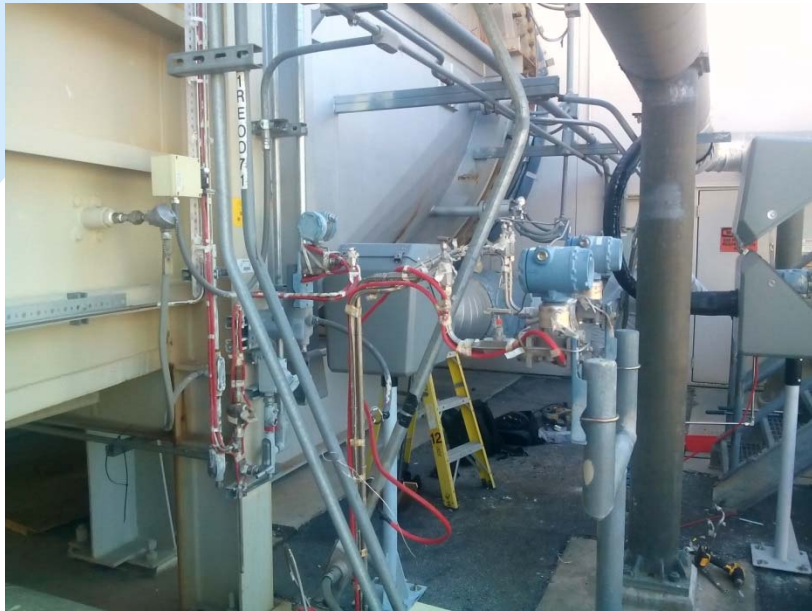
Original Installation

NOx Transmitter

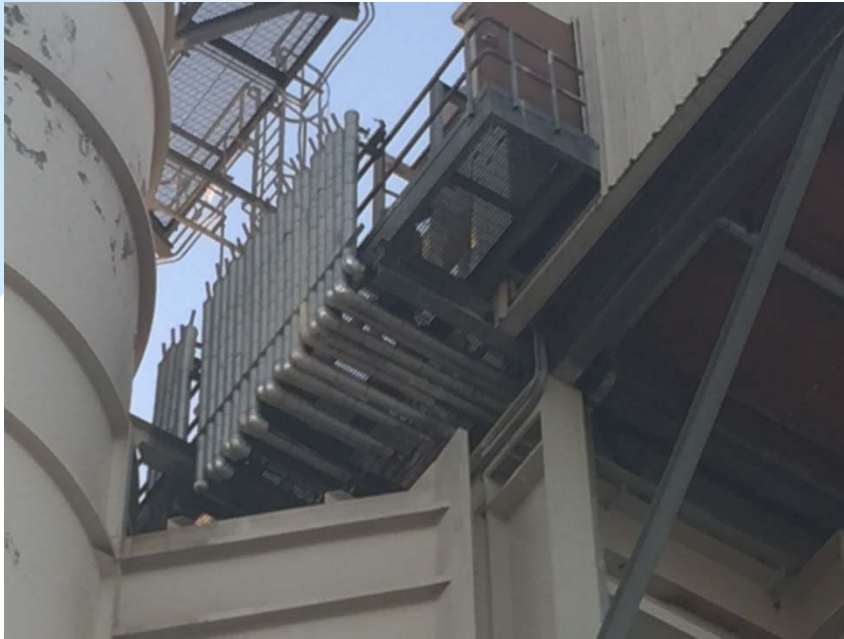
Original Installation

- 22 vent lines were located together, making them susceptible to collective failure

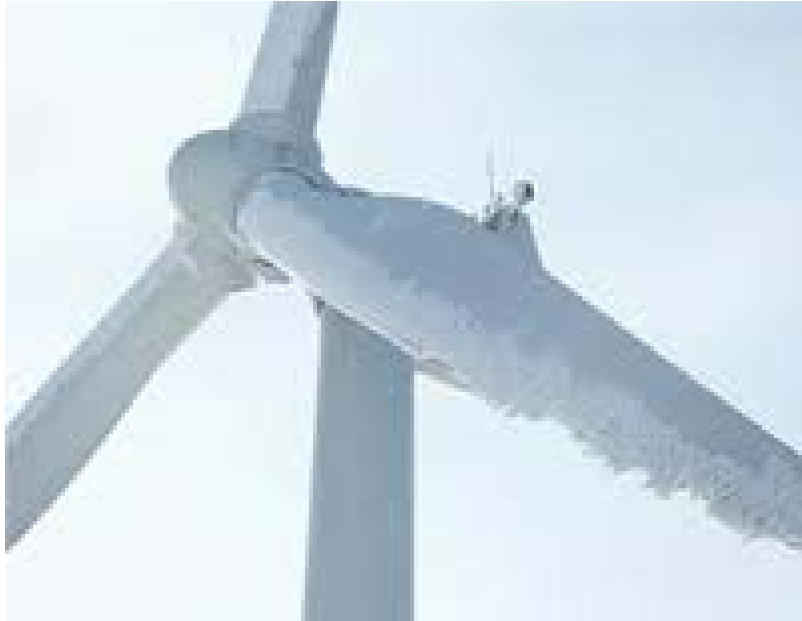
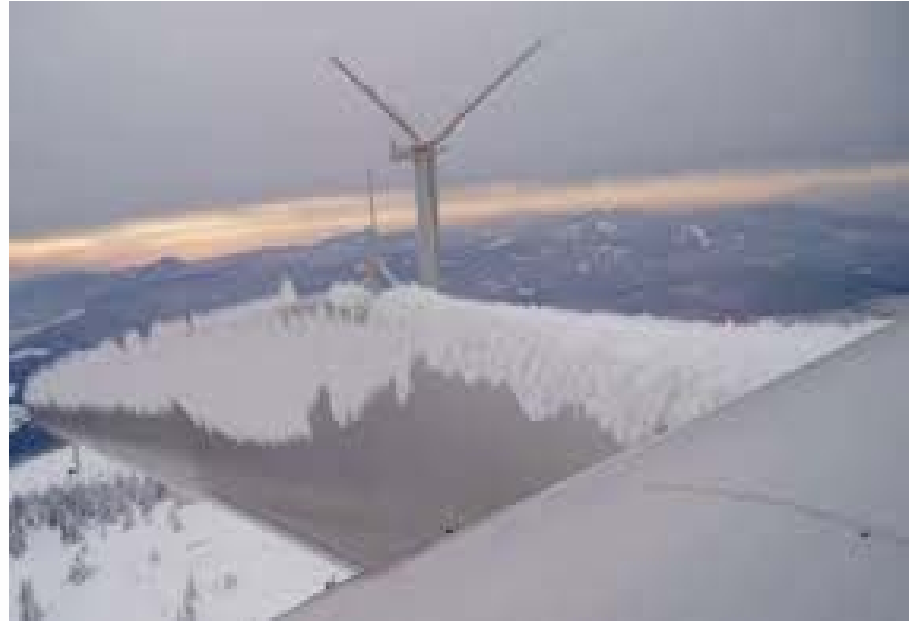
Icing Impacts

- Icing created a mismatch between the forecast and actual production.
- This created an error in the forecast which then was provided to WGRs.
- This error was used in the COP for RUC.
- Could lead to ERCOT counting on more wind than WGRs are able to generate.

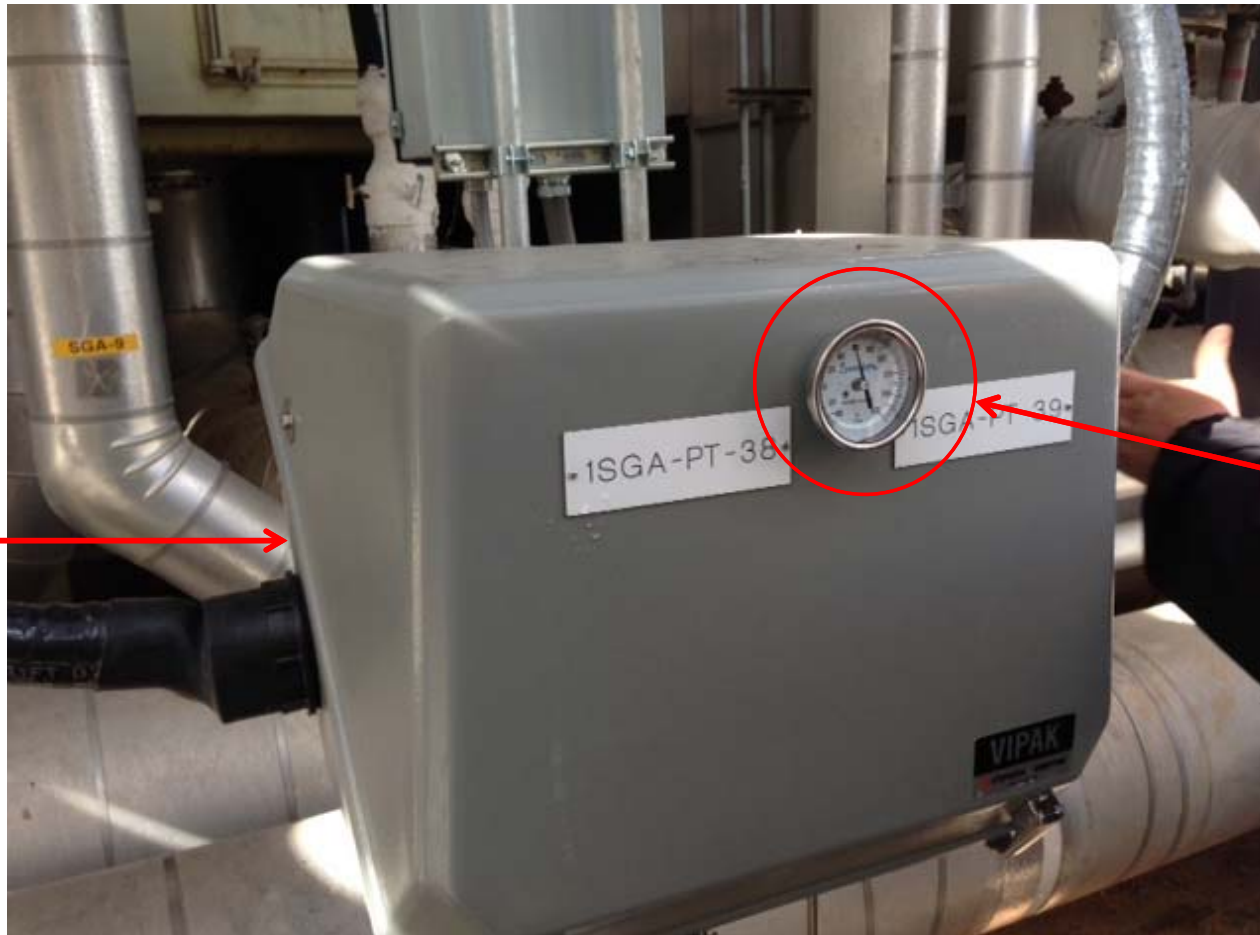
Insulated heated enclosure for transmitters – best practice

Insulated heated enclosure for transmitters

Outside temperature gauge to monitor inside temperature

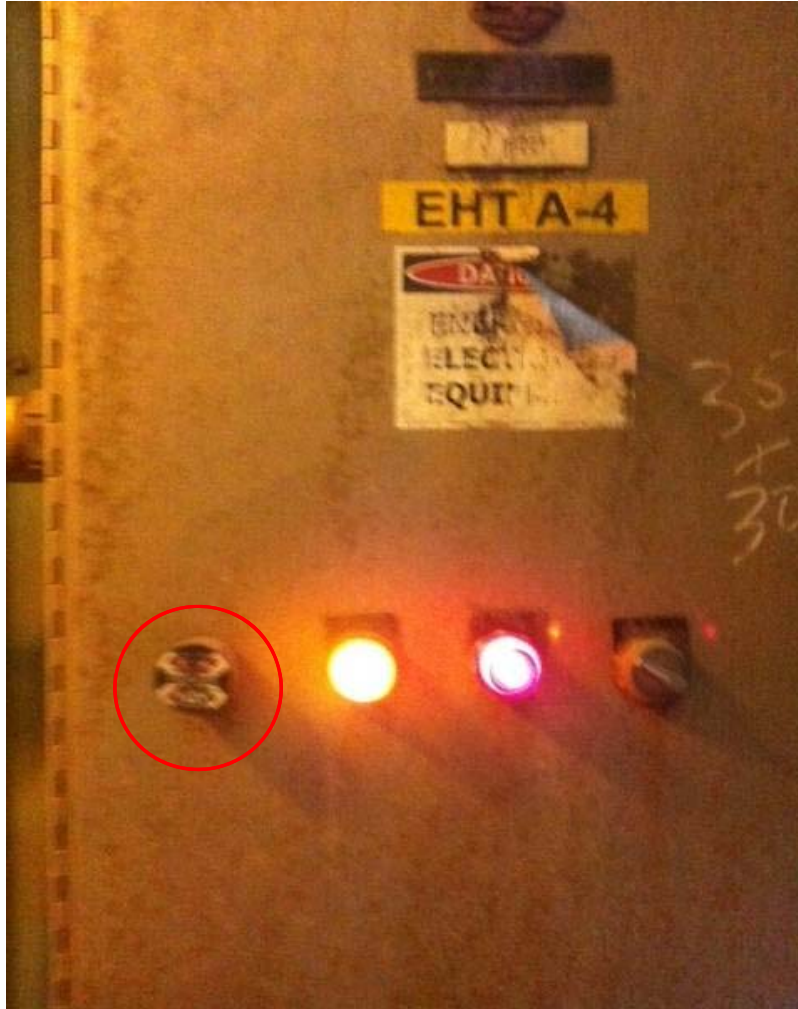
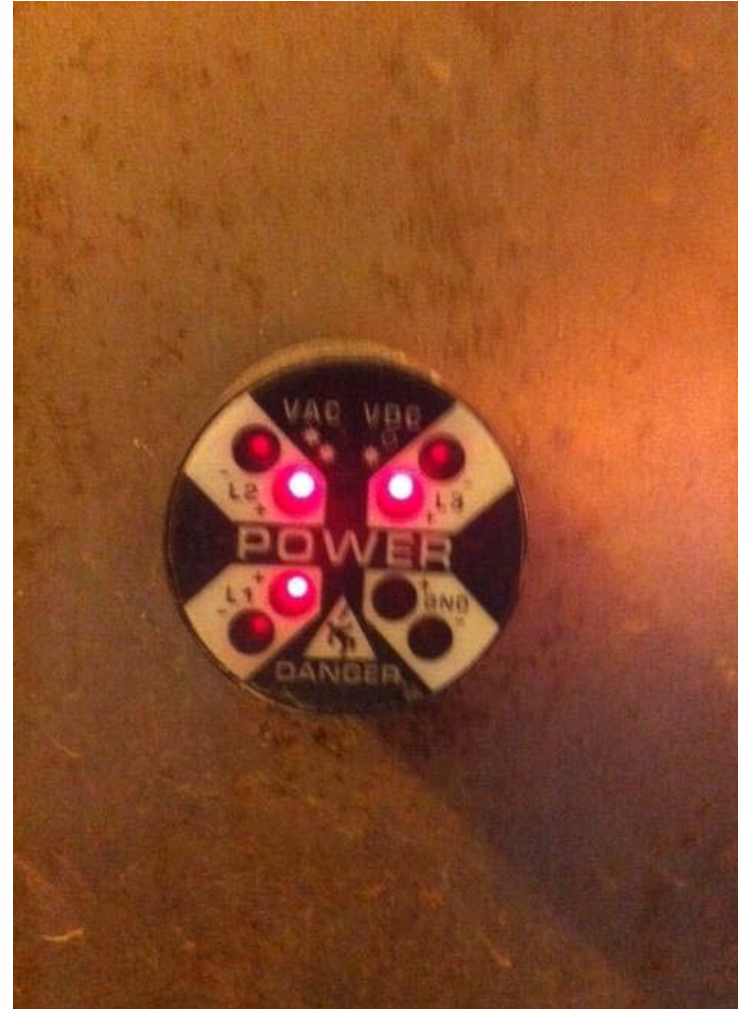
Three phase monitor on heat trace panel – best practice

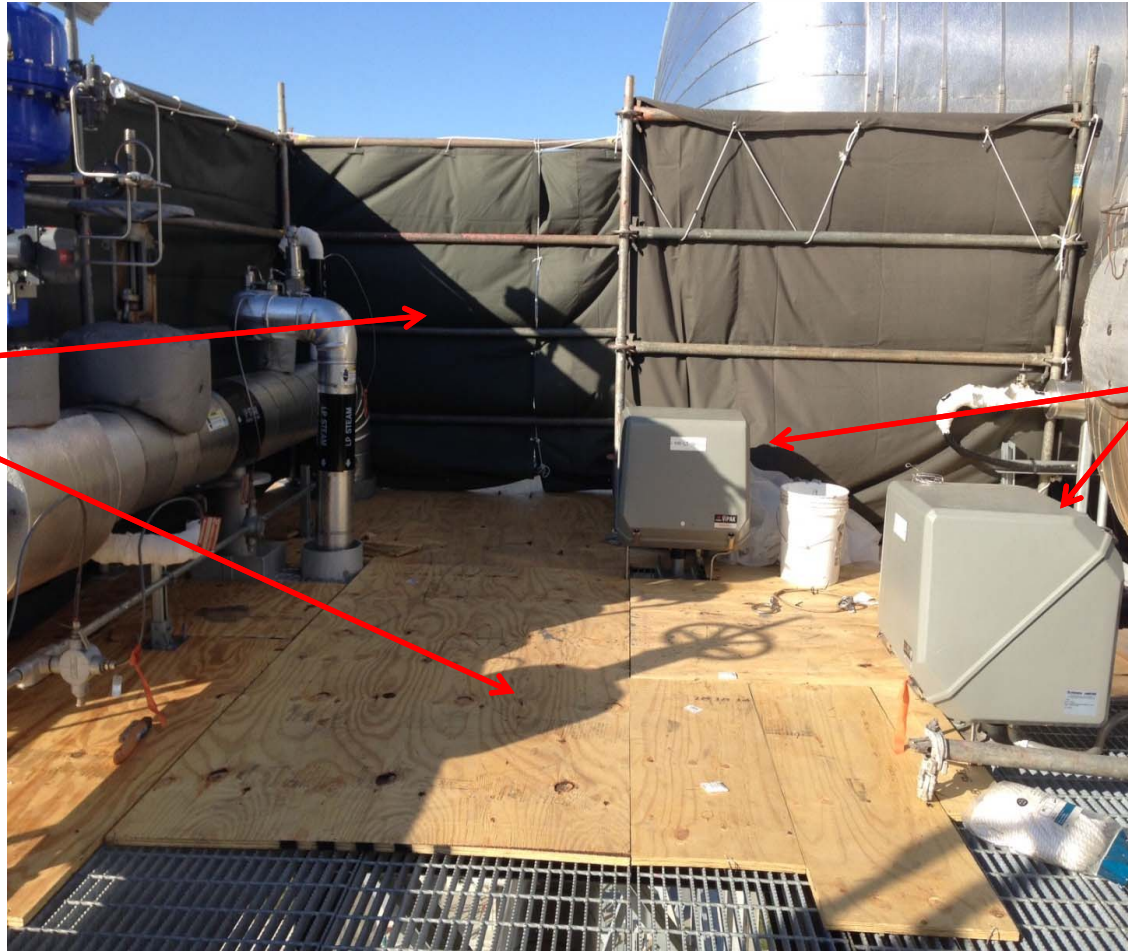
Best practice wind break and flooring to prevent tunneling effect.

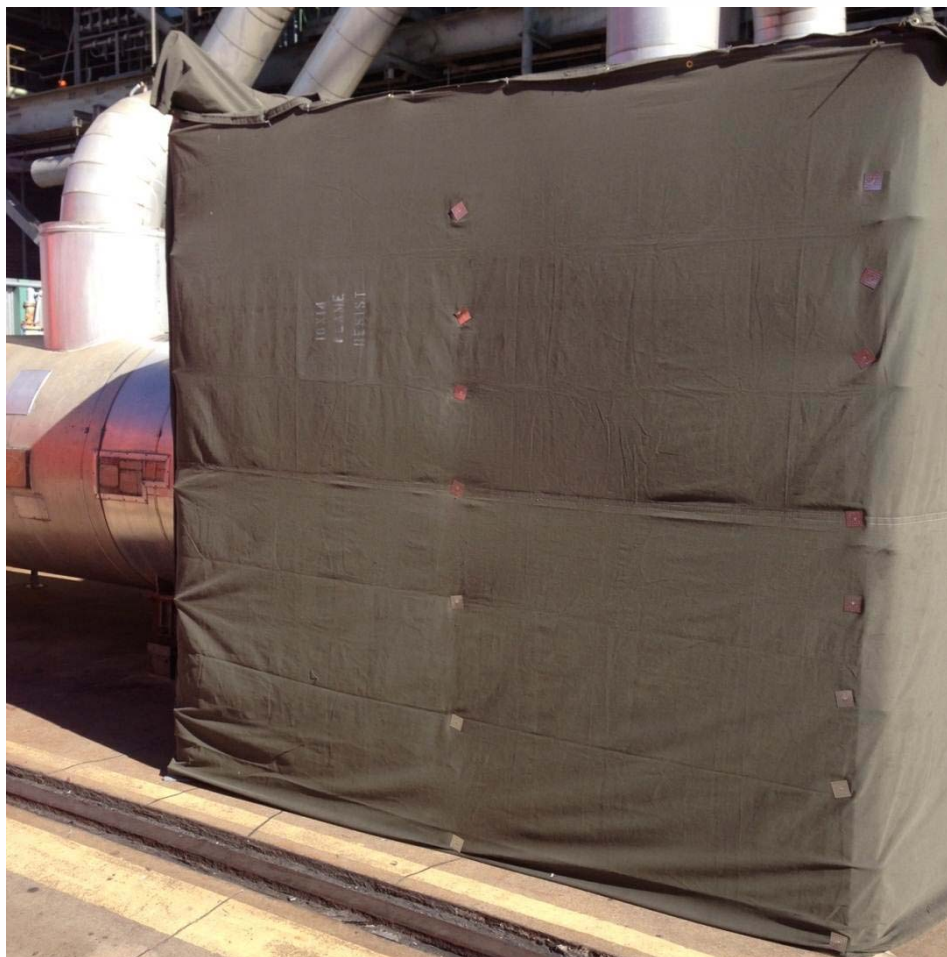
Insulated transmitter boxes

Best Practice

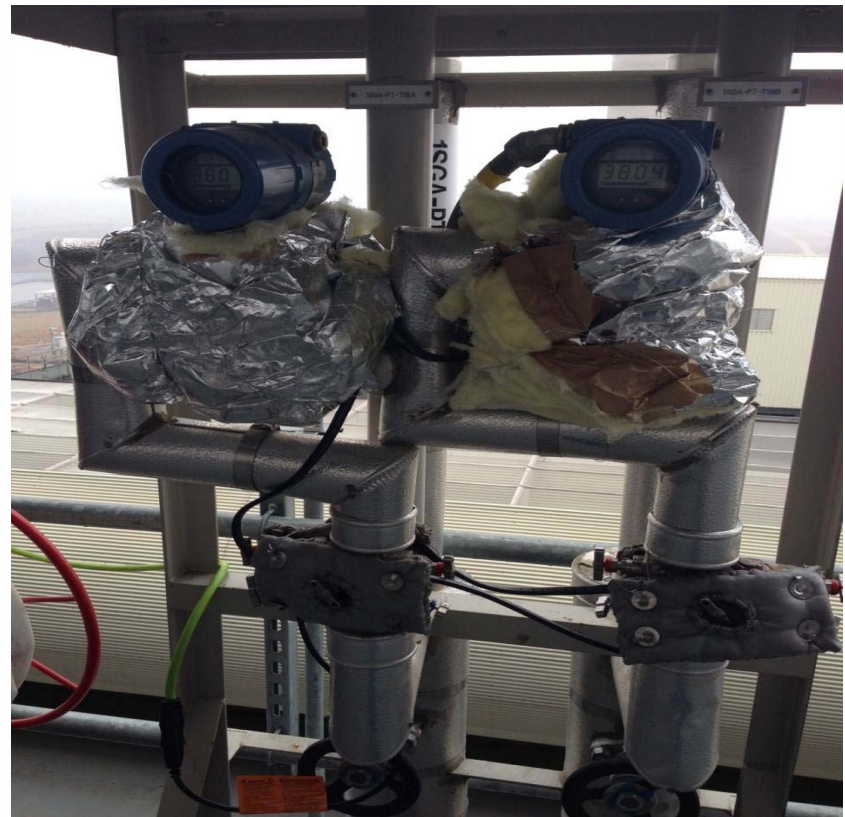
Plant 4 – superheat steam transmitters that caused trip on 1/6/14 with boiler logic set to OR. Uninsulated transmitter manifolds.

Uninsulated transmitter manifolds

Mitigation for remainder of winter 2014

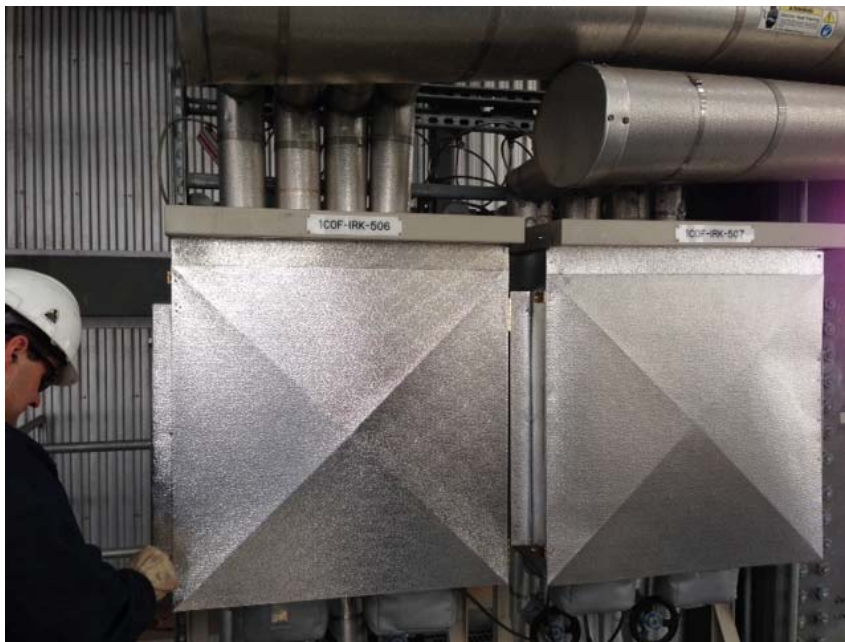
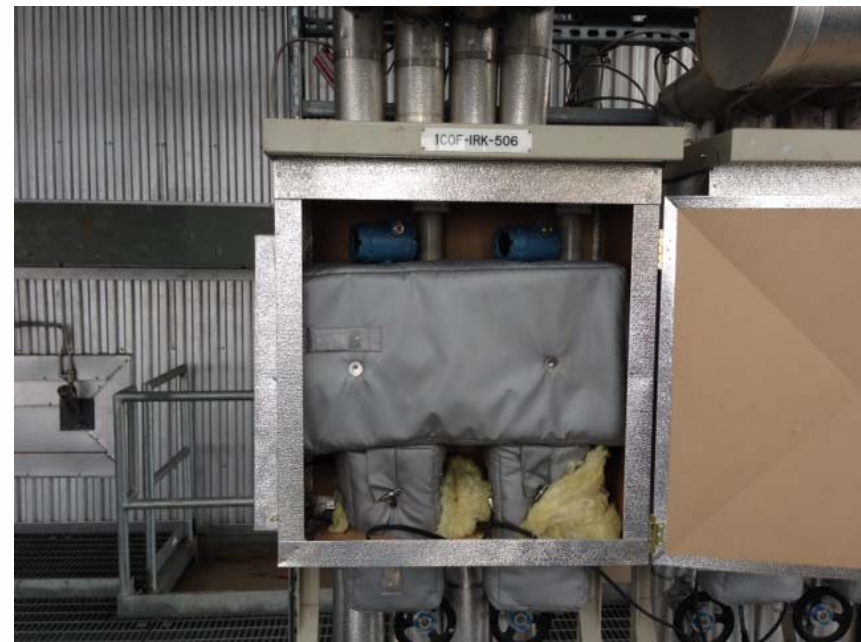
Plant 4 (continued) transmitters winter 2014/2015.
Relocated, wind break, insulated and transmitter
manifolds are heat traced.

Unit experienced no freezing equipment for winter
2014/2015.

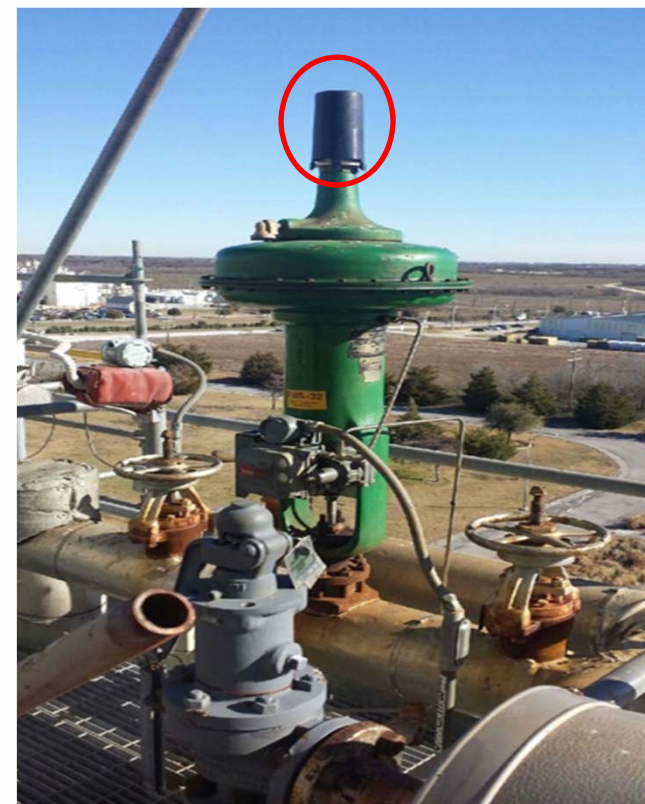
1 – IP drum level control valve - water penetrating resulting in valve failing to regulate due to ice

Inspection discovered valves with water that freeze up during extreme temperatures

Plant experienced no freezing equipment for winter 2014/2015

Plant 5 - regulating valve improvements. Nineteen valves rebuilt with rain caps installed.
