Agenda for the Fifth Annual ERCOT and Texas RE Generator Weatherization Workshop For winter 2017/2018

September 7, 2017

Winter Weatherization Review

Weatherization Program

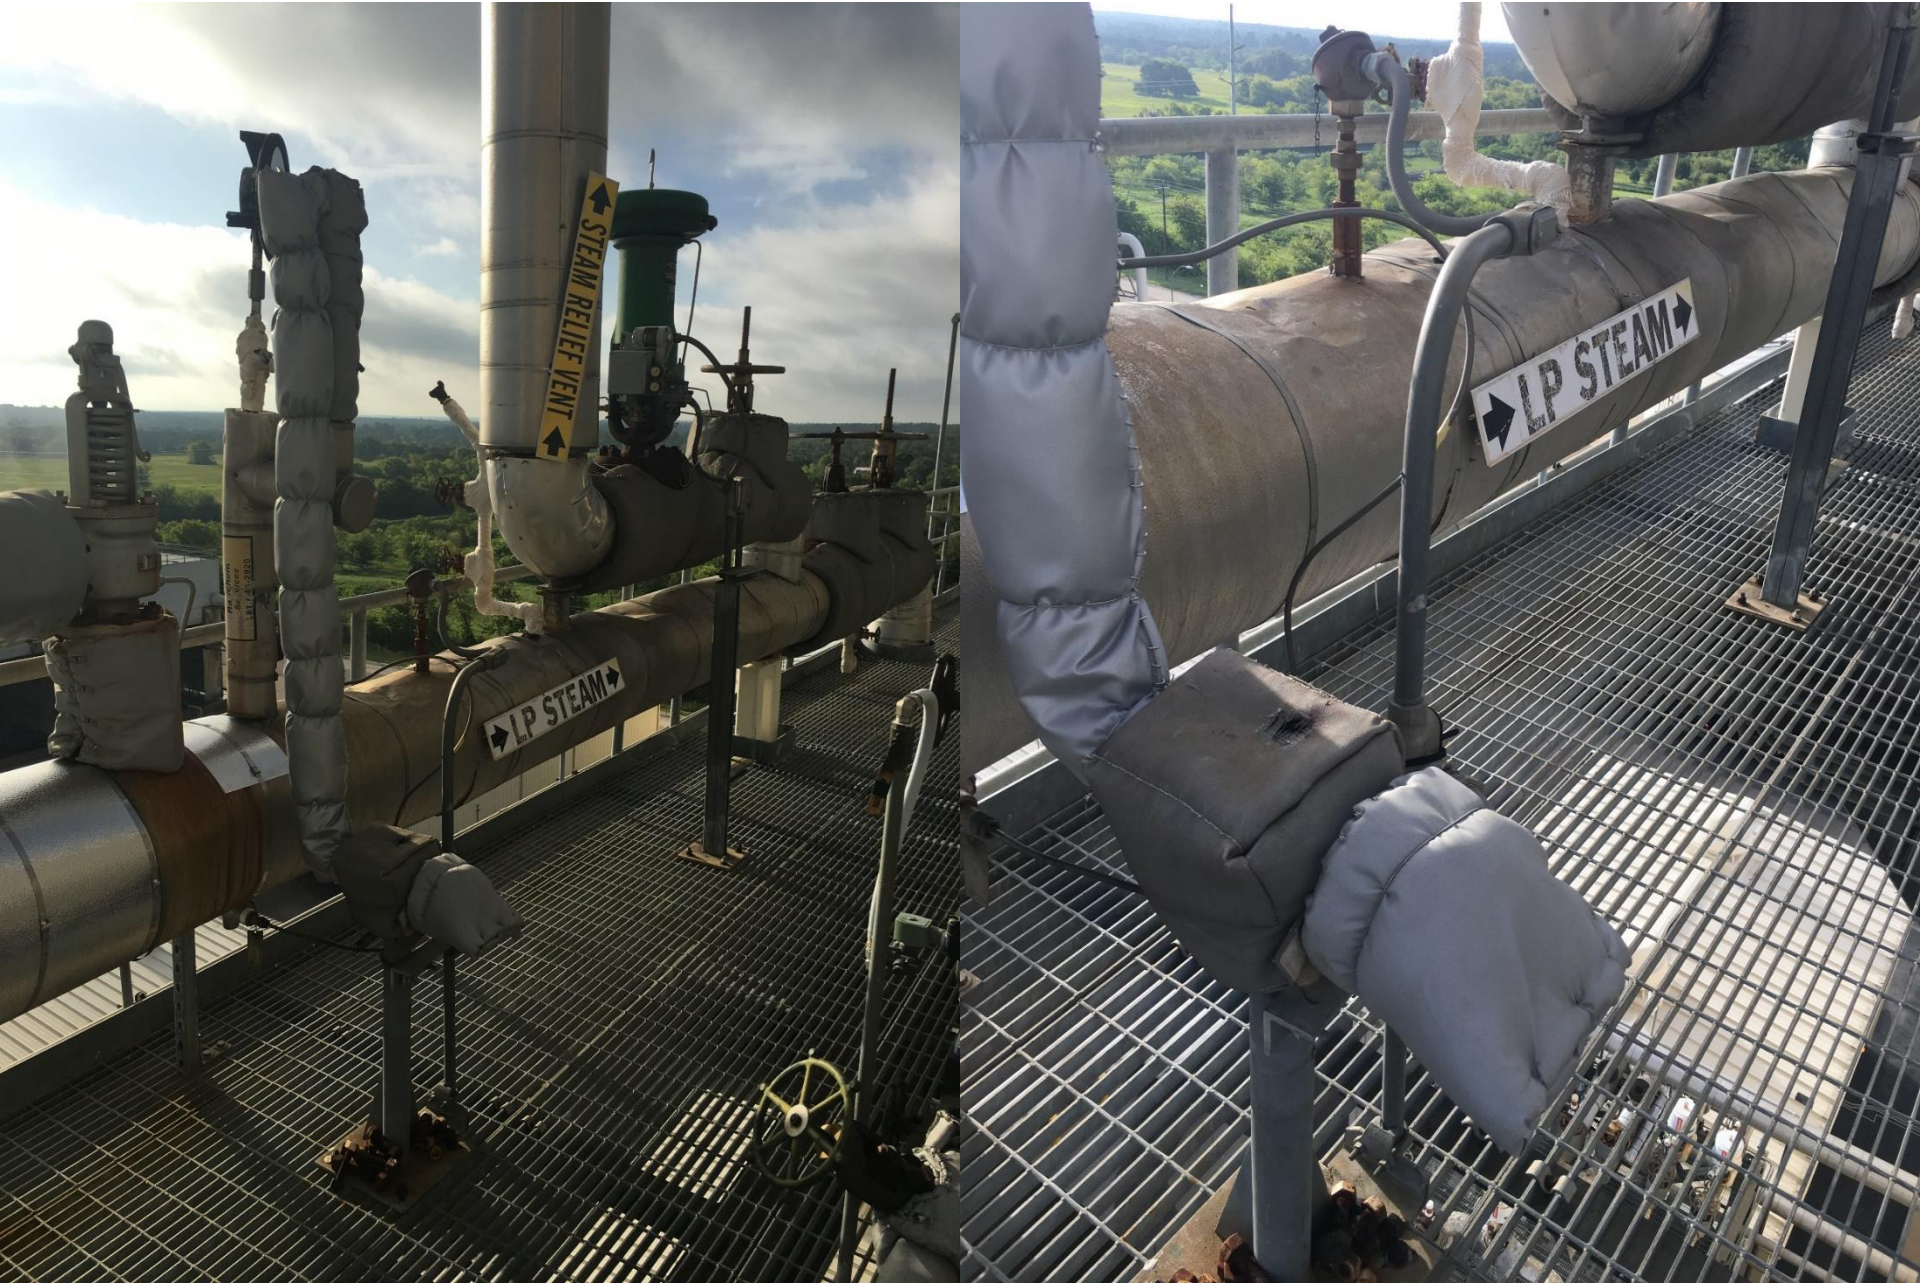
After Jan.7th event

& IP BFW FT
to drum

- IP BFW PT - Original cloth tape & plaster on the sensing lines needs newer insulation to be tightened up. Add layer of new insulation & weak solution of antifreeze to sensing lines. Complete.
- HP drum LT 'C' - Insulation is not made up in 2 places along sensing line at transmitter allowing cold air to enter. Recommend sensing line & transmitter with weak solution of antifreeze. Long term replace tubing with larger pipe.
- LP SH outlet PT- Pipe is plugged & needs replacement. Add new heat trace, insulation & diluted antifreeze solution after replacement. Complete.

- IP SH outlet FT- No heat trace (HT). Recommend new heat trace & insulation. Antifreeze at transmitter. Complete.
- IP BFW flow to drum - Operators have covered with tarp & installed a temporary lamp. Long term replace tape insulation with thicker new insulation. Antifreeze at transmitter. Complete.
- HP drum PT 'C' – Limited insulation. Removed to examine small steam leak. Fix leak & replace insulation. Complete.
- Condensate to LP economizer FTs – Insulation missing at bottom of mezzanine on west side. Complete.
