NERC and Texas RE Update

**ERCOT/Texas RE Generator Winter Weatherization
Workshop**

September 6, 2018

Sand Hill Energy Center

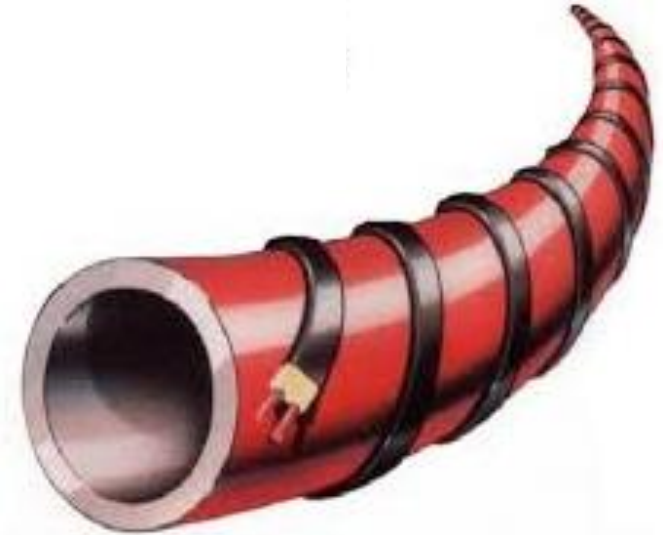
Heat Tracing Issues in the Past

- Moisture can corrode heat trace
- Insulation can fall off
- Inadvertent line damage
- Expensive to install and operate
- Test today, fails tomorrow without notice

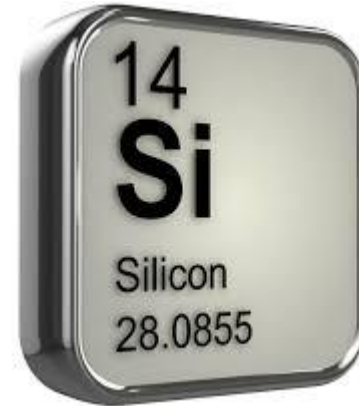
New Transmitter Issues

- Fluctuations during startup/shutdown
- Readings (fluid density) affected by:
 - Skin leaks
 - Ambient temperature
- Expensive
- Still have to heat trace leg to transmitter
