Texas Reliability Entity Event Analysis

Event:
June 27, 2011 EEA-1 Event

Texas Reliability Entity
July 15, 2011

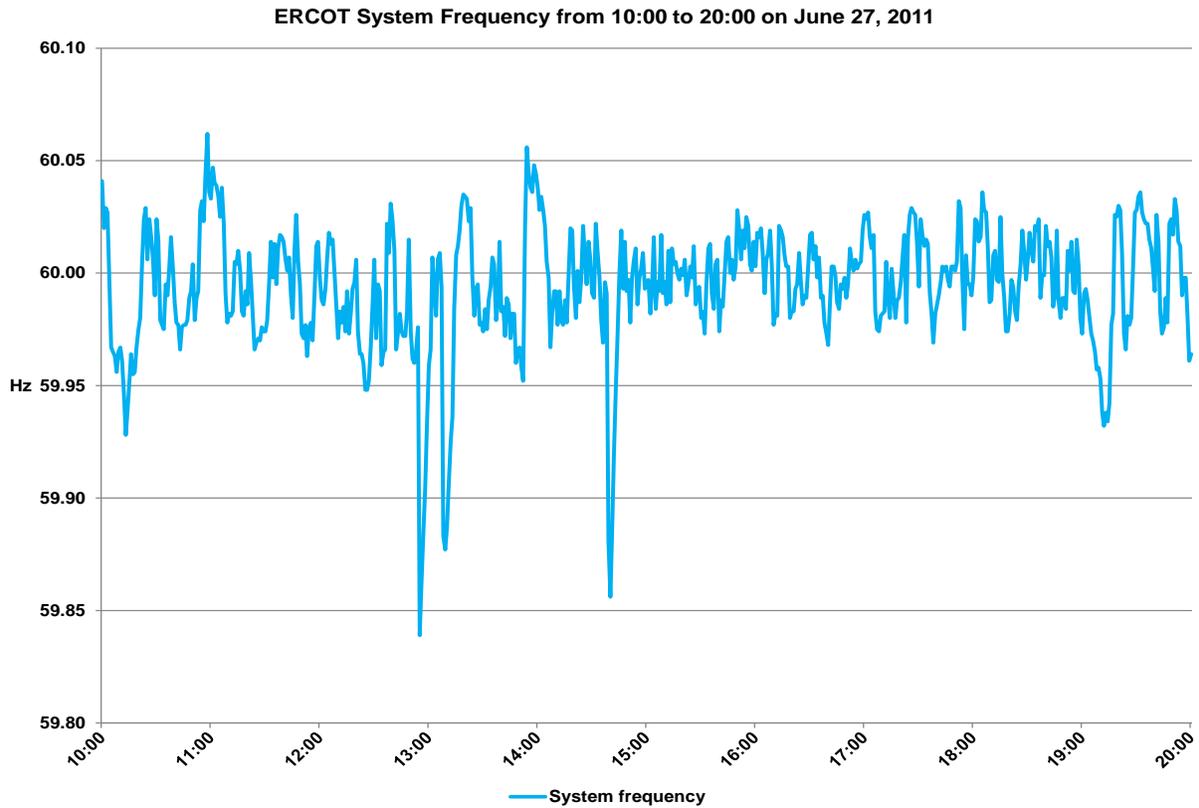
ERCOT Region system frequency (measured at the RC control center) was at 59.978 Hz immediately prior to the disturbance at 12:54. Immediately after the initial disturbance at 12:54, system frequency dropped to 59.825 Hz and recovered in 7 minutes, 44 seconds. System frequency dropped to 59.87 Hz following the second disturbance at 13:07 and recovered in 6 minutes, 14 seconds. The following are among the actions that Registered Entities initially took to stabilize the system:

- Generator governor response arrested the frequency decline, as analyzed by the Performance, Disturbance, Compliance Working Group (PDCWG) in its report. The initial calculated system frequency response, termed the "B" point, was 393.22 MW/0.1 Hz, which failed to meet the target of 420 established in ERCOT Protocols. The second calculated response point, termed "B+30" to denote that it measures how well response is sustained 30 seconds after the event, was 361.94 MW/0.1 Hz, which also failed to meet the minimum response level.
- At 13:40, BA requested deployment of 1909 MW of Non-Spin Reserve Service (NSRS).
- At 14:40, BA deployed 203 MW of responsive reserve (RRS). RRS was recalled at 14:44
- At 15:45, 20 minutes after the EEA-1 declaration, exports to Mexico were requested to be curtailed to zero through DC ties

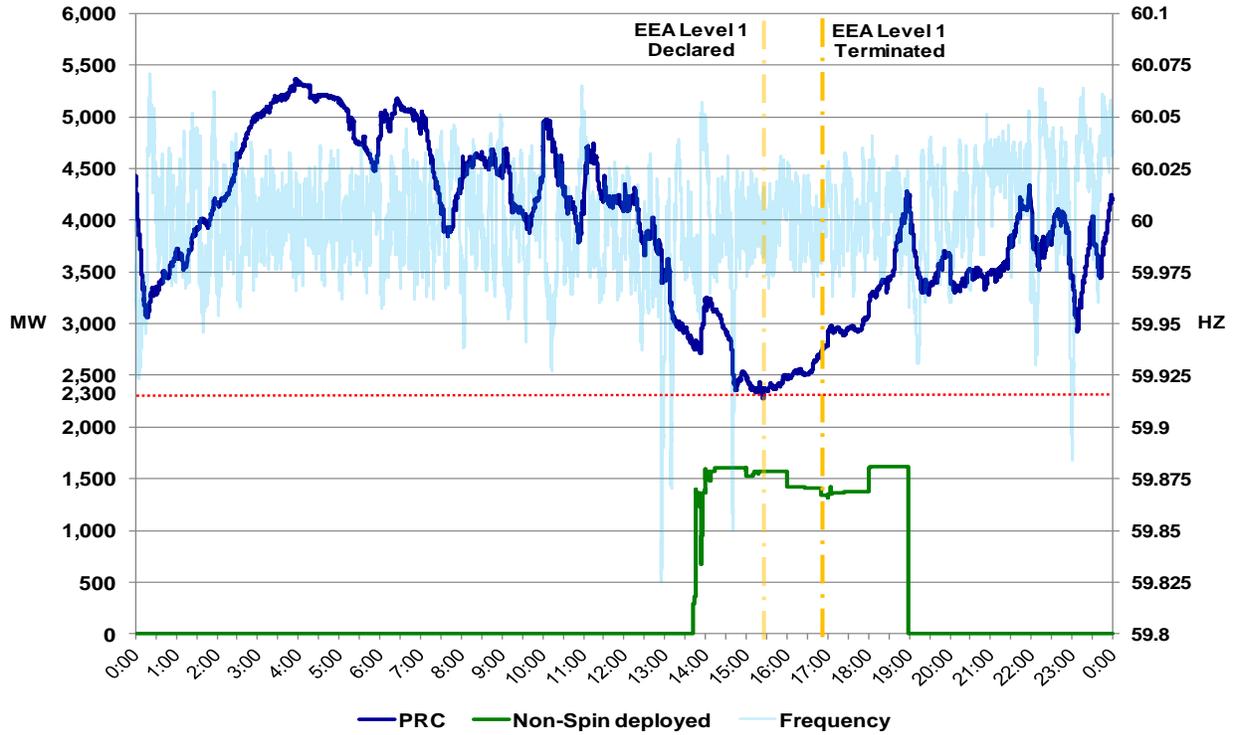
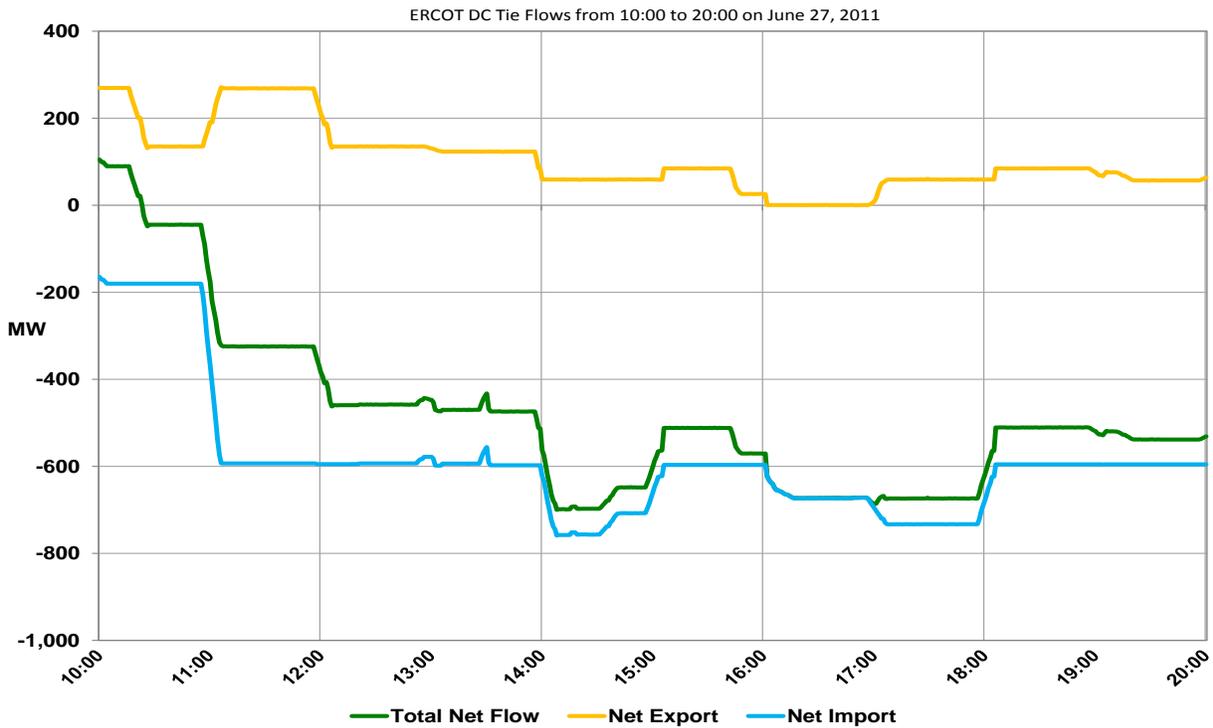
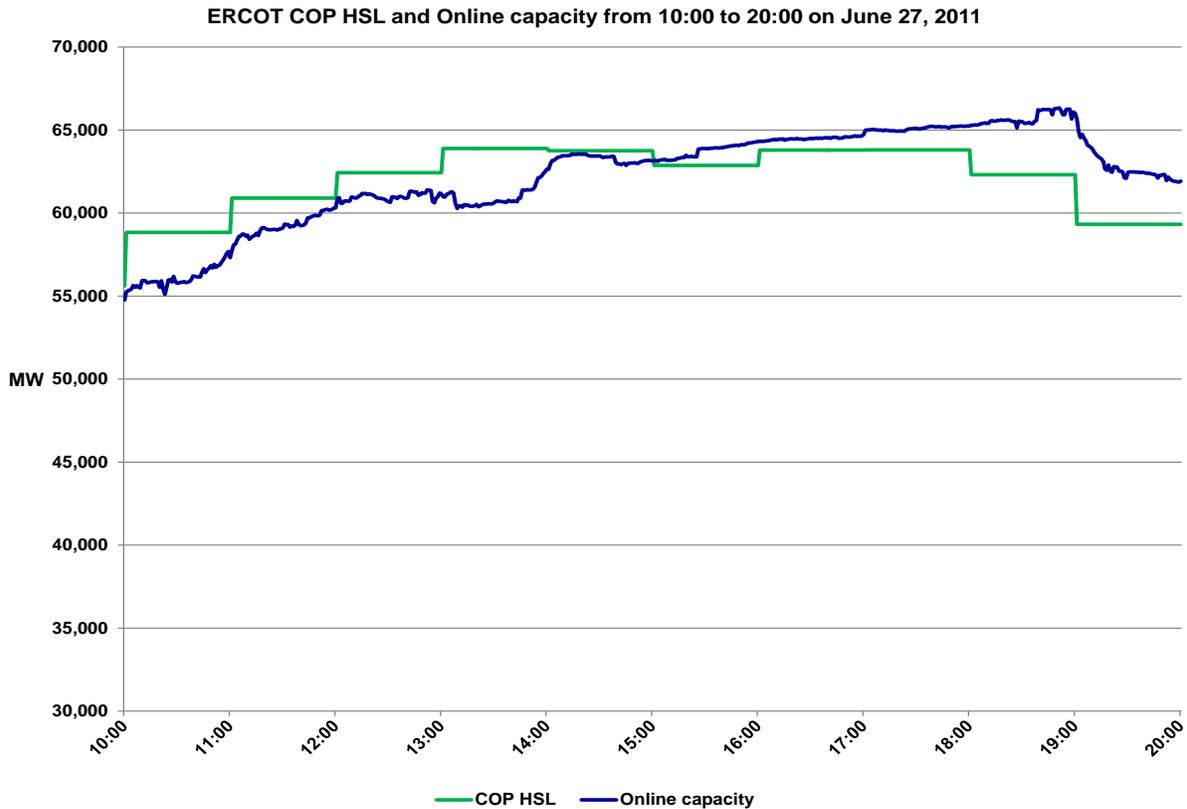
The recovery from the initial disturbance caused the reserve level to drop below 2300 MW at 15:25. The BA had previously requested 1909 MW NSRS services to deploy at 13:40 and the RC declared an EEA Level 1 at 15:25. Reserve levels recovered and the RC cancelled the EEA Level 1 at 16:50.
