Texas Reliability Entity, Inc.  
Protocol and Operating Guide Compliance Report  
For The  
February 2, 2011, Energy Emergency Alert Level 3 Event  
May 13, 2011

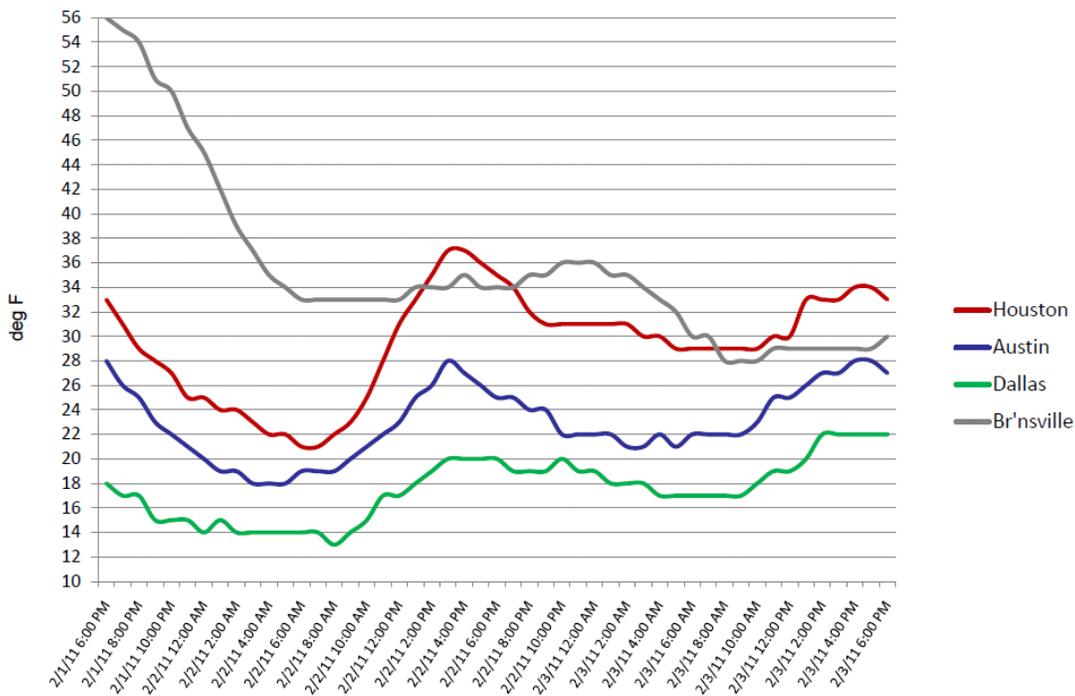
Prolonged freezing temperatures were forecast several days in advance of February 1, 2011. The freezing temperatures that were experienced across the state were accompanied by significant winds, resulting in wind chill factors ranging from -5 degrees in the Dallas area to the low teens in Austin and Houston. The chart below shows the temperatures that were actually experienced.

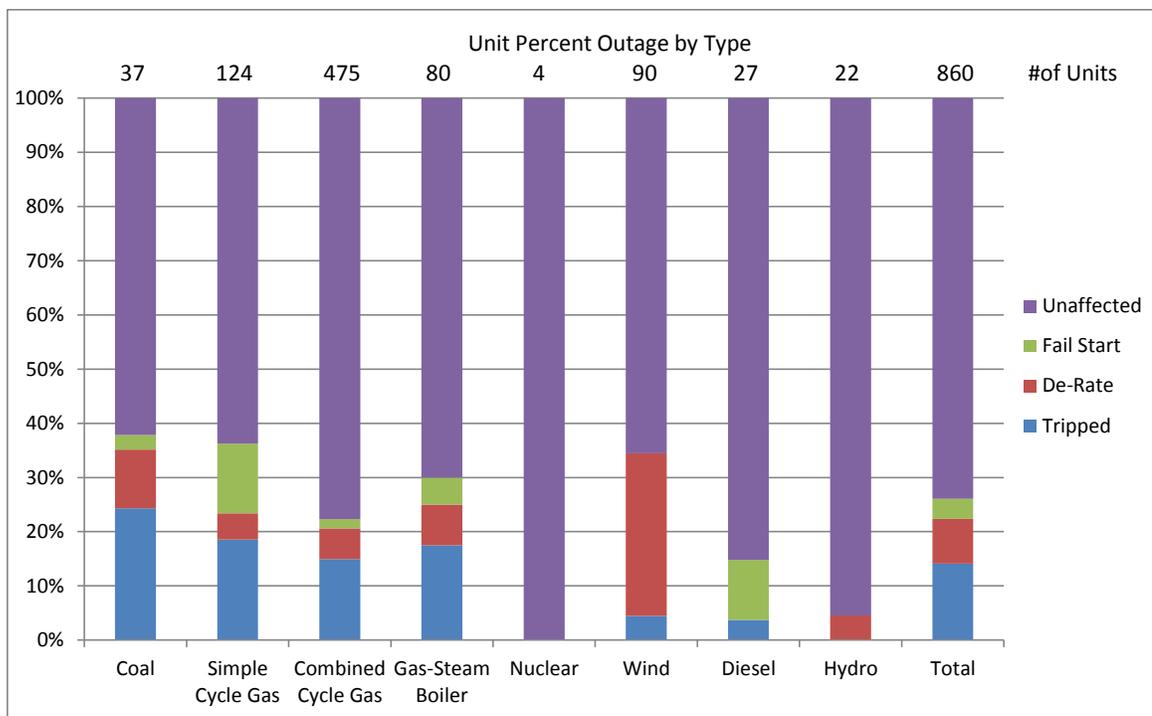
The following chart shows the percentage of generating units of various types that experienced problems due to the freezing weather. All plant types, except nuclear, experienced problems. As can be seen, the majority of plants did not experience problems. This chart shows the number of units that had problems; some units had multiple instances of tripping off-line or failing to start.

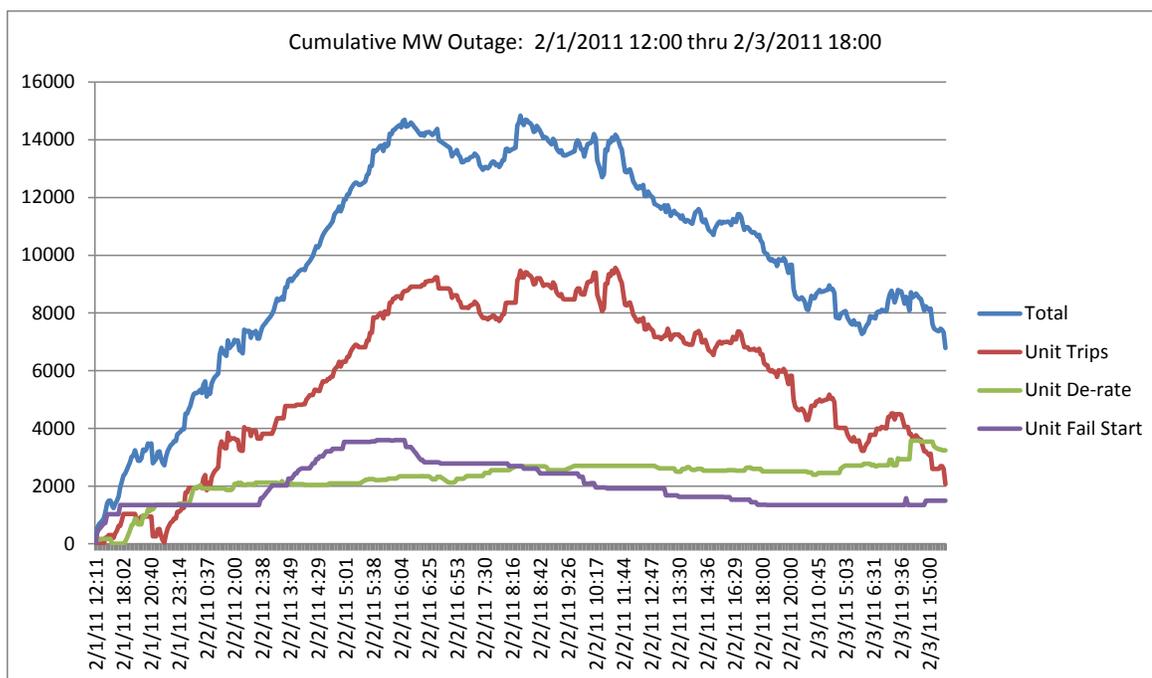
The chart below shows the magnitude of the generation capacity lost due to the prolonged freezing weather during the February 2 event, beginning at 12:00 on February 1, 2011. According to the NERC 2010/2011 Winter Reliability Assessment for the ERCOT Region, dated November 2010, 84,133 MW of existing generation was expected to be in service during the 2010/2011 winter period. The peak forced outage MW associated with the February 2 event represented 17.6% of this total capacity.

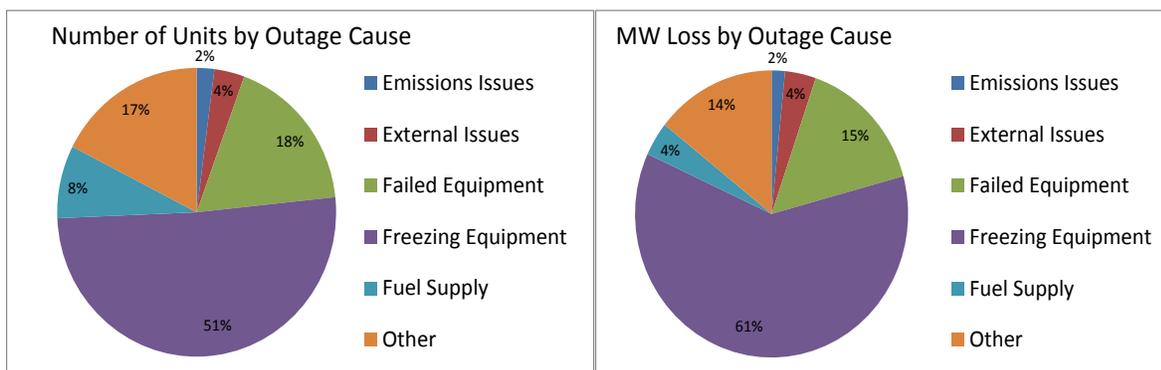
The charts below show the percentage of generating units affected by outage cause, and MW loss by outage cause. By far, the biggest issue was freezing equipment, piping, and instrumentation, which accounted for 51% of the unit issues and 61% of the unavailable capacity. Failed equipment accounted for an additional 18% of the unit issues and 15% of the unavailable capacity. Transmission issues external to the power plants accounted for 4% of the unit issues and 4% of the unavailable capacity.

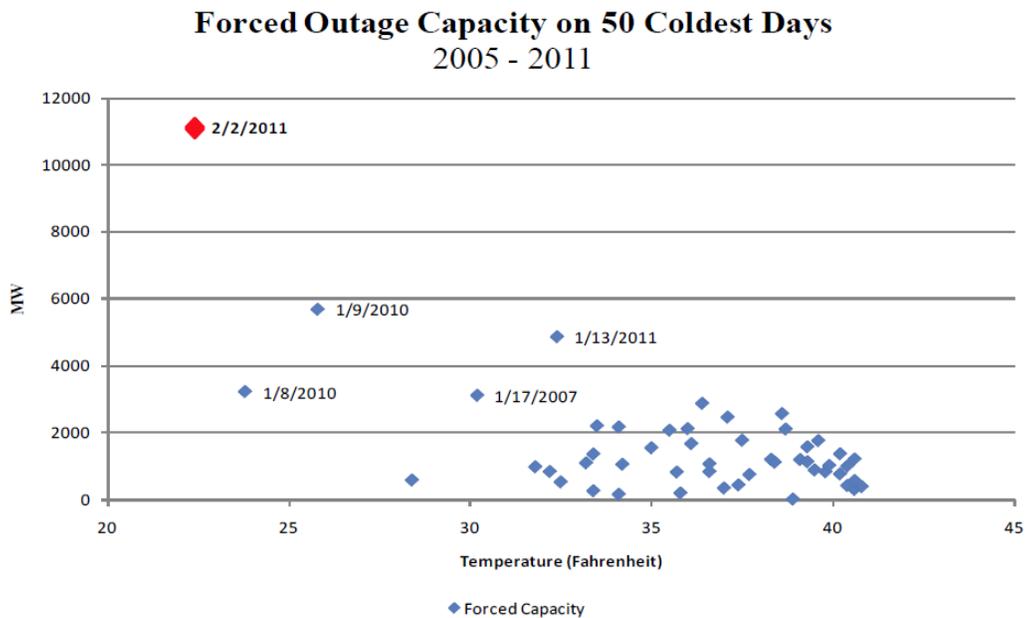
The following chart, which shows the number of forced outages on the fifty coldest days from 2005 to 2011, indicates a higher than normal level of generation outages should be anticipated and planned for during prolonged freezing weather. A concern about ERCOT's planning approach is whether ERCOT made an underlying assumption that forced outages for generation units were expected to occur at the same rate at a temperature of 18°F as would be expected at a temperature of 70°F. That is, it appears the planned reserves took into account a forecasted increase in demand, but may not have adequately taken into account the possibility of an increase in the number of generating facilities that might fail due to weather. However, because of the extraordinary number of plant failures that occurred on February 2, it would have been very difficult for ERCOT to predict or plan for so many generation units being impacted by the cold weather.

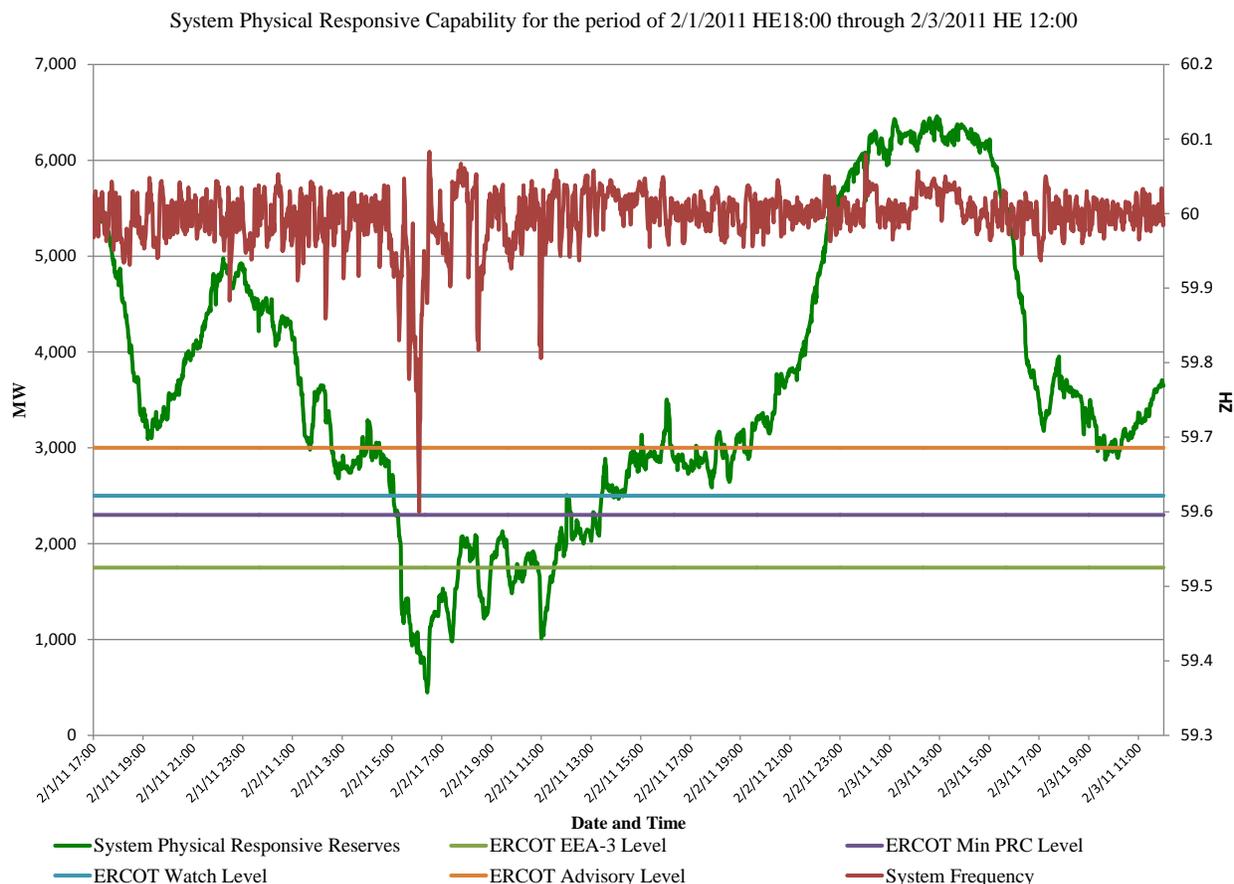
The chart below shows the PRC level and system frequency for the period from February 2, 2011, at 06:00 to February 3, 2011, at 12:00. When the reserve level dropped below 3000 MW of reserves, ERCOT Operating Procedures required ERCOT to issue an Advisory notice, which occurred at 02:47. Reserve levels dropped to 2500 MW at 05:04, causing ERCOT to issue a Watch notice at 05:08. Reserve levels fell below the 2300 MW minimum level at 05:15, causing ERCOT to declare EEA Level 2A at 05:18. Reserve levels and frequency continued to worsen, and ERCOT declared EEA Level 3 at 05:43, the point at which manual load shedding is ordered.

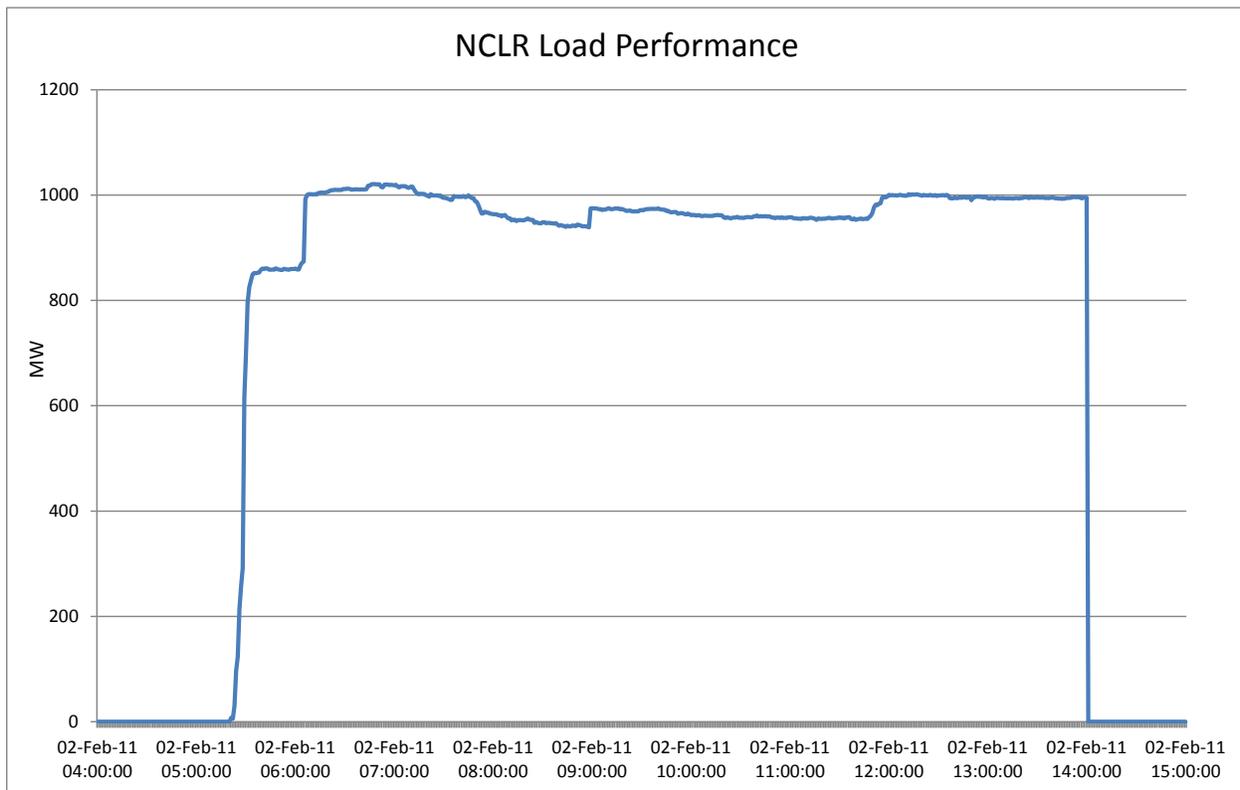
The chart below displays the NCLR performance during the event.

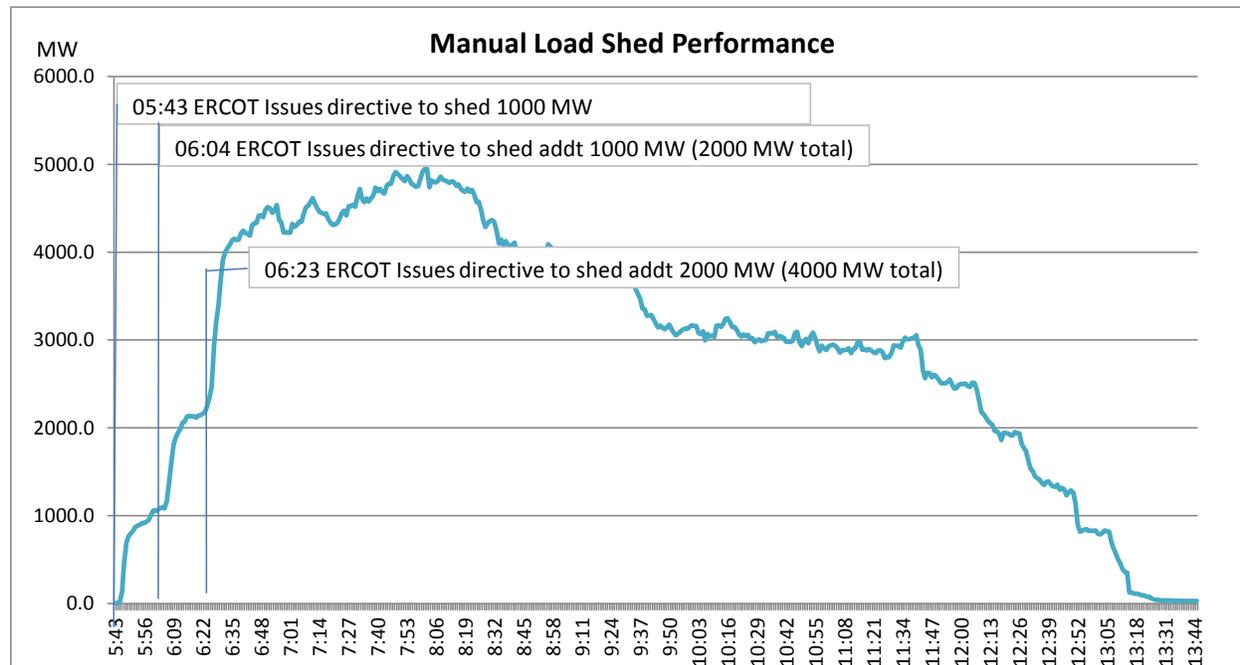
The actual performance of the manual load shed exceeded the obligation, with a peak load shed value exceeding 4900 MW at 08:02. The chart below shows the manual load shed performance over the course of the event.
